FINAL REPORT:

Lake Illawarra Bank Management Strategy

November 2022

Lake Illawarra Coastal Management Program

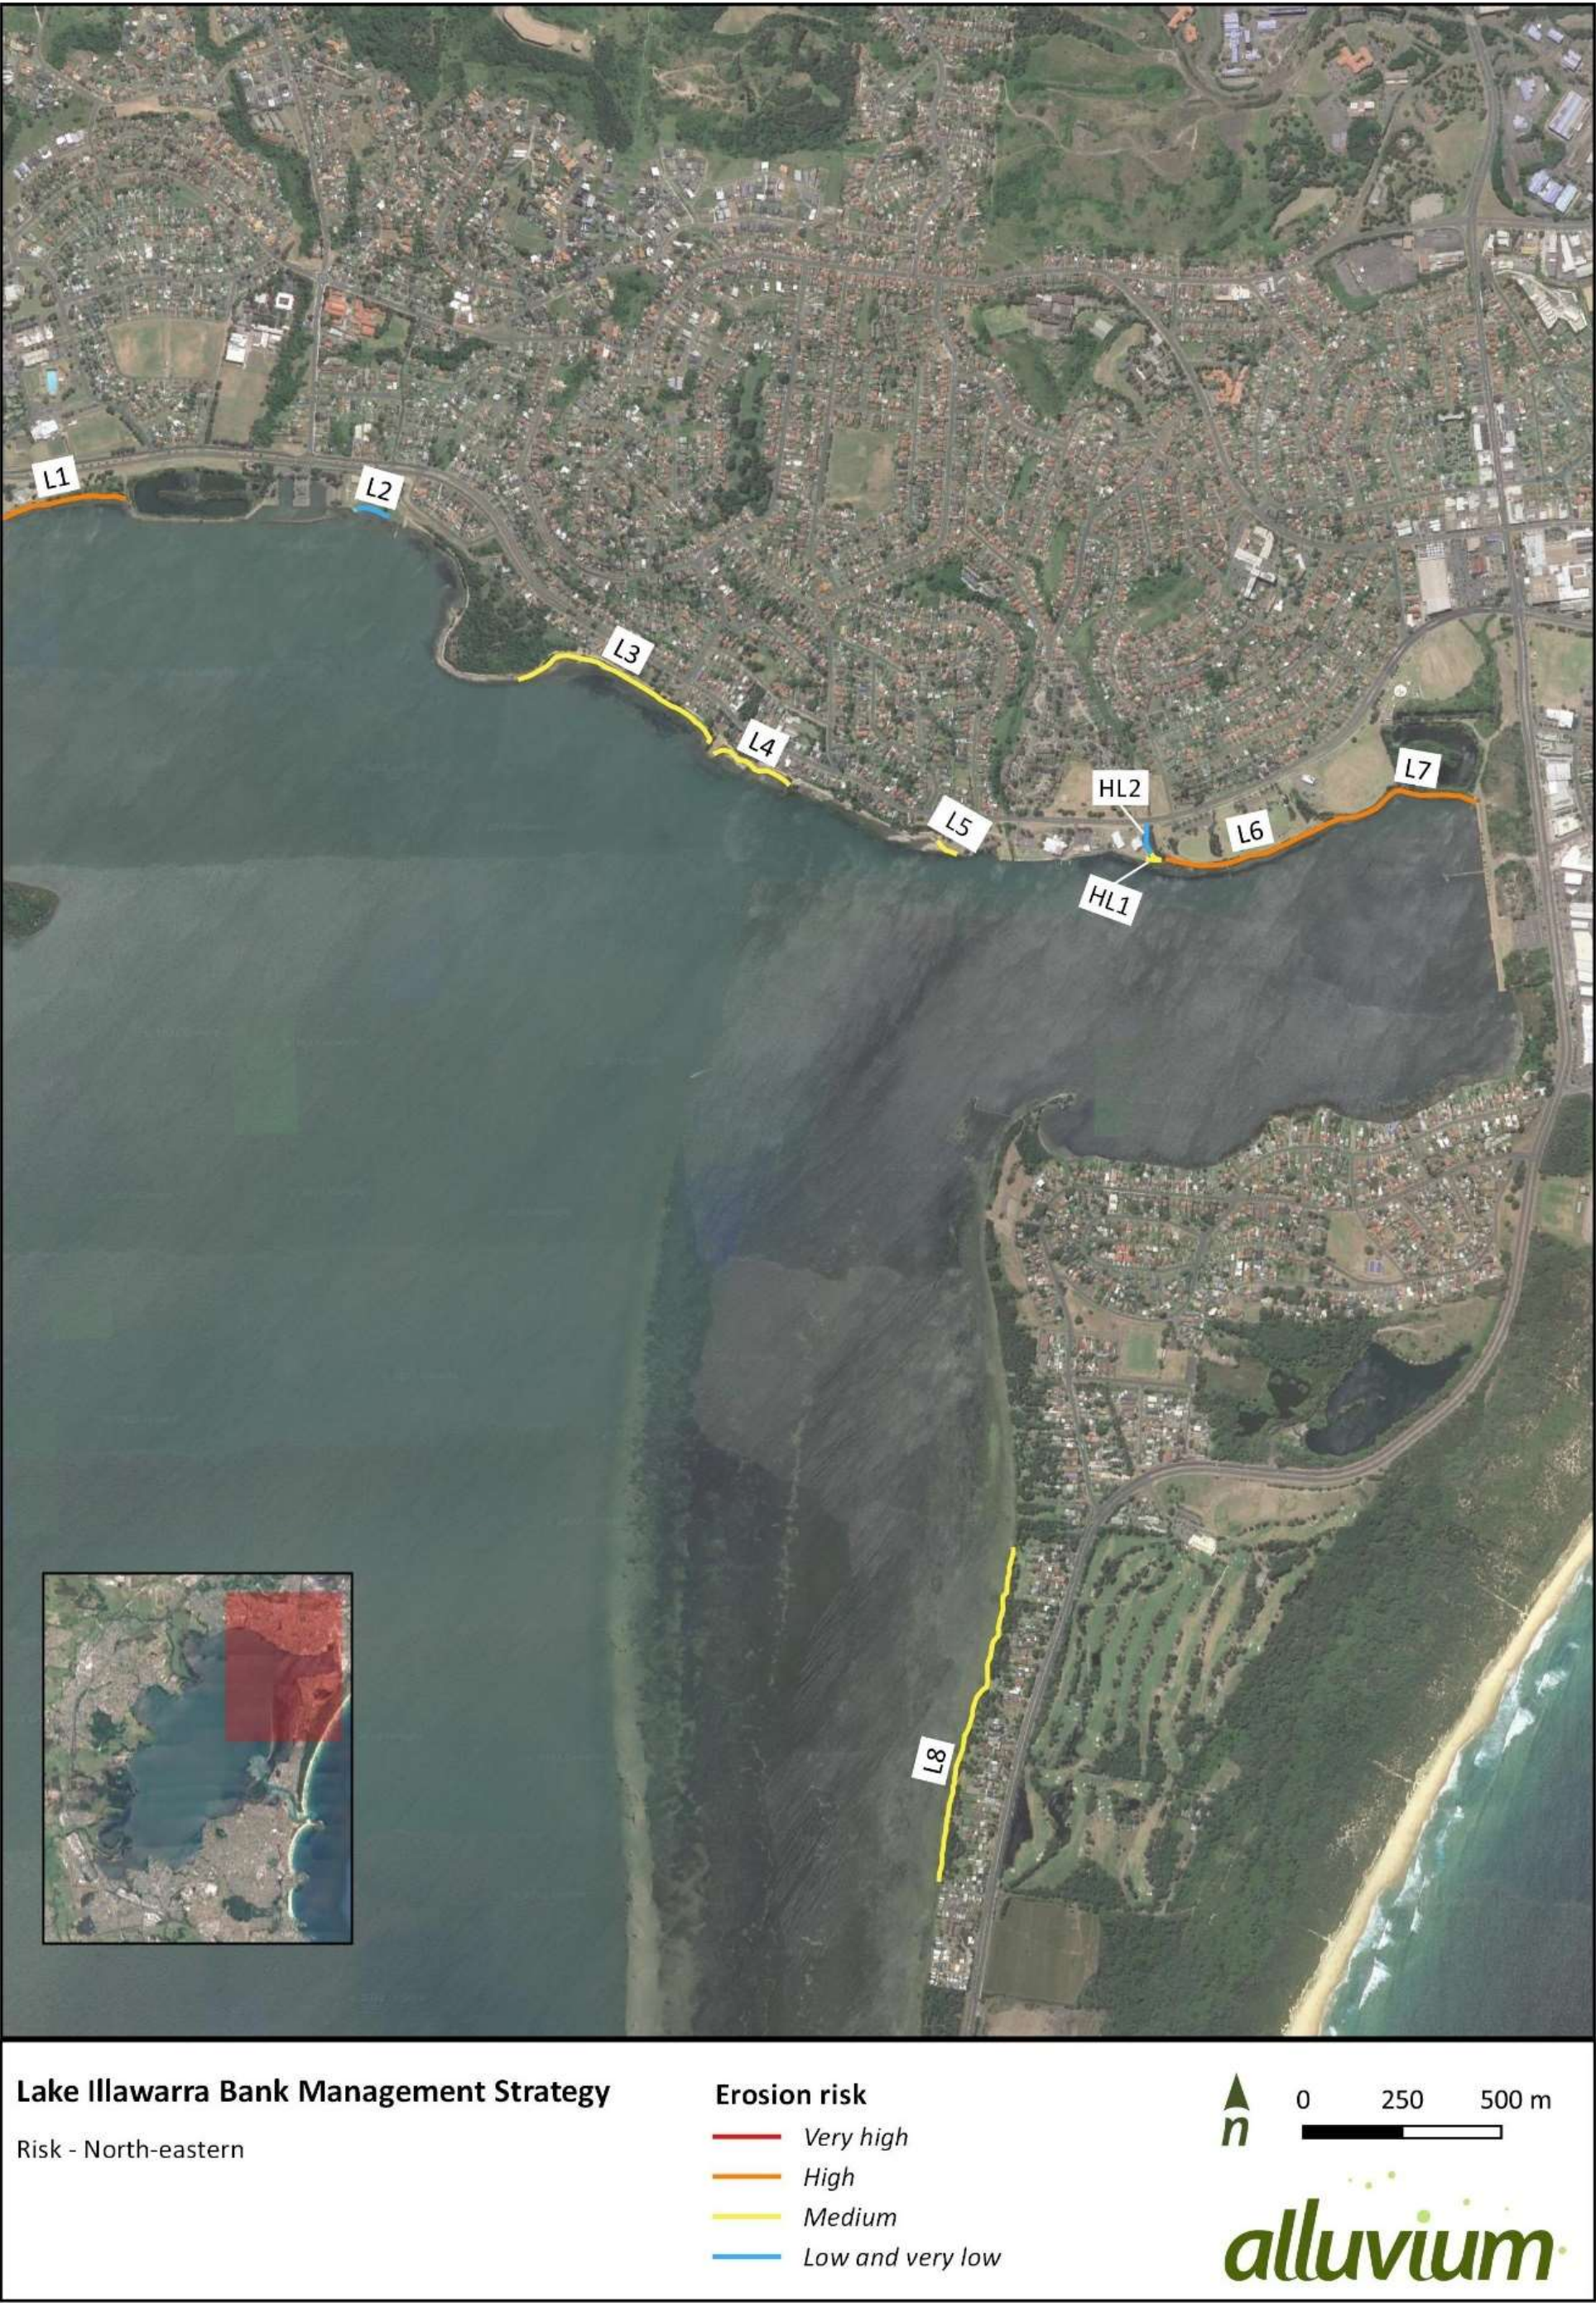
Figure 8. A map showing the results of the erosion risk assessment in the North-eastern quadrant

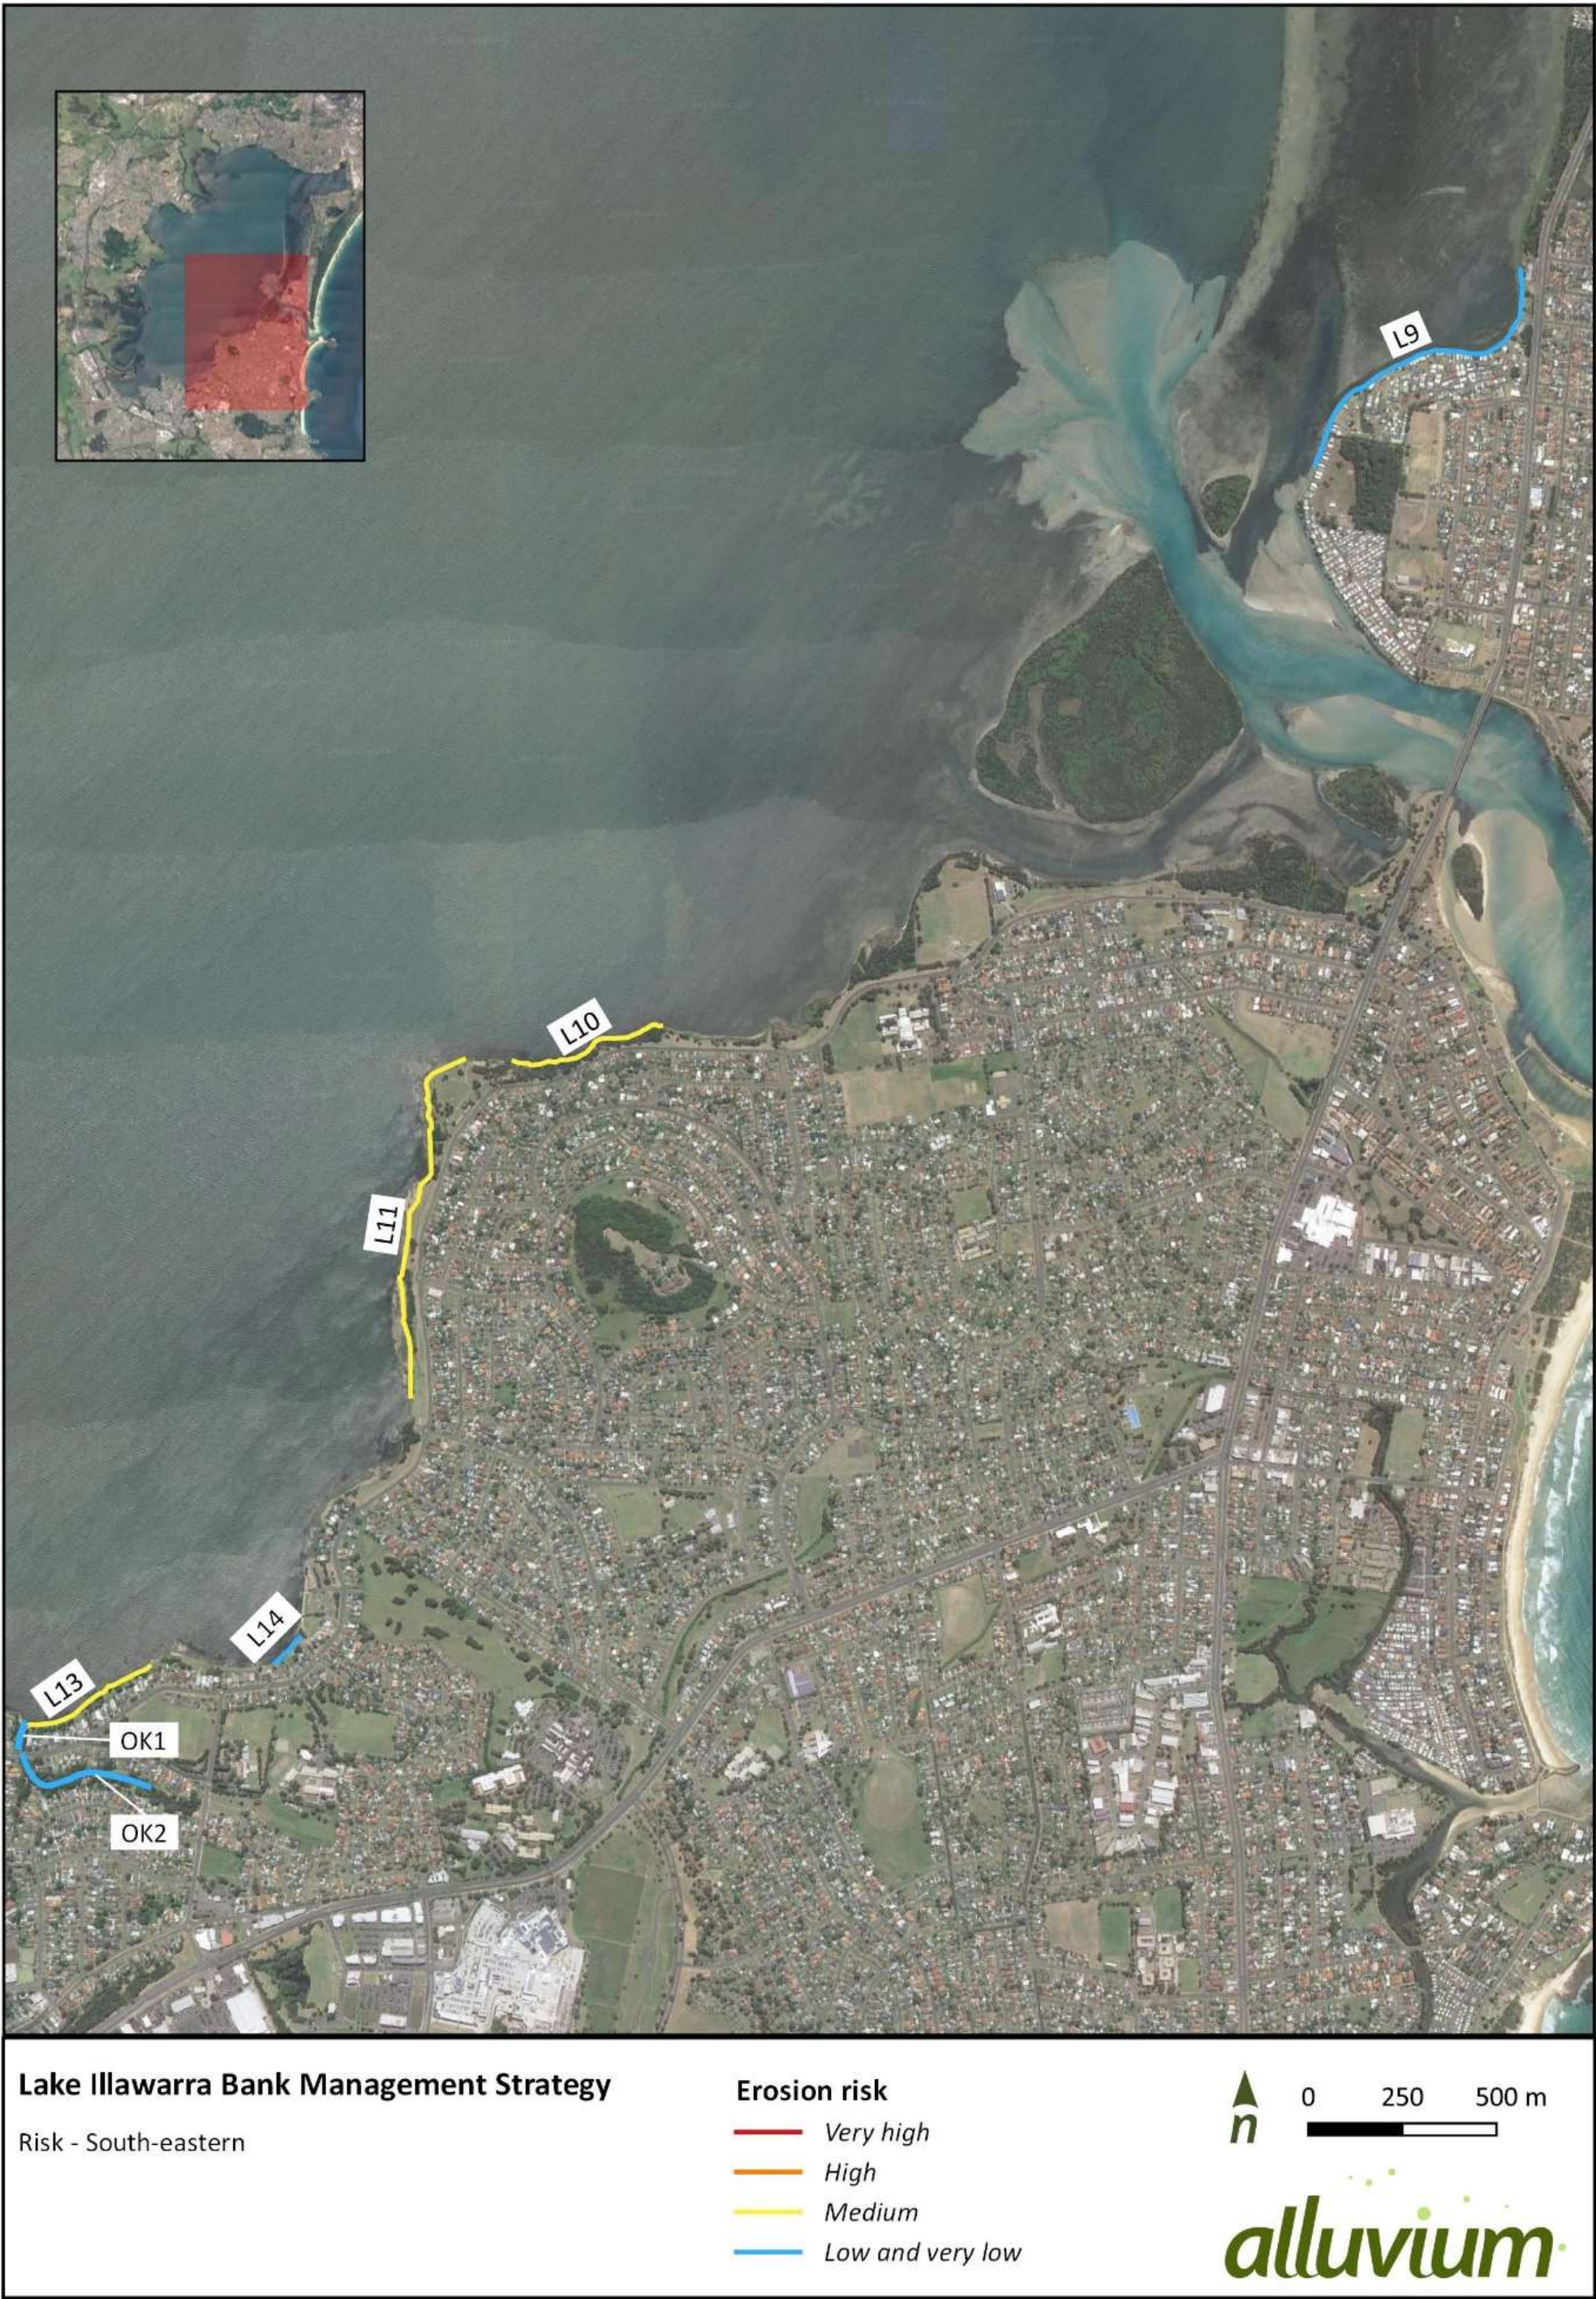
Figure 9. A map showing the results of the erosion risk assessment in the South-eastern quadrant

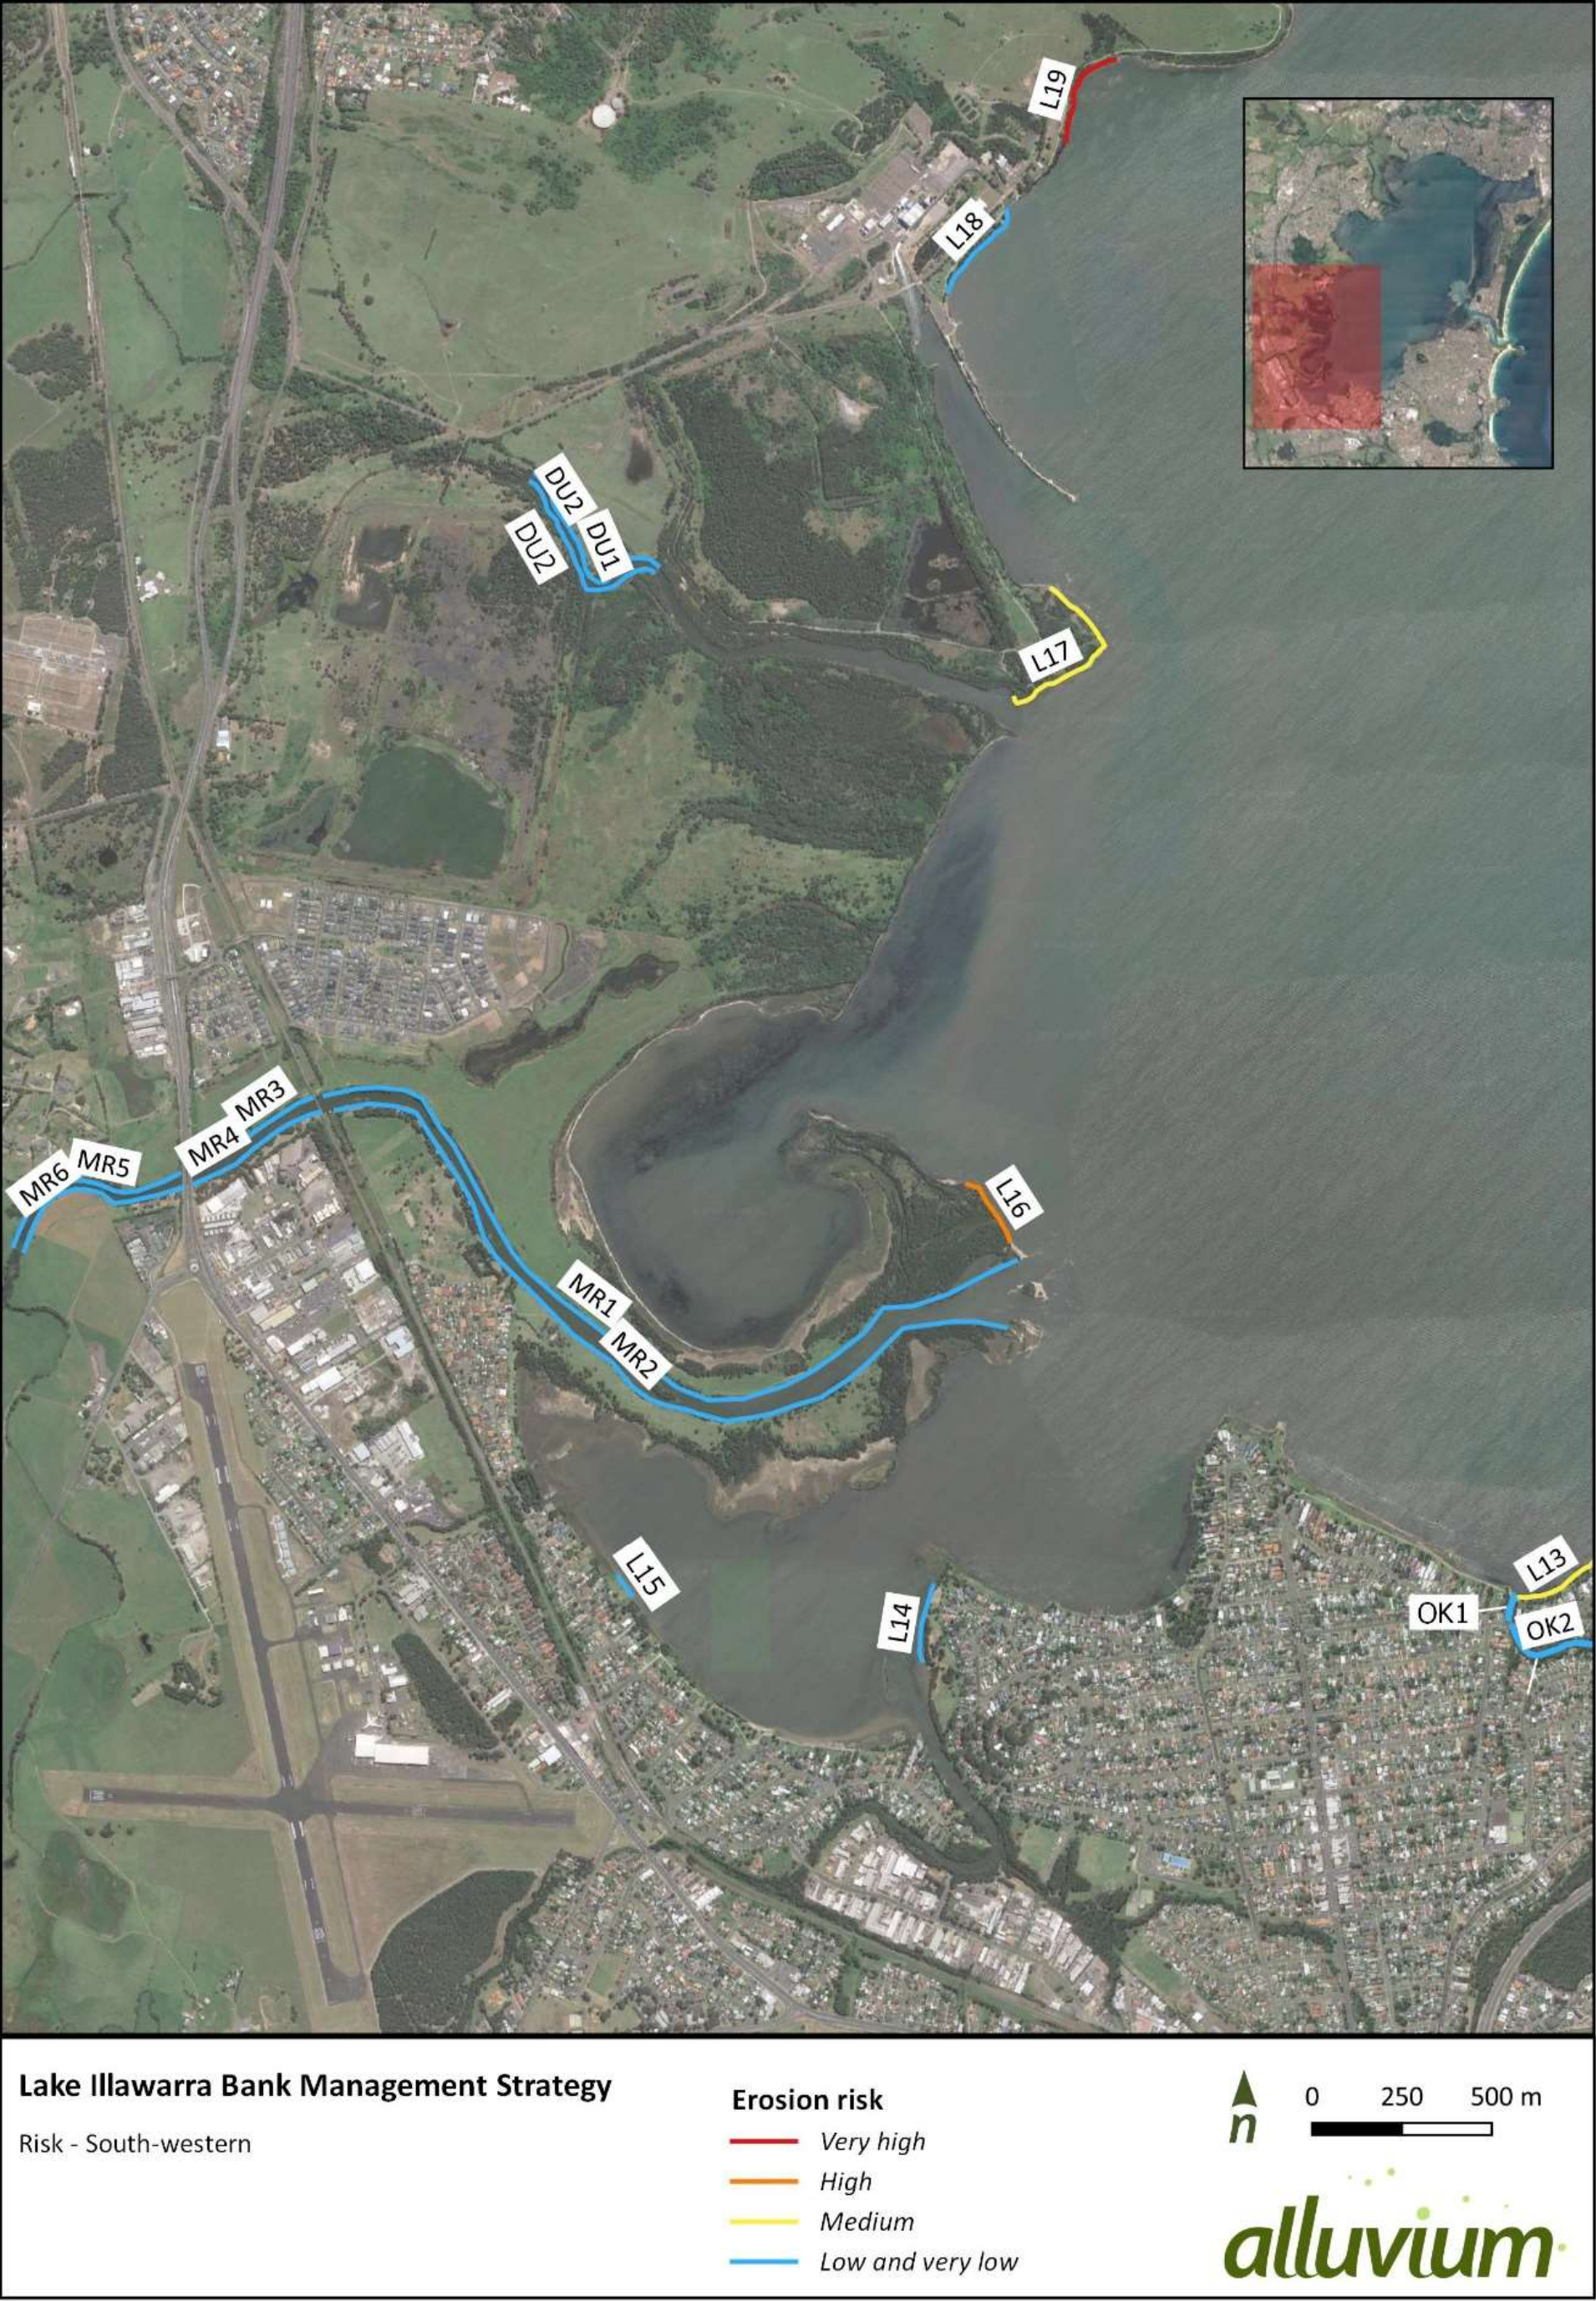
Figure 10. A map showing the results of the erosion risk assessment in the South-western quadrant

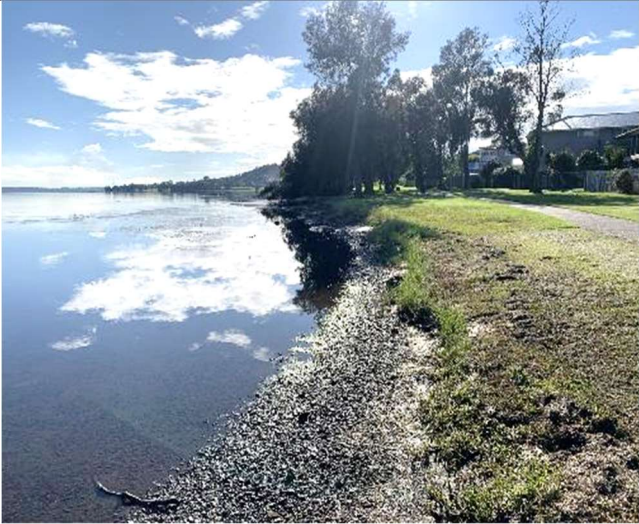
| Site descriptor | Key characteristics | Example photo | Sites | Options |
|---|--|--|---|---|
| 1. Lake shoreline with poor vegetation coverage | <ul style="list-style-type: none"> • Lakefront • Shallow water • Low angle shoreline • High amenity areas • Poor vegetation coverage • Wind wave dominated erosion | <p>(photo taken on 5 April 2022)</p> | L1, L3, L5, L13, L20, L6*, L8* | <ul style="list-style-type: none"> • Revegetation • Low key stabilisation with logs, or rock rubble, or geotextile sandbags |

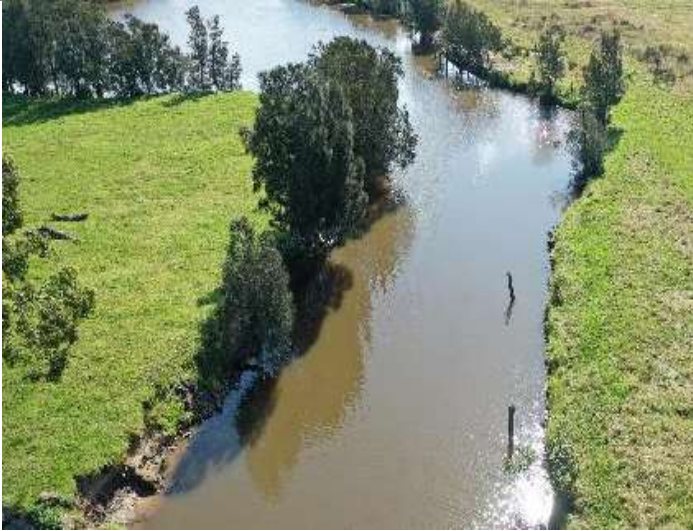
| 5. Tributary channel with poor riparian vegetation corridor | <ul style="list-style-type: none"> • Within tributary channel • Vertical banks • Mixed amenity areas • Patchy, discontinuous, and narrow vegetation corridor • Erosion scarps in active areas of erosion • Exposed to fluvial and tidal currents • Bank saturation contributes to erosion | <p>(photo taken on 5 April 2022)</p> | MU1, MU2, MT1, MR1, MR2, MR4, MR6 | <ul style="list-style-type: none"> • Revegetation and stock exclusion fencing • Bank reprofiling in active erosion areas • Large woody debris to reduce fluvial energy and enhance fish habitat in active erosion areas |

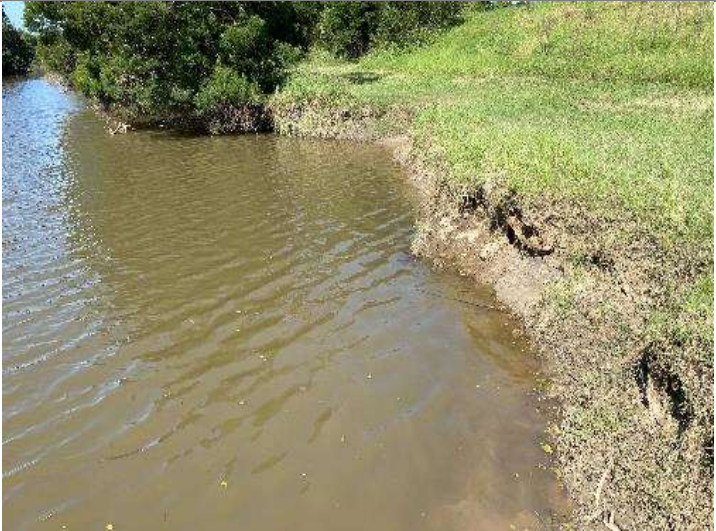
| 7. Tributary with meander development | <ul style="list-style-type: none"> • Within tributary channel • Low erosion scarp • Erosion at the edge of existing rock protection • Meander cut-off prevented by existing rock protection • Carpark within the meander peninsula • Discontinuous /poor vegetation • Exposed to fluvial and weak tidal currents | <p>(photo taken on 5 April 2022)</p> | MU5, MU7 | <ul style="list-style-type: none"> • Revegetation and monitoring • Toe or bank stabilisation works in active erosion areas (logs, piled rock or geotextile sandbags) |

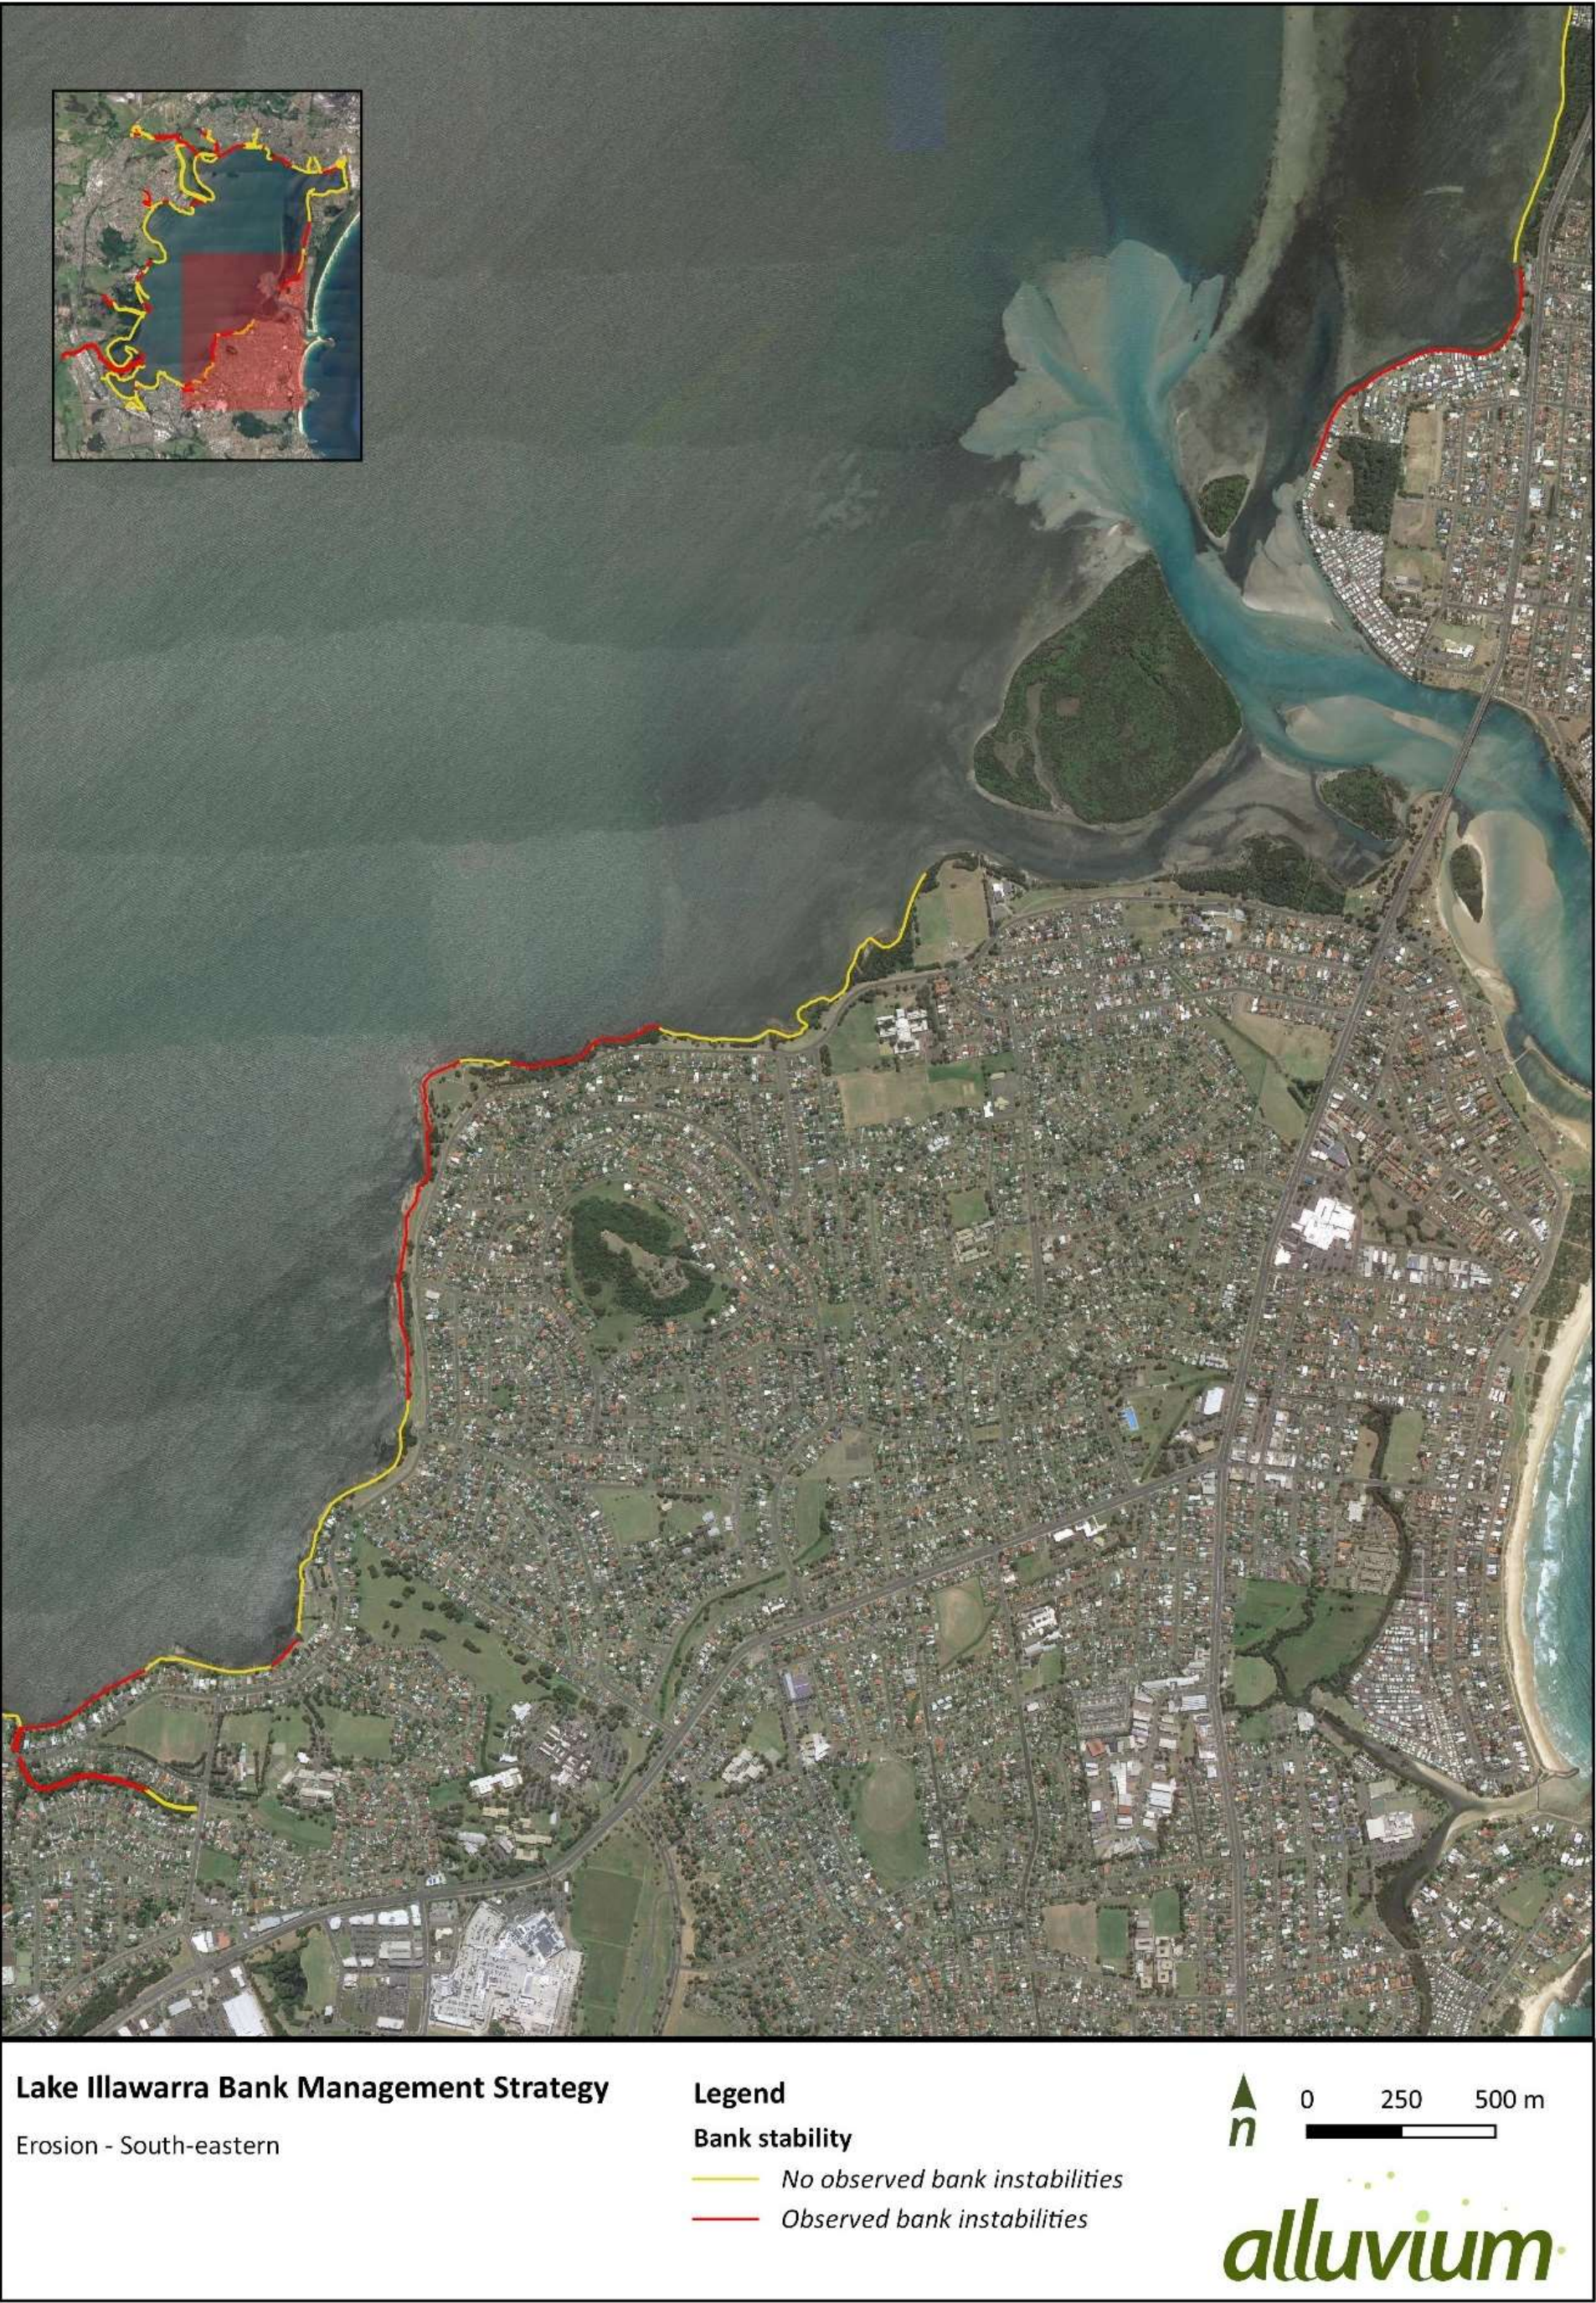
Figure 17. Observed erosion in the South-eastern quadrant

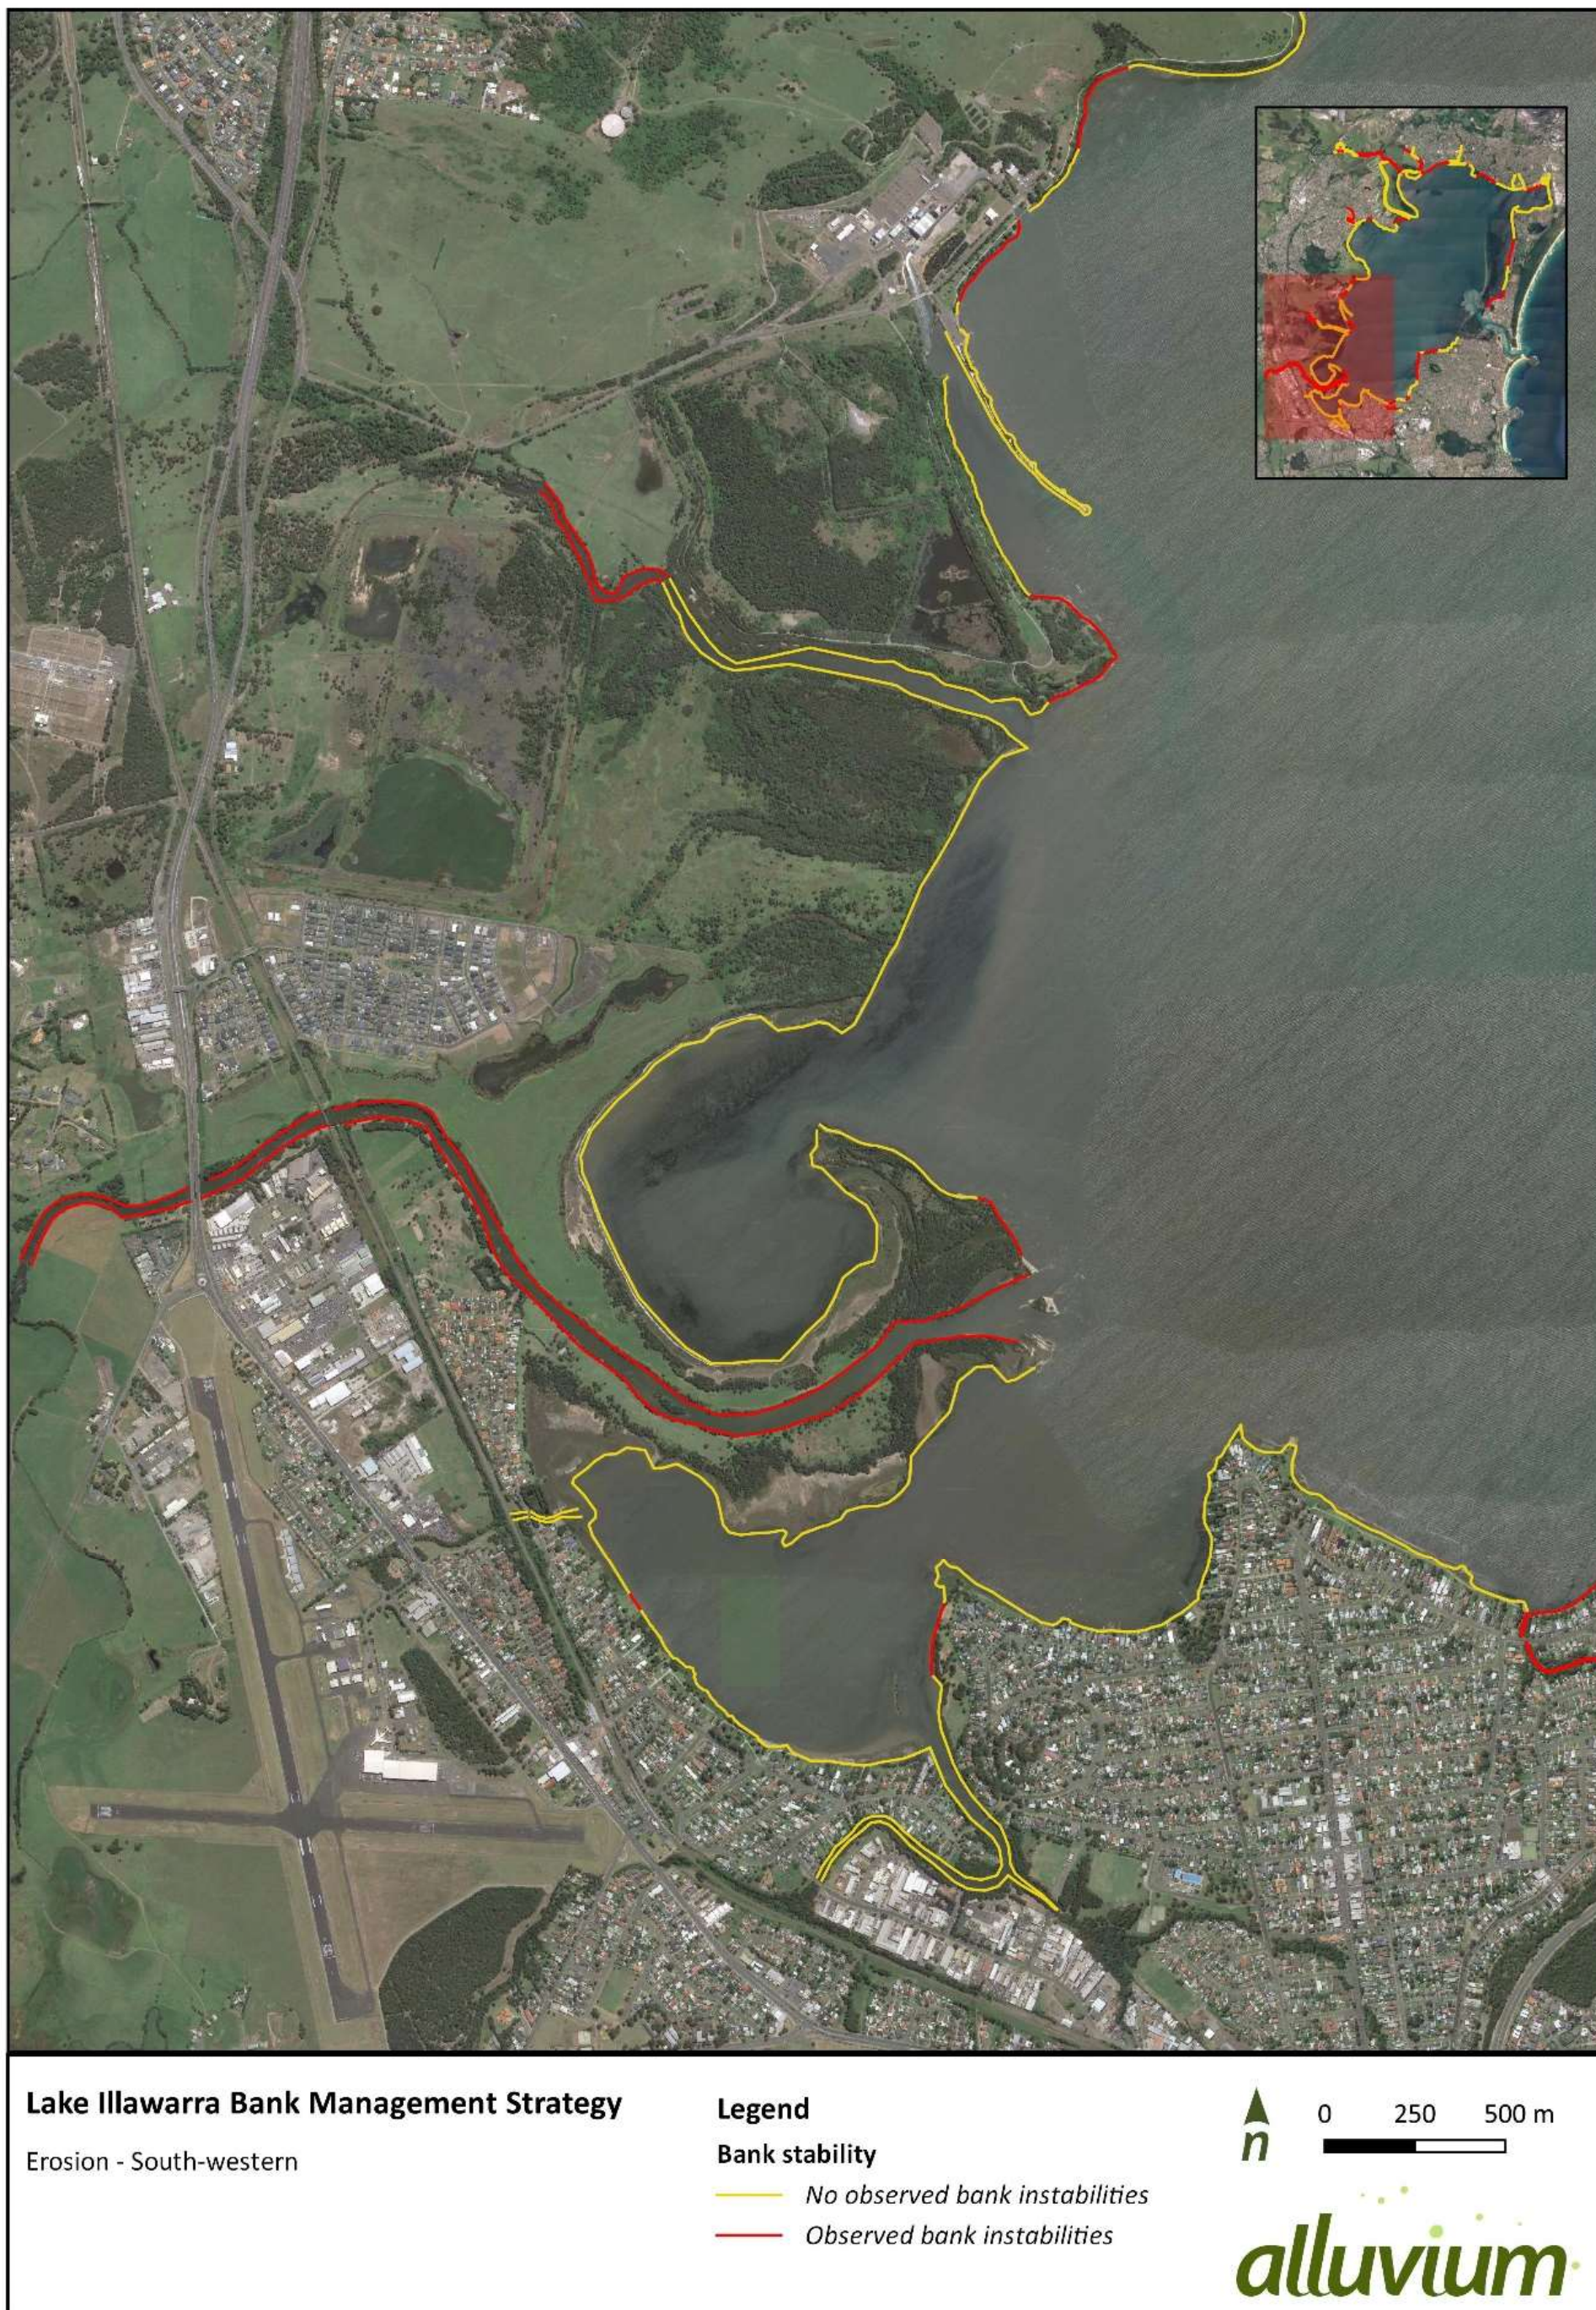
Figure 18. Observed erosion in the South-western quadrant
