FINAL REPORT:

Lake Illawarra Bank Management Strategy

November 2022

Lake Illawarra Coastal Management Program

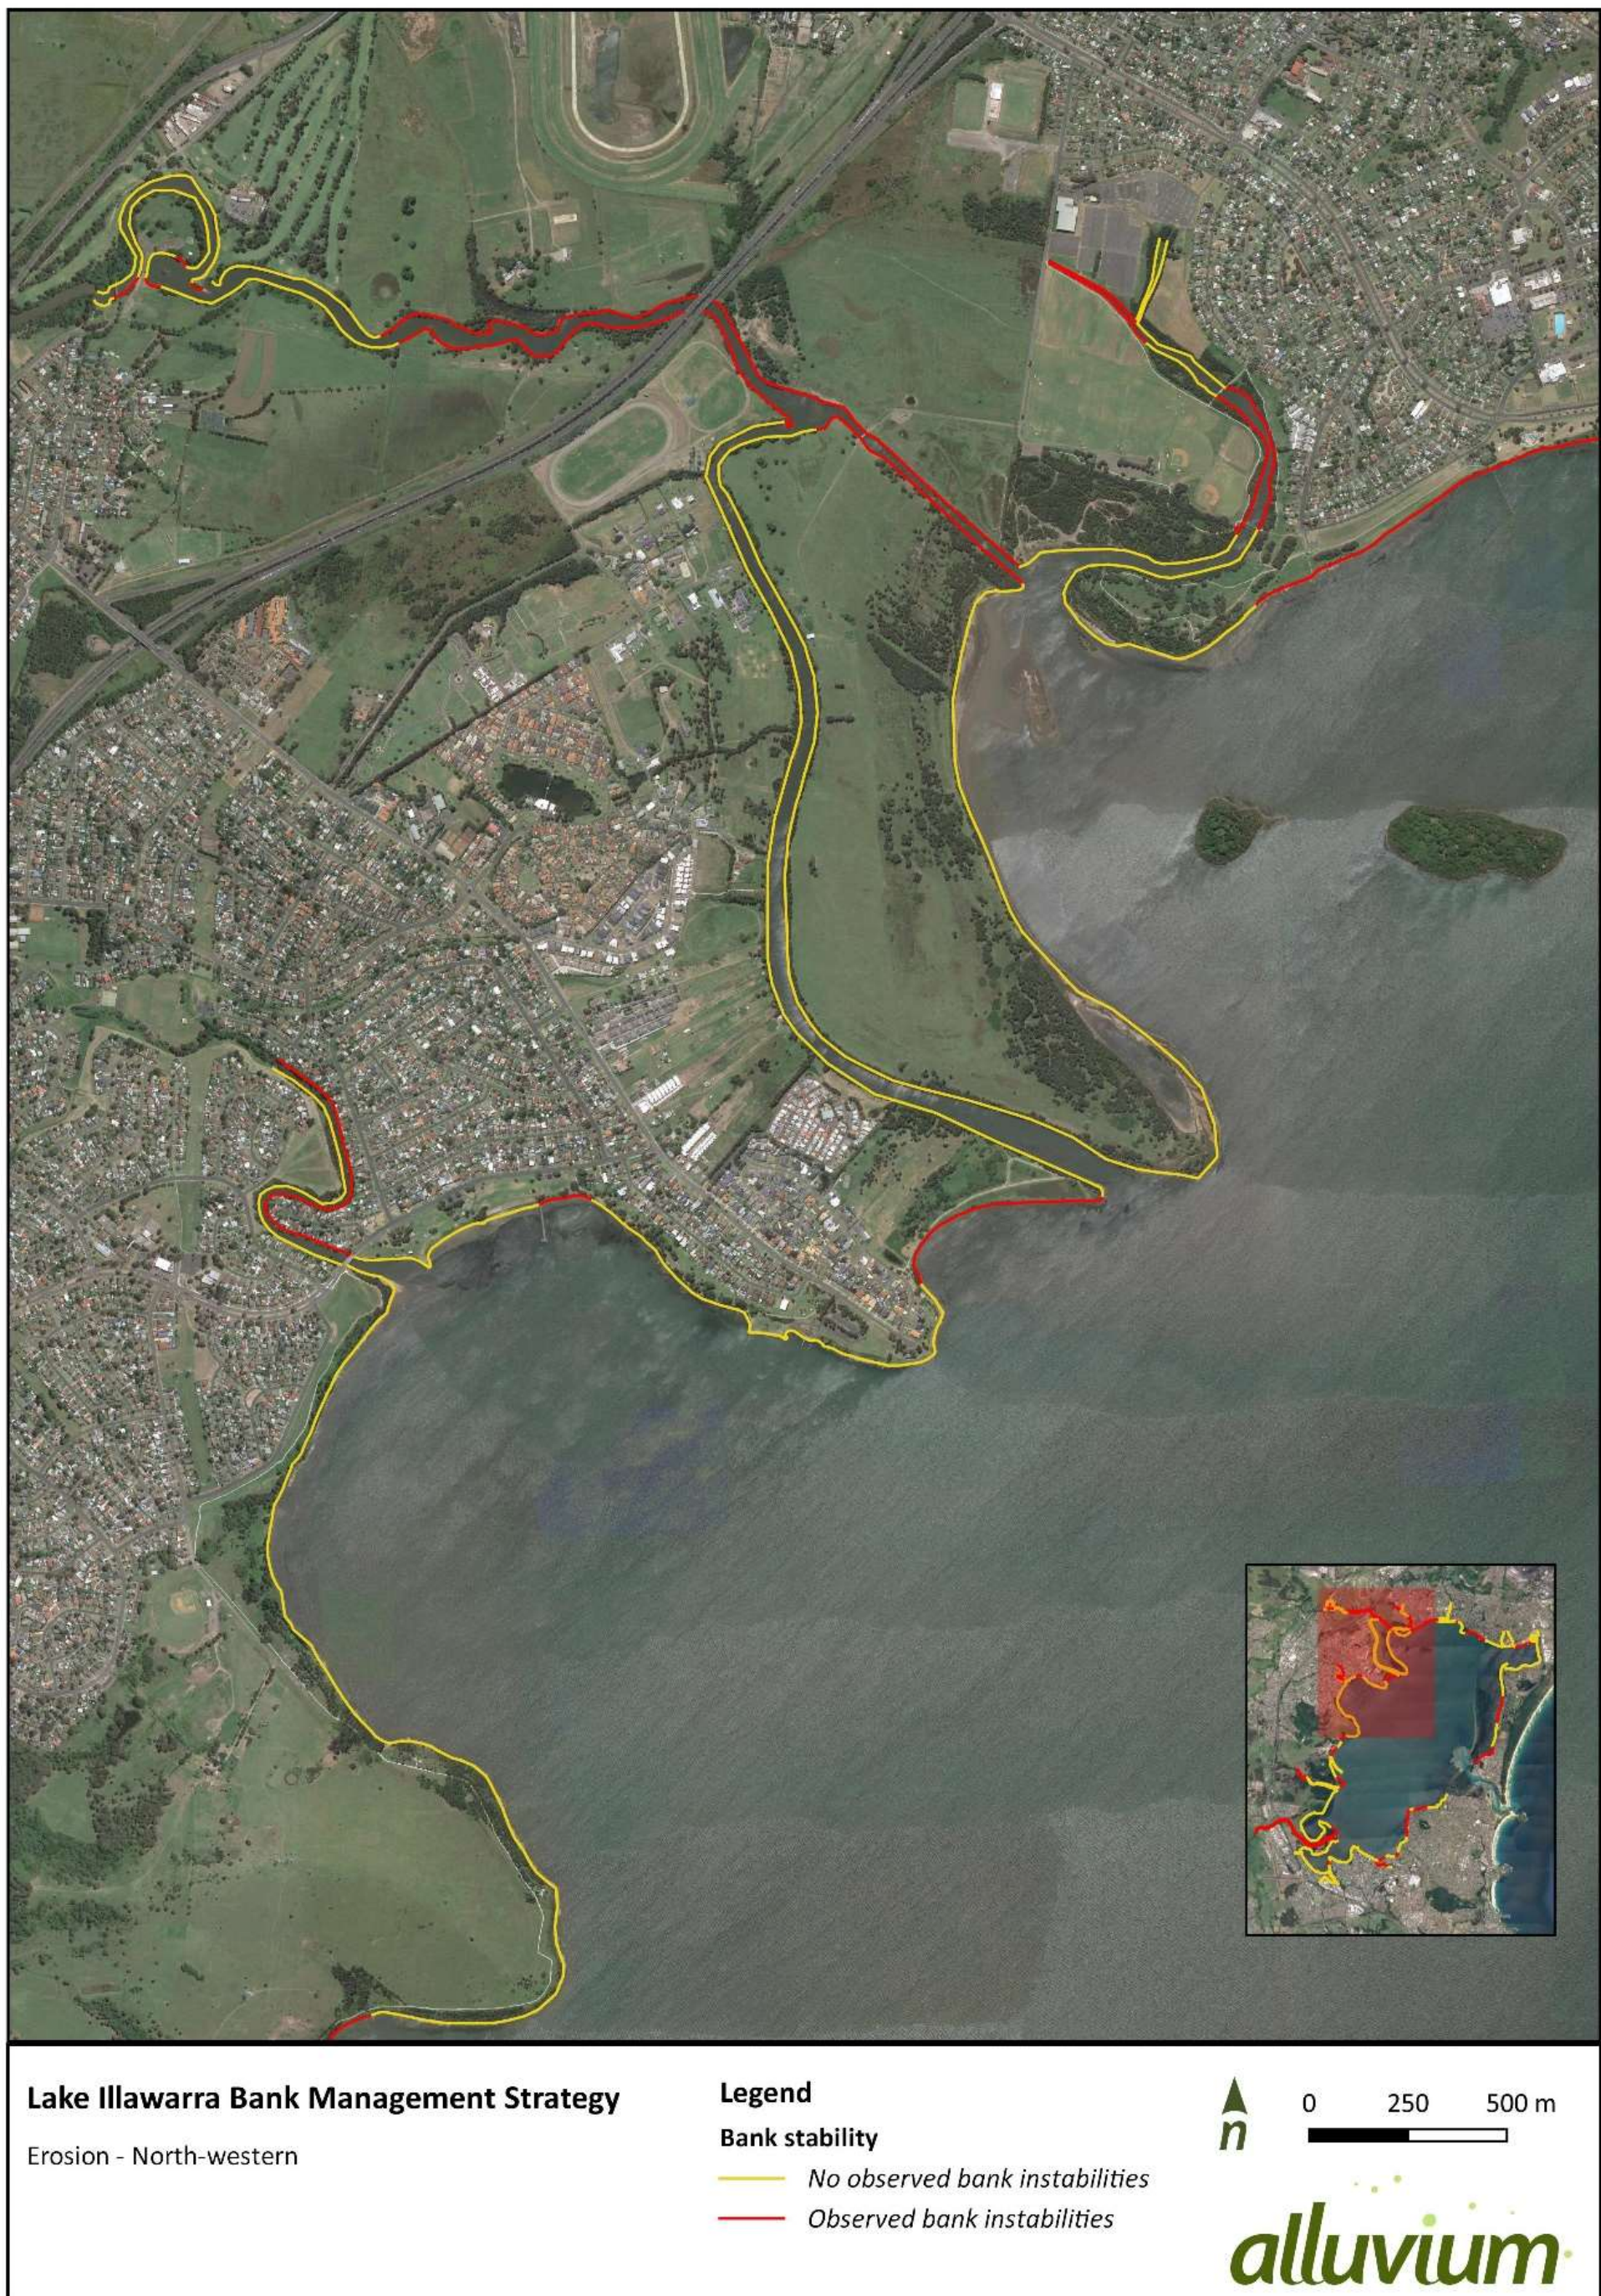
Figure 19. Observed erosion in the North-western quadrant
