Whytes Gully Landfill Annual Report 2017-2018

Environmental Protection
Licence 5862

Prepared for
Wollongong City Council

26 July 2018

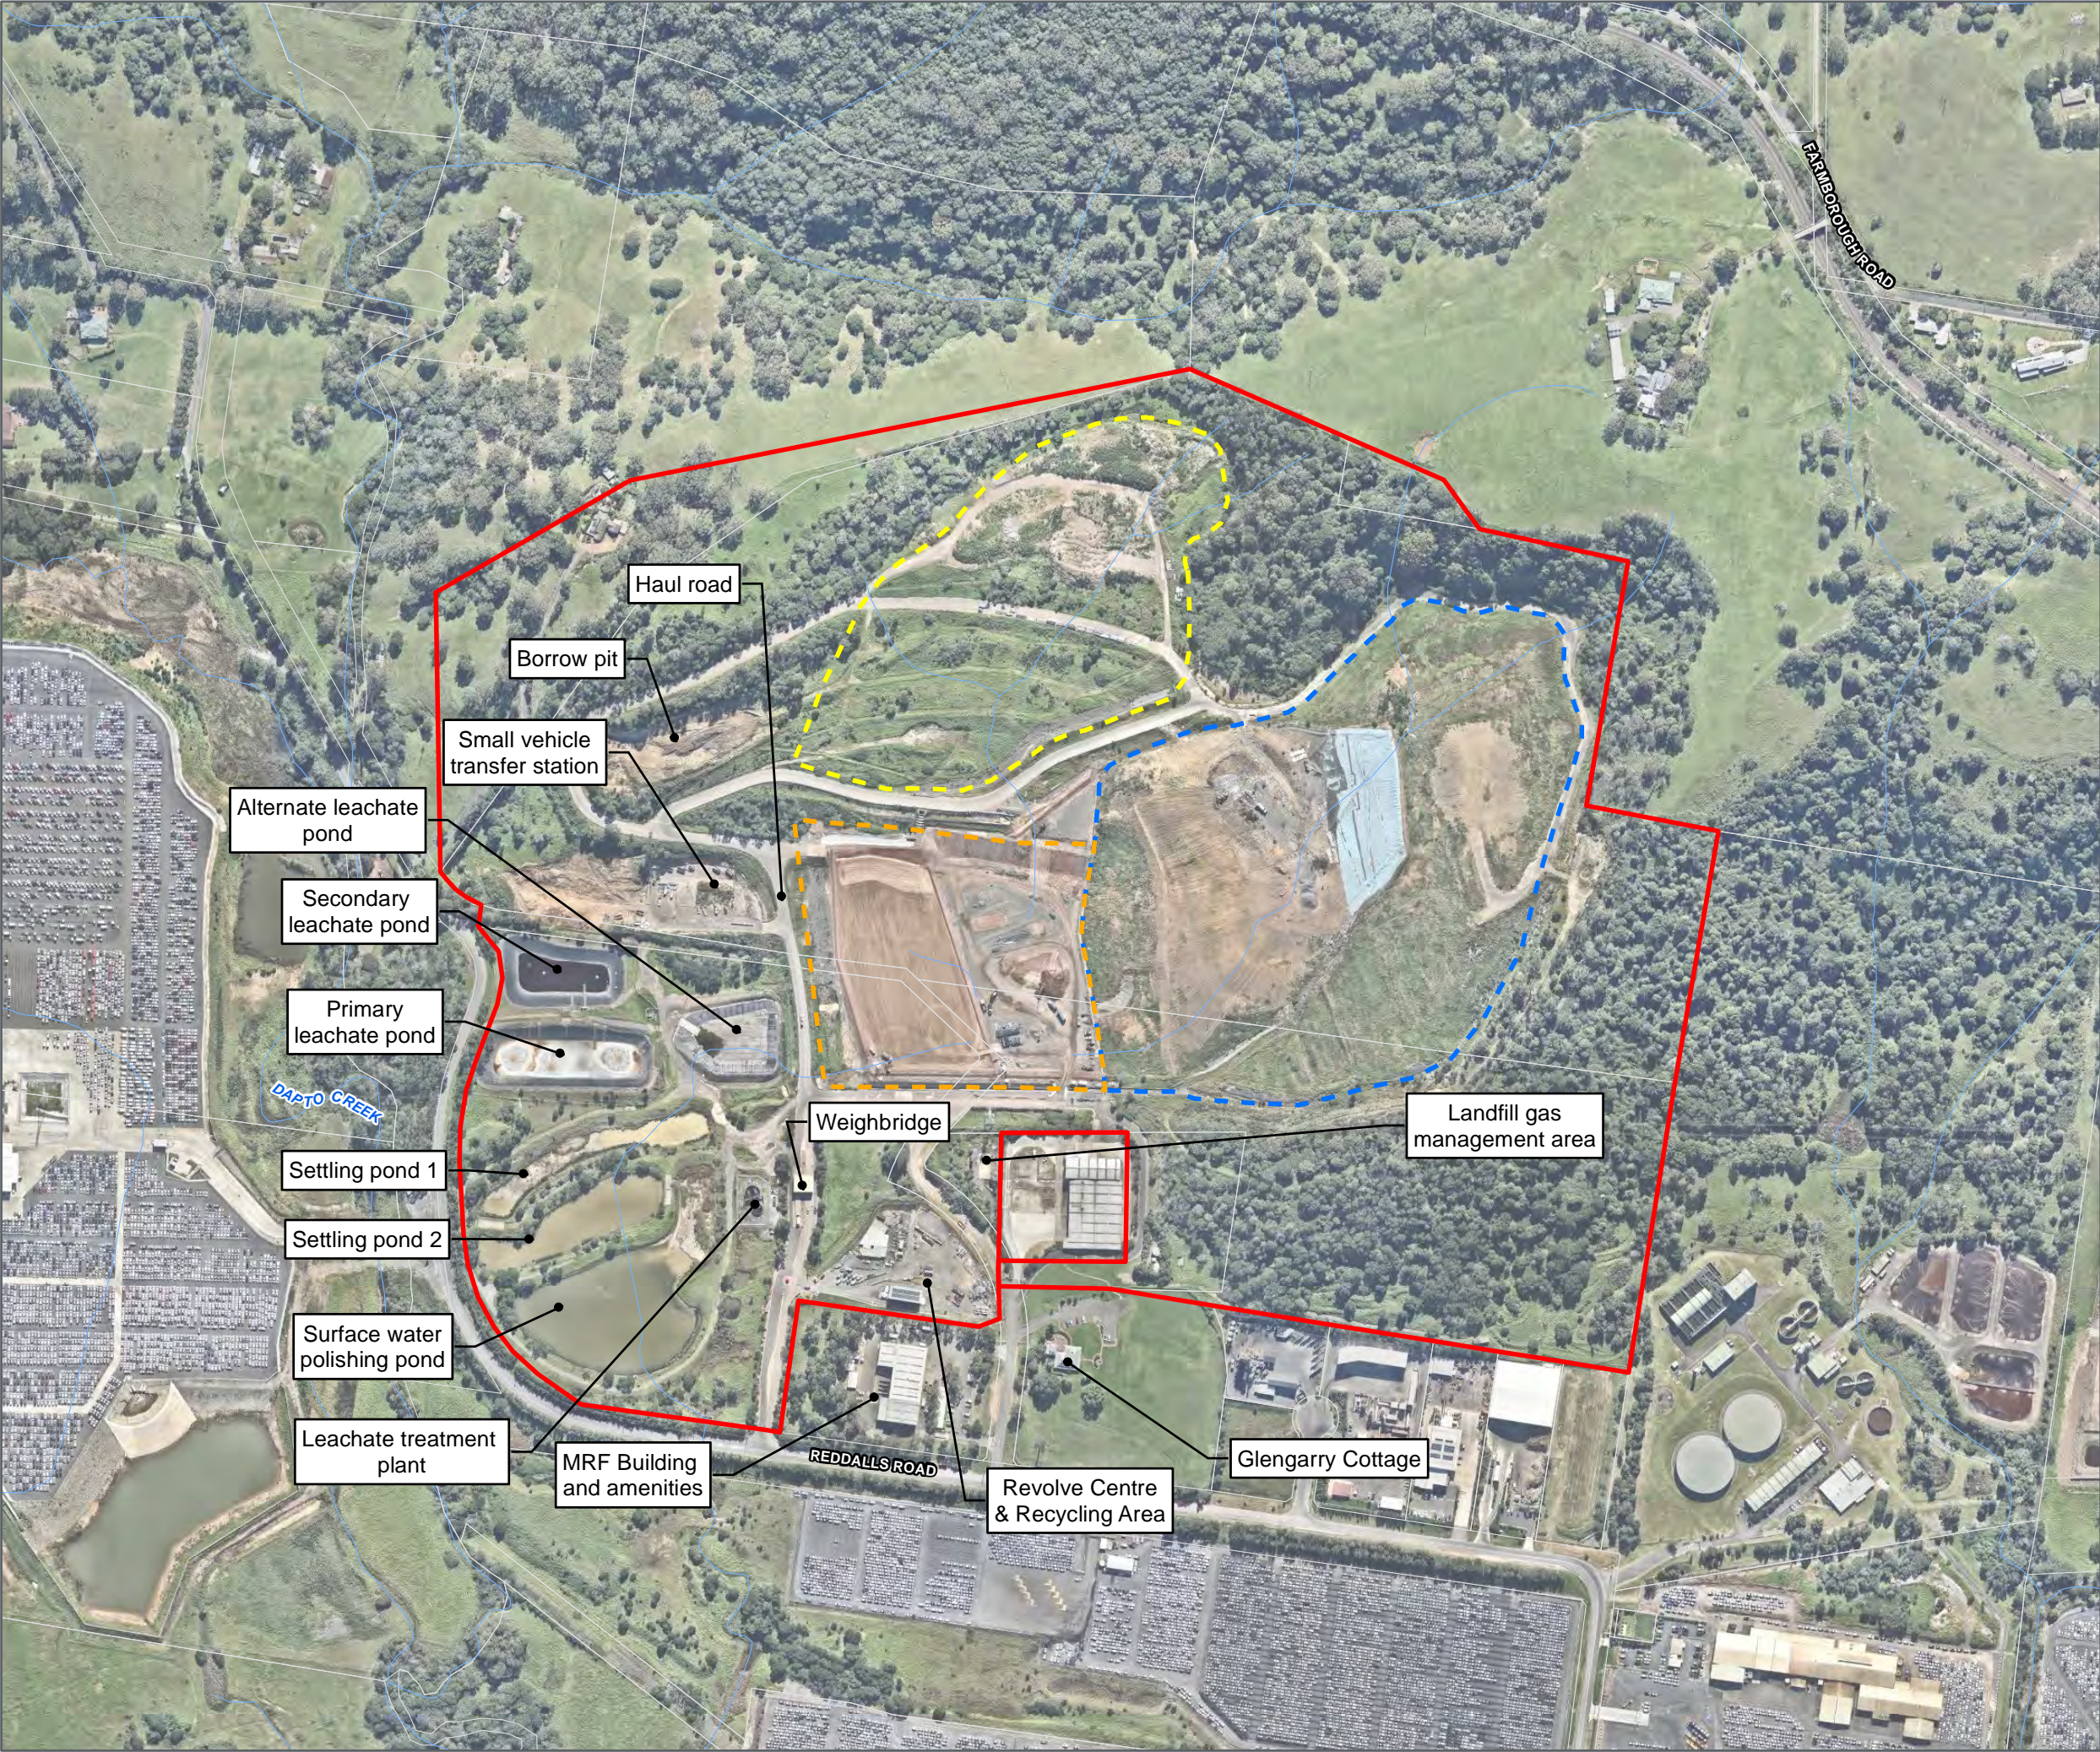
Site Plan

The location of each cell and significant Site features such as leachate ponds and shown on **Figure 2 of Appendix A**).
