Wollongong City Council

**Estuary Management Plan for  
Several Wollongong Creeks and Lagoons**

Estuary Processes Study

December 2007

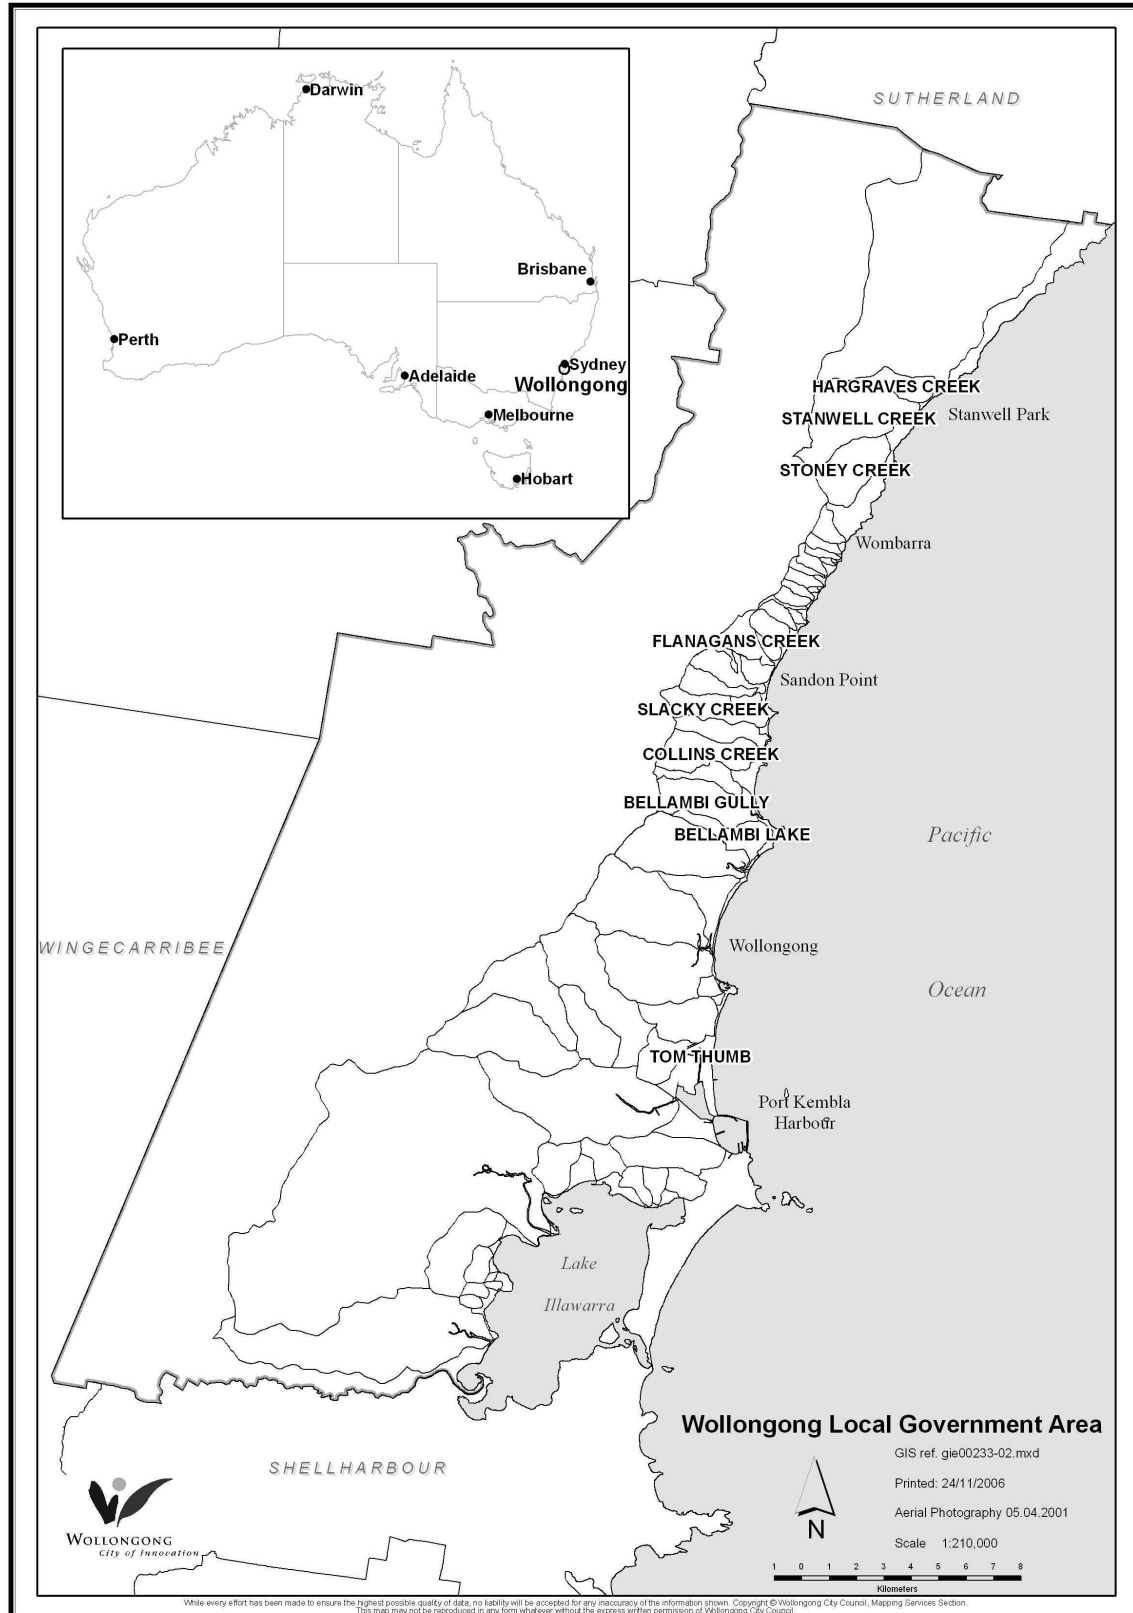
**Figure 1.1 Location of the estuaries**

The location of these estuaries is shown in Figure 1.1.

The locations of the estuaries are detailed in Figure 1.1. The majority of the estuaries are characterised as intermittently closed and open lakes or lagoons (ICOLLs) and their entrances only open during periods of high rainfall or during large tidal influenced events. However, Tom Thumb Lagoon is a coastal creek that is permanently open to the ocean and, as a consequence, is subject to daily tidal flushing.

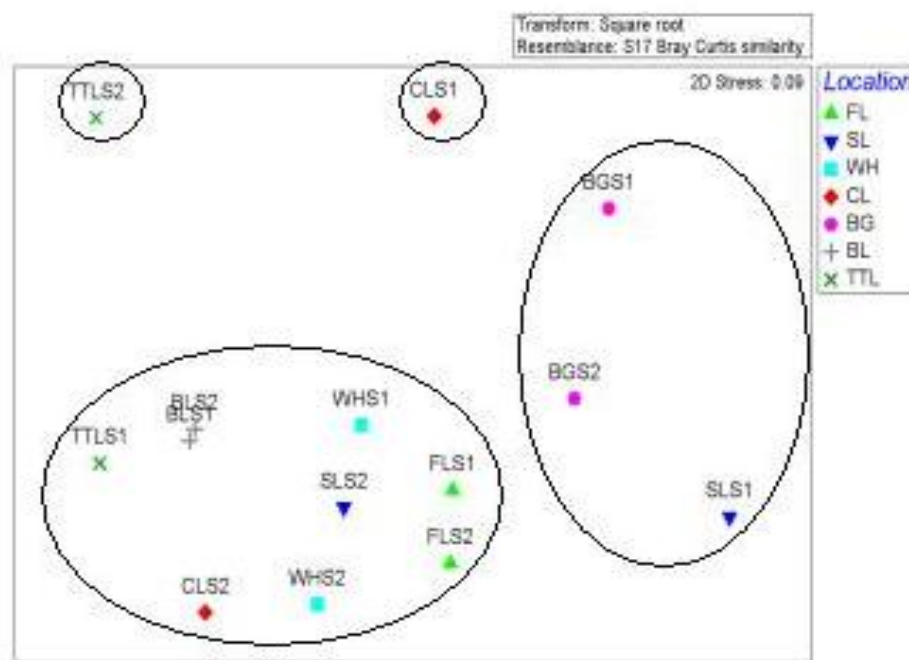
**Figure 4.1 nMDSplot, edge habitat**

supported assemblages that are considered similar to each other. The remaining sites, one from Collins Creek and one from Tom Thumb Lagoon, were dissimilar to the other sites and to each other. A stress value of 0.09 indicates that the analysis provides an accurate representation of the data, and can be interpreted with confidence (Clarke and Warwick 2001).

The analyses for both edge and pool rock habitat indicate that Flanagans Creek, Whartons Creek and Slacky Creek are most similar to each other, and that Bellambi Lagoon and Tom Thumb Lagoon are also very similar to each other but different to Flanagans Creek, Whartons Creek and Slacky Creek. Bellambi Gully appears to be quite dissimilar to all other creeks.

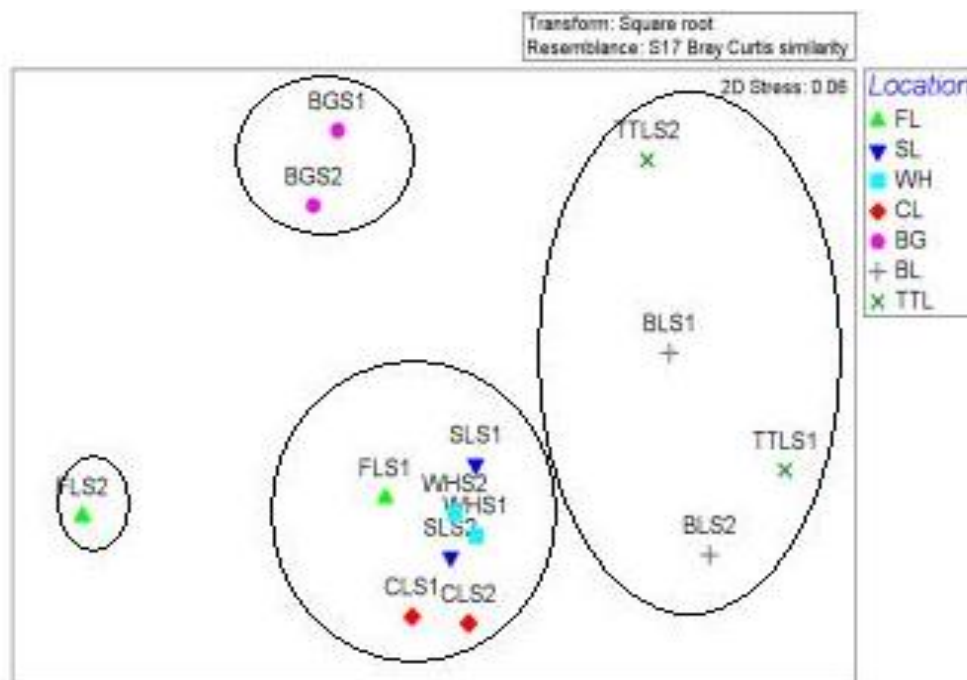
**Figure 4.3 nMDS plot, pool rock habitat**

Primer V6 was also used to analyse macroinvertebrate assemblages from pool rock habitat. The nMDS and cluster analysis results for pool rock habitat, based on macroinvertebrate abundance, indicate that assemblages formed four groups of similar structure, as presented in Figure 4.3 and Figure 4.4.

The largest group of similar assemblages included both sites at Whartons Creek, Slacky Creek, Collins Creek and one site from Flanagans Creek. Another group included both sites from Bellambi Lagoon and Tom Thumb Lagoon, as would be expected given that these sites were both sampled in their brackish reaches, as freshwater sites were inaccessible. Both sites from Bellambi Gully formed the third group and one site from Flanagans Creek formed the fourth group of similar macroinvertebrate assemblages. A stress value of 0.05 indicates this analysis provides an accurate representation of the data, and can be interpreted with confidence (Clarke and Warwick 2001).

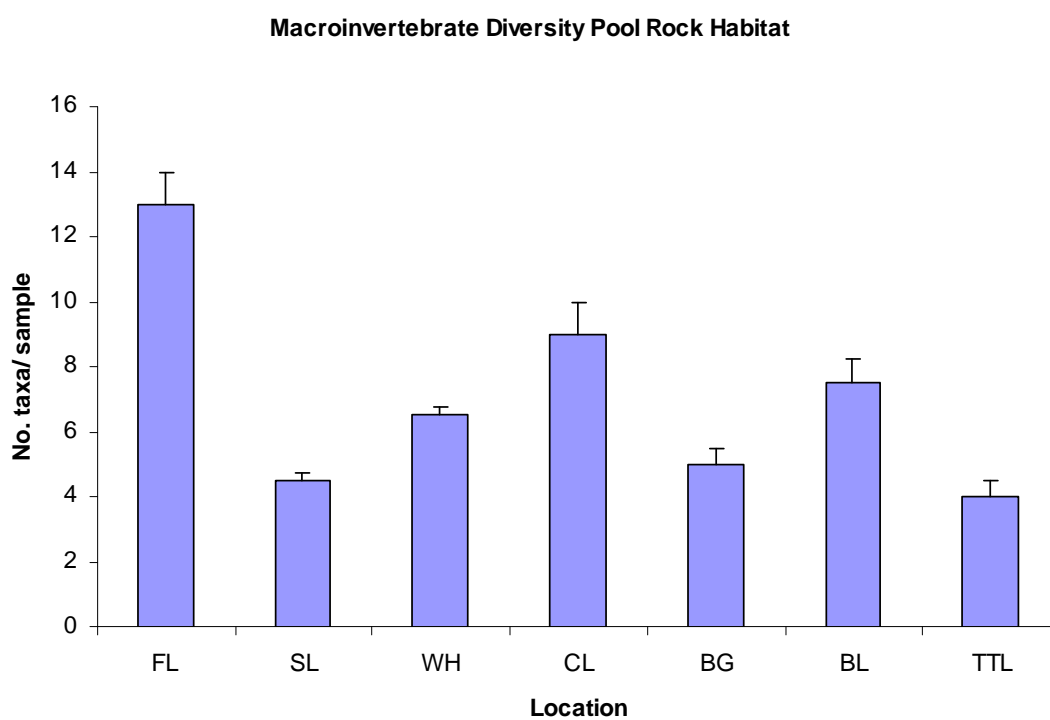
**Figure 4.6 Mean (+/- SE, n = 2) family diversity, pool rock habitat**

Of the pool rock habitat samples, the highest diversity was recorded at Flanagans Creek. Whartons Creek, Collins Creek and Bellambi Lagoon recorded similar levels of family diversity, while Slacky Creek, Bellambi Gully and Tom Thumb Lagoon recorded the lowest family diversity, as presented in

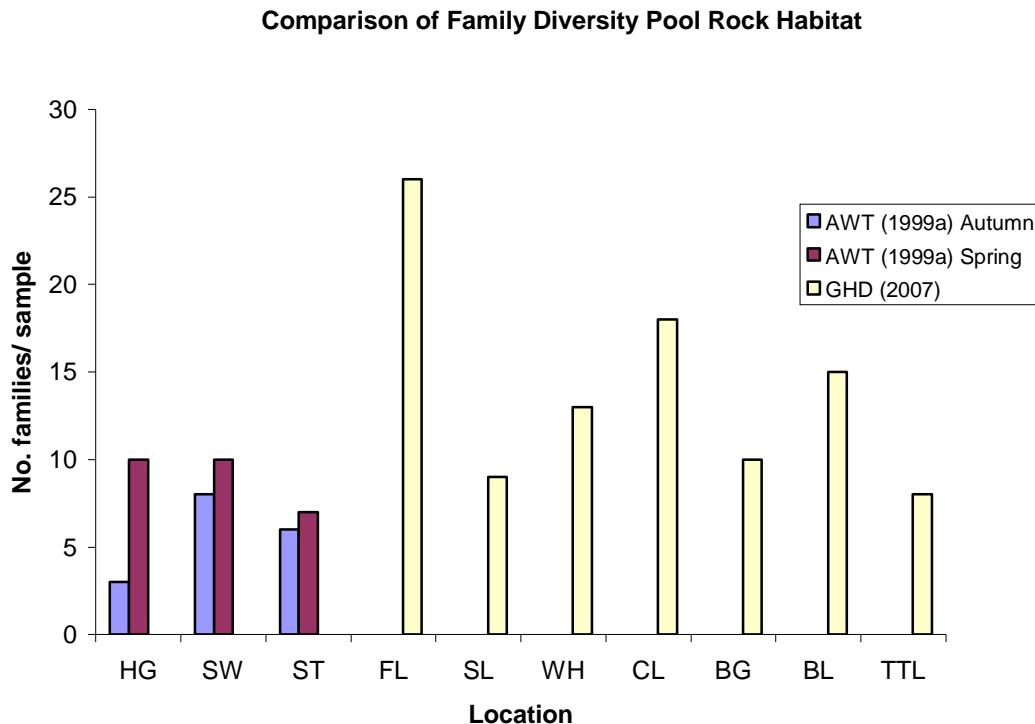
**Figure 4.8 Total (n = 2) family diversity, pool rock habitat**

Figure 4.8 presents the pool rock habitat family richness data recorded for Hargraves Creek, Stanwell Creek and Stoney Creek by AWT (1999a), as well as the pool rock habitat family richness data collected at Flanagans Creek, Slacky Creek, Whartons Creek, Collins Creek, Bellambi Gully, Bellambi Lagoon and Tom Thumb Lagoon in this study to enable comparisons between family richness across the ten creeks. Flanagans Creek has the highest family diversity of all ten creeks. Whartons Creek, Collins Creek and Bellambi Lagoon have similar family diversity, greater than Hargraves Creek, Stanwell Creek and Stoney Creek. Hargraves Creek, Stanwell Creek and Stoney Creek have the lowest levels of diversity, similar to Slacky Creek, Bellambi Gully and Tom Thumb Lagoon.

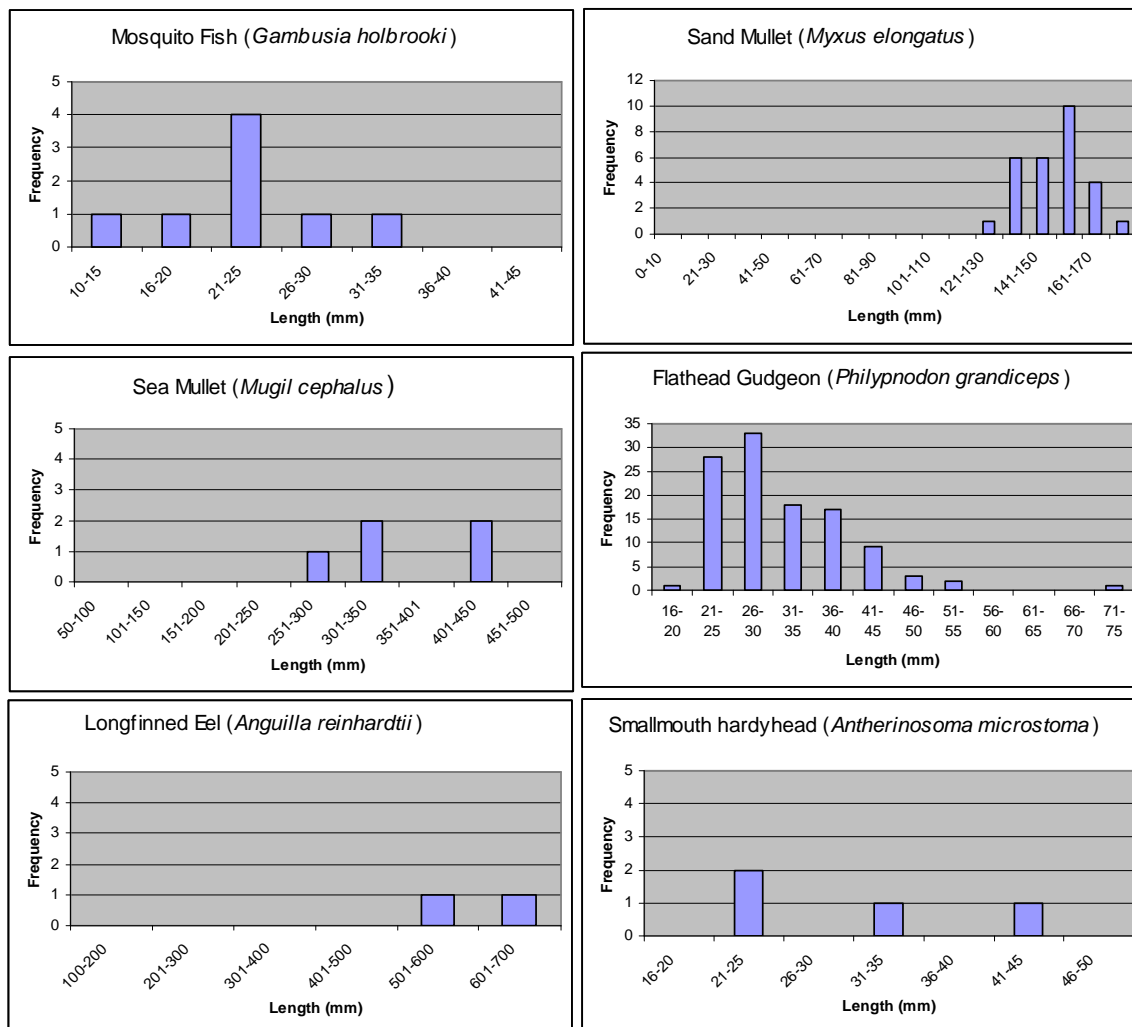
**Figure 5.5 Species abundance, Whartons Creek**

The size class distributions indicate that the Mosquito Fish has established a small breeding population, and that the Flathead Gudgeon population is also viable. With a size class ranging from 21 mm to 75 mm, the sand mullet population appears to be mostly comprised of juvenile specimens. As this lagoon was open at the time of the survey, it is possible that the sand mullet are recent arrivals into the estuary.
