HELENSBURGH WASTE DISPOSAL DEPOT ANNUAL REPORT 2023

For EPL 5861 (July 2023)

WOLLONGONG CITY COUNCIL (WASTE SERVICES)

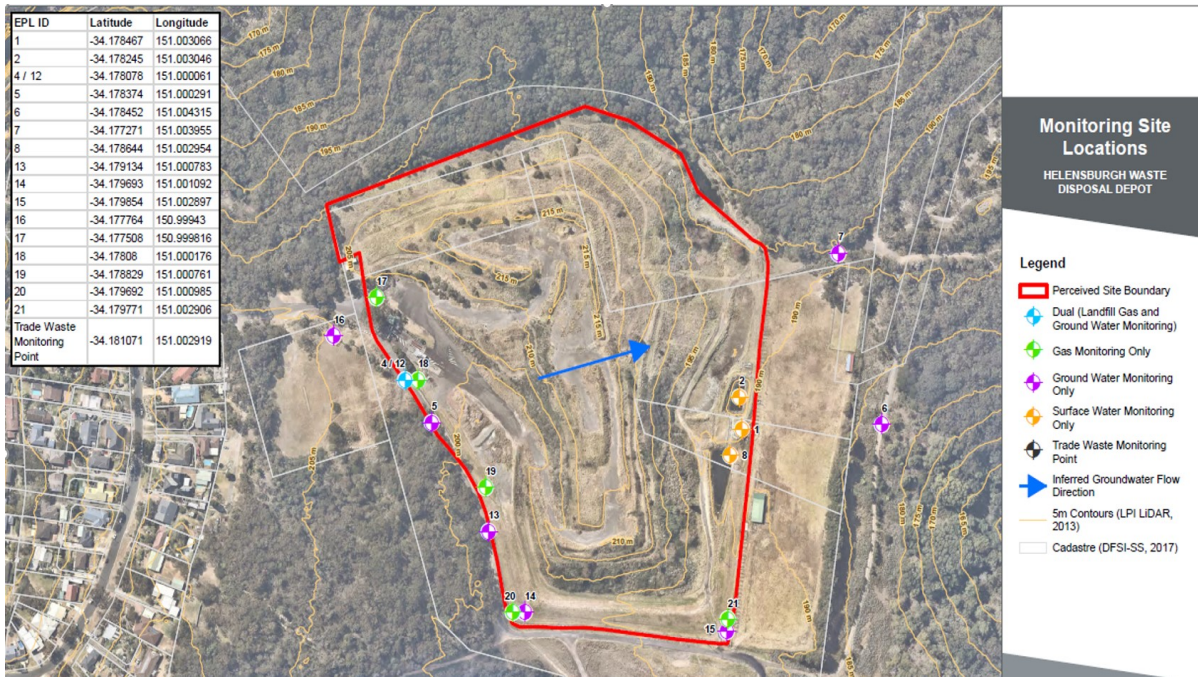
Figure 2: Monitoring Site Locations

Approximate surface contours are shown on **Figure 2**.

Subsurface gas monitoring was completed during the reporting period to assess for potential offsite migration. The fieldwork methodology for subsurface gas monitoring is summarised below in **Table 1-4**. The location of each subsurface gas monitoring location is shown on **Figure 2**.

The fieldwork methodology for stormwater monitoring is summarised below in **Table 1-5**. The location of stormwater monitoring locations is shown on **Figure 2**.

Leachate monitoring was completed periodically during the reporting period to provide data on the composition, height levels and volumes of leachate produced by the Site, and to record details about any irregular discharges or overflows of leachate from the Site. The fieldwork methodology for leachate monitoring is summarised below in **Table 1-6**. The location of leachate monitoring locations is shown on **Figure 2**.

Surface water monitoring was completed periodically during the reporting period to verify that offsite surface water bodies were not being impacted by leachate or by sediment-laden stormwater from the landfill. The fieldwork methodology for surface water monitoring is summarised below in **Table 1-7**. The location of each stormwater monitoring location is shown on **Figure 2**.

groundwater monitoring is summarised below in **Table 1-8**. The location of each groundwater monitoring location is shown on **Figure 2**.

Monitoring of trade wastewater was completed periodically during the reporting period to confirm that water quality parameters of wastewater discharge were within the acceptable criteria. Discharge of trade waste to sewer was undertaken by Council in accordance with the *Consent to Discharge Industrial Trade Wastewater* (Sydney Water 2019) (the *Consent*). The fieldwork methodology for trade wastewater monitoring is summarised below in **Table 1-9**. The trade waste monitoring location is shown on **Figure 2**.

Interpretation of groundwater levels across the Site from the reporting period indicate that the inferred groundwater flow direction is from the west to the north east, which is consistent with the local topography and is shown on **Figure 2**. Groundwater is situated at the greatest depths in the higher elevations of the Site toward the western boundary and is shallowest toward the eastern boundary in close proximity to the nearest surface water body, the Hacking River. Since the drought ended in 2020, the monitoring points at higher elevations along the western and southern boundaries began to flow after the prolonged period of drought was broken. This has resulted in an overall decrease in analyte concentrations in the water column across the Site.

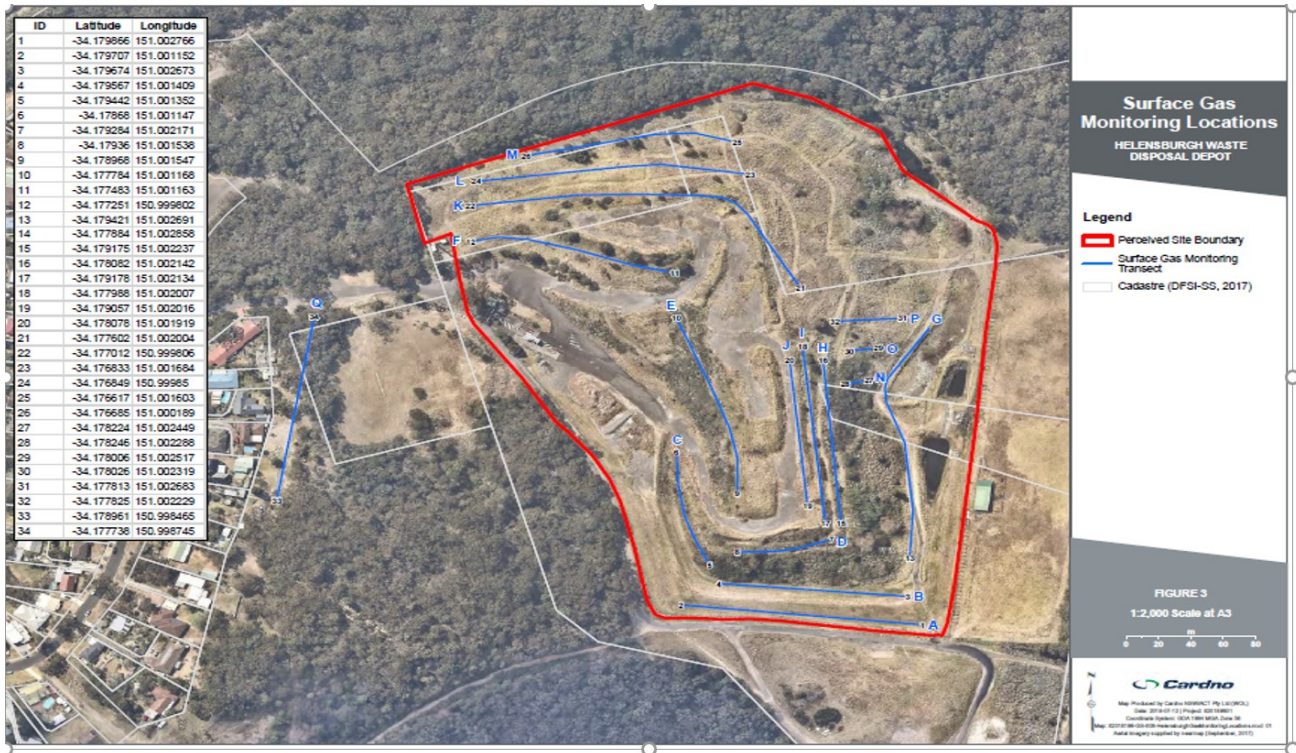
Figure 3: Surface Gas Monitoring Locations

Surface gas monitoring was completed during the reporting period to assess for potential surface emissions of landfill gases (LFG) emanating from the landfilled areas at the Site. The purpose of surface gas monitoring is to demonstrate that the cover material effectively controls the emission of landfill gas. The fieldwork methodology for surface gas monitoring is summarised below in **Table 1-3**. The location of each surface gas monitoring location is shown on **Figure 3**.
