Wollongong Northern Coastal Creeks and Lagoons

Data Compilation and Review Report

Wollongong Coastal Creeks and Lagoons Data Compilation and Review

Prepared For:	Wollongong City Council
Prepared By:	WBM Oceanics Australia

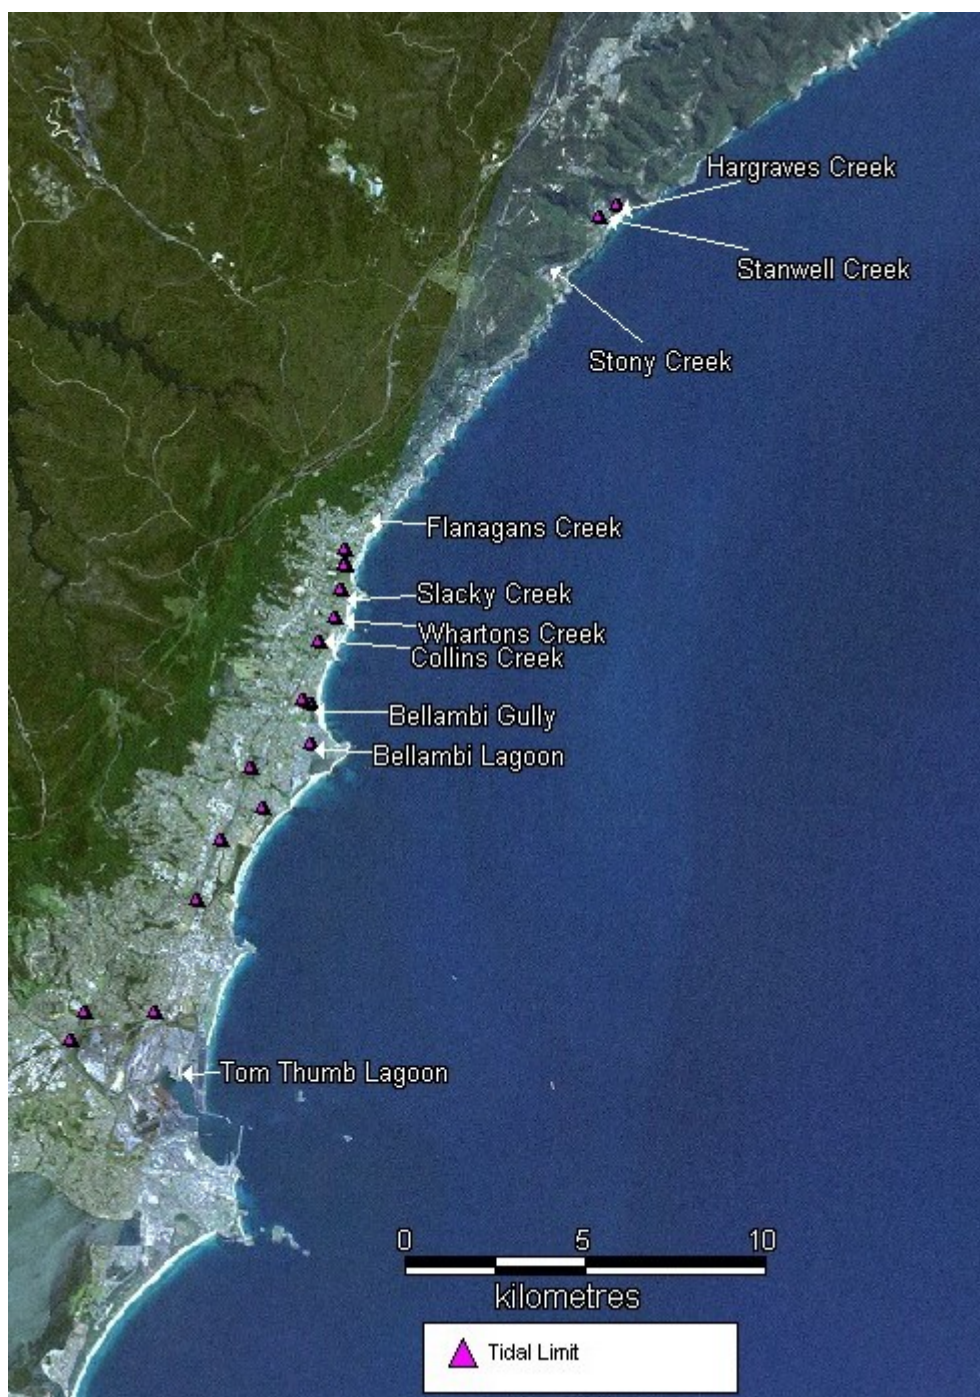
Figure 1-1 The location of the ten study site creeks along the Illawarra Coastline

The locations of the creeks along the Illawarra coastline are shown in Figure 1-1. All further GIS mapping is presented in Appendix A.

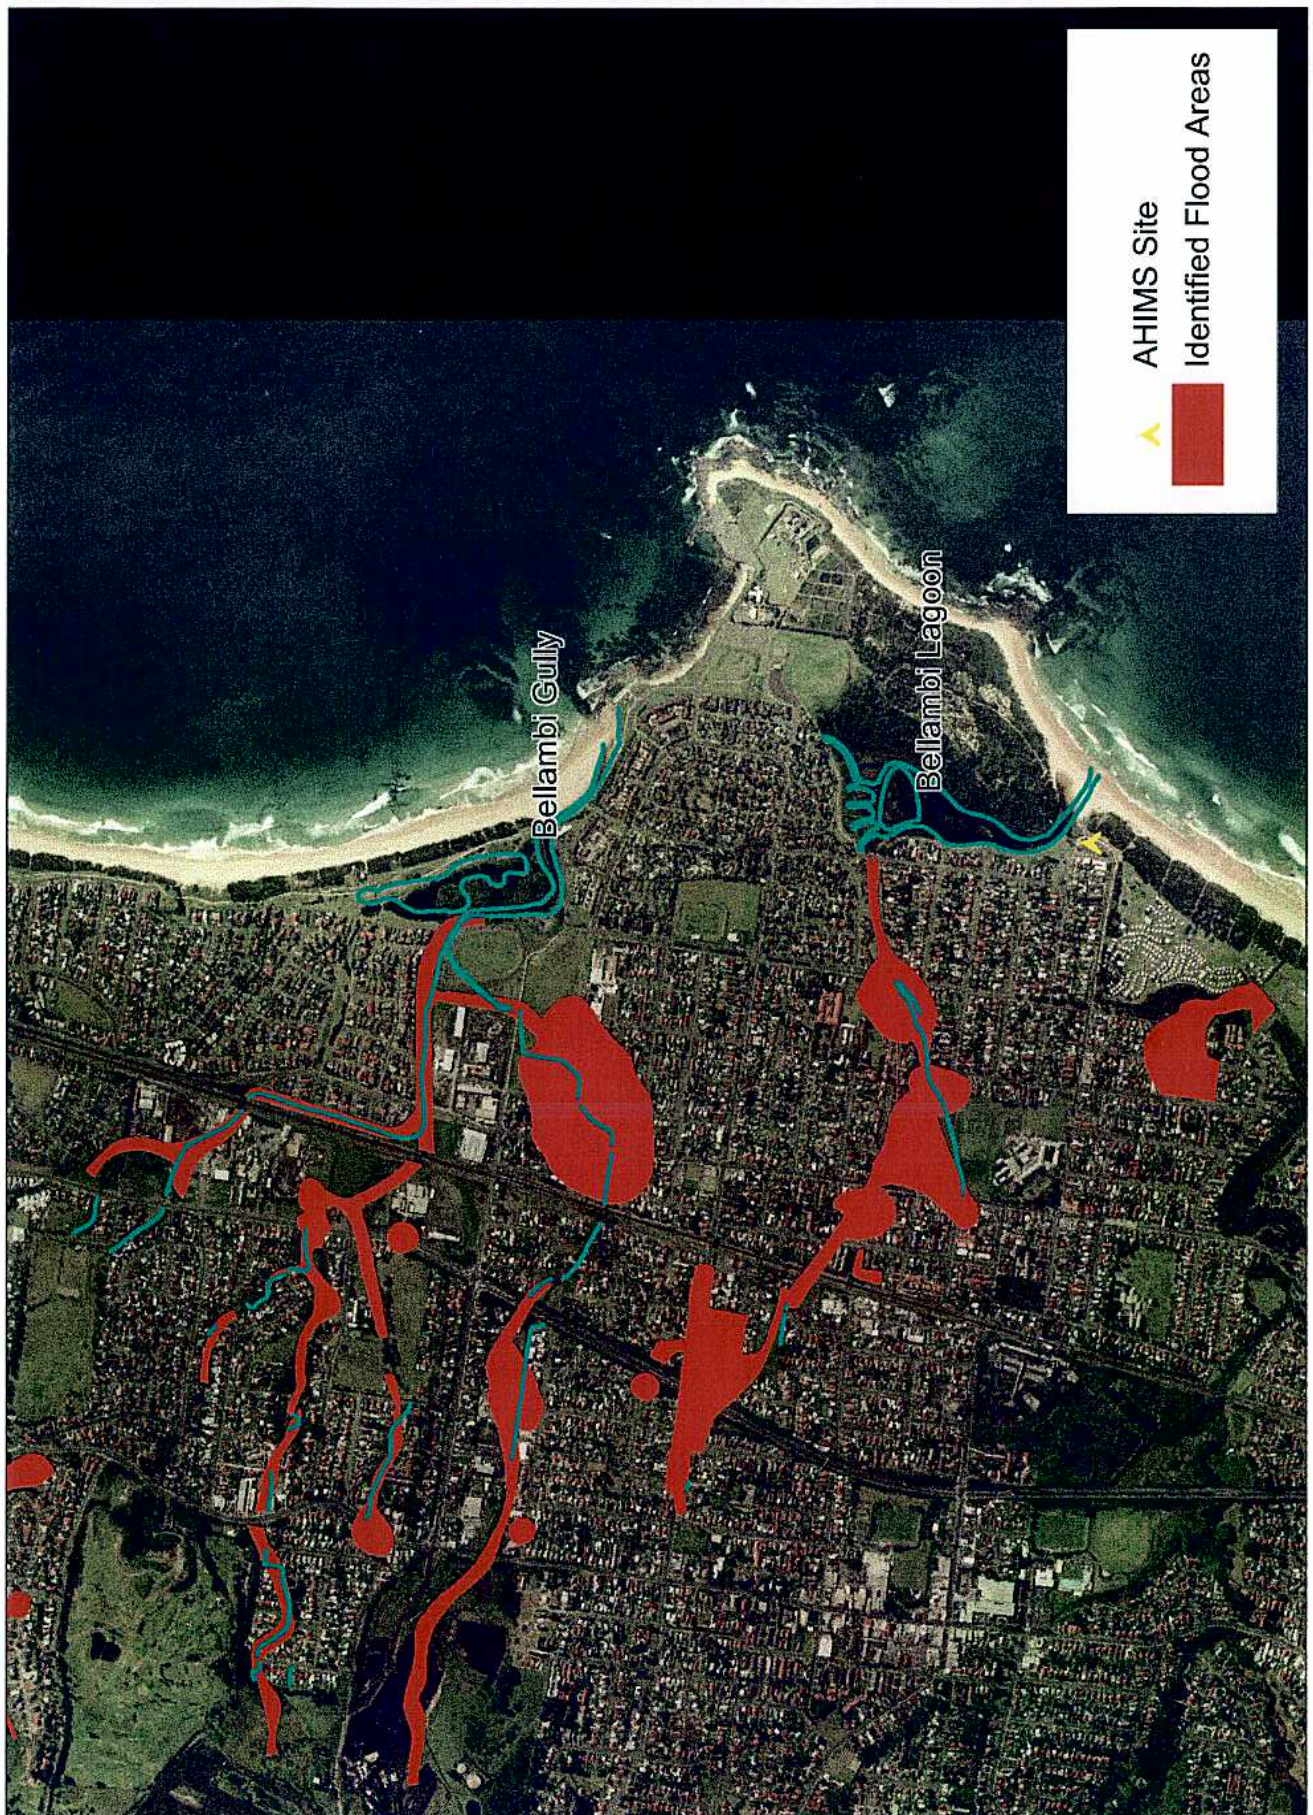
Figure 9-16

**AHIMS Sites and identified flooding areas for
Bellambi Gully and Bellambi Lagoon**

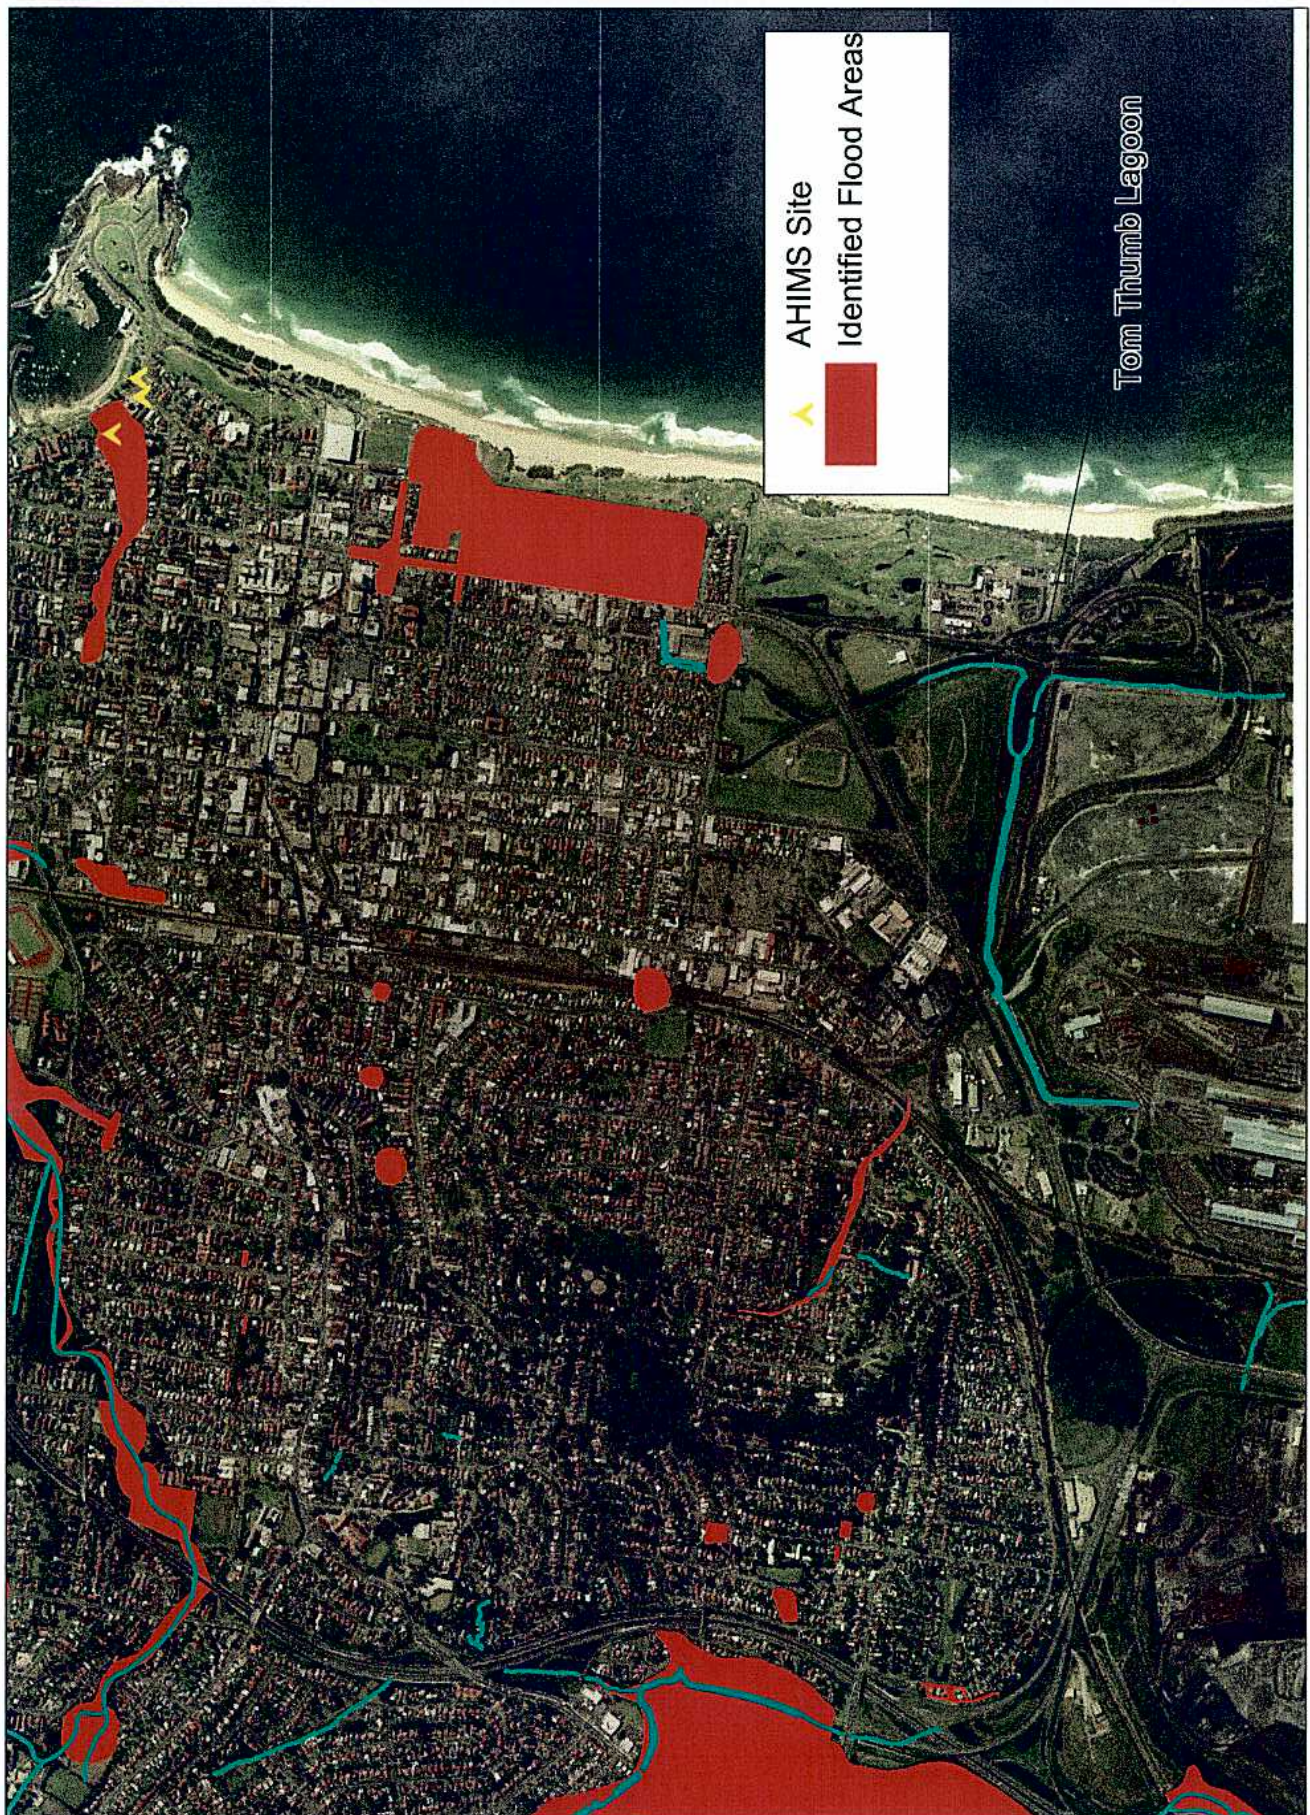
Figure 9-17

**AHIMS Sites and identified flooding areas for
Tom Thumb Lagoon**
