# HELENSBURGH WASTE DISPOSAL DEPOT ANNUAL REPORT 2020/2021

For EPL 5861 (August 2021)

WOLLONGONG CITY COUNCIL (WASTE SERVICES)

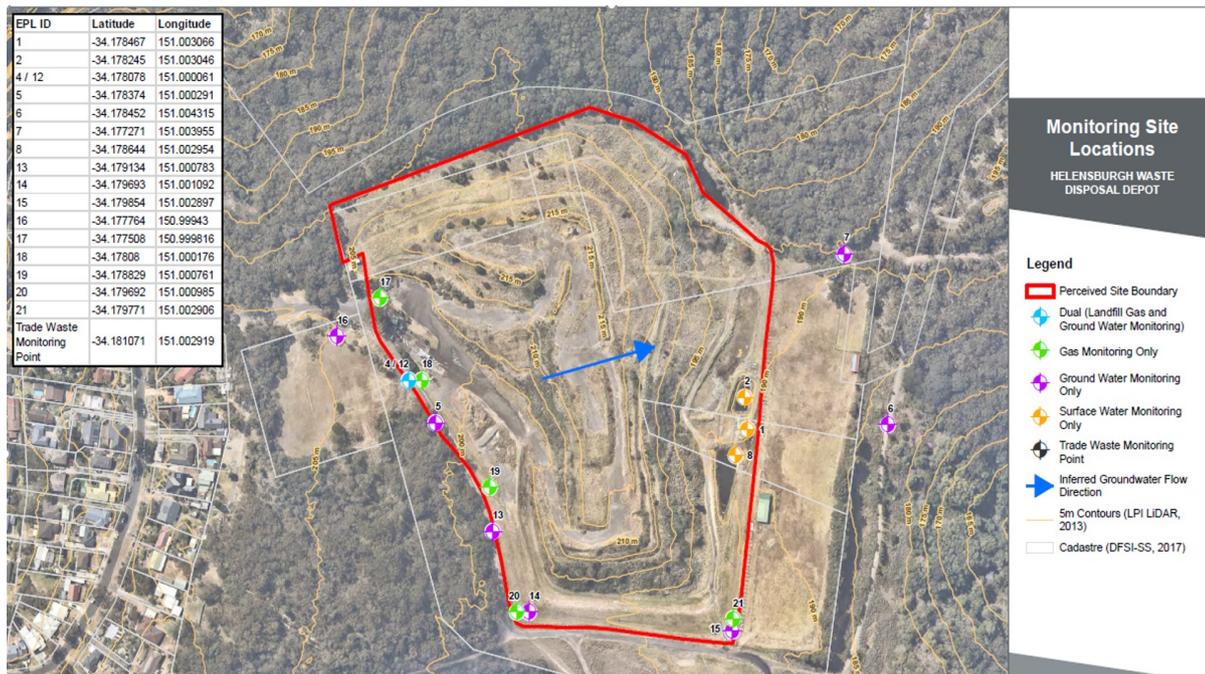
Figure 2: Monitoring Site Locations

The site is situated on the upper slopes of a hill on the northern eastern most outskirts of the suburb of Helensburgh. The gradient of the site slopes towards the north and east in the direction of the adjoining Garrawarra State Conservation Area. The final form of the landfill is mounded with a slight to moderate radial grade in all directions toward the site boundary.

An elevation profile was created utilising an aerial image taken in December 2019 from Nearmap which shows that the lowest elevations of the site are located in the eastern portion with an approximate relative level (RL) of 190 m Australian Height Datum (AHD). The highest elevations are located at the centre of the site at the location of the former waste deposition area with an approximate RL of 210 m AHD.

Approximate surface contours are shown on **Figure 2**.

Subsurface gas monitoring was completed during the reporting period to assess for potential offsite migration. The fieldwork methodology for subsurface gas monitoring is summarised below in **Table 1-4**. The location of each subsurface gas monitoring location is shown on **Figure 2**.

The fieldwork methodology for stormwater monitoring is summarised below in **Table 1-5**. The location of stormwater monitoring locations is shown on **Figure 2**.

Leachate monitoring was completed periodically during the reporting period to provide data on the composition, height levels and volumes of leachate produced by the Site, and to record details about any irregular discharges or overflows of leachate from the Site. The fieldwork methodology for leachate monitoring is summarised below in **Table 1-6**. The location of leachate monitoring locations is shown on **Figure 2**.

Surface water monitoring was completed periodically during the reporting period to verify that offsite surface water bodies were not being impacted by leachate or by sediment-laden stormwater from the landfill. The fieldwork methodology for surface water monitoring is summarised below in **0 1-7**. The location of each stormwater monitoring location is shown on **Figure 2**.

groundwater monitoring is summarised below in **Table 1-8**. The location of each groundwater monitoring location is shown on **Figure 2**.

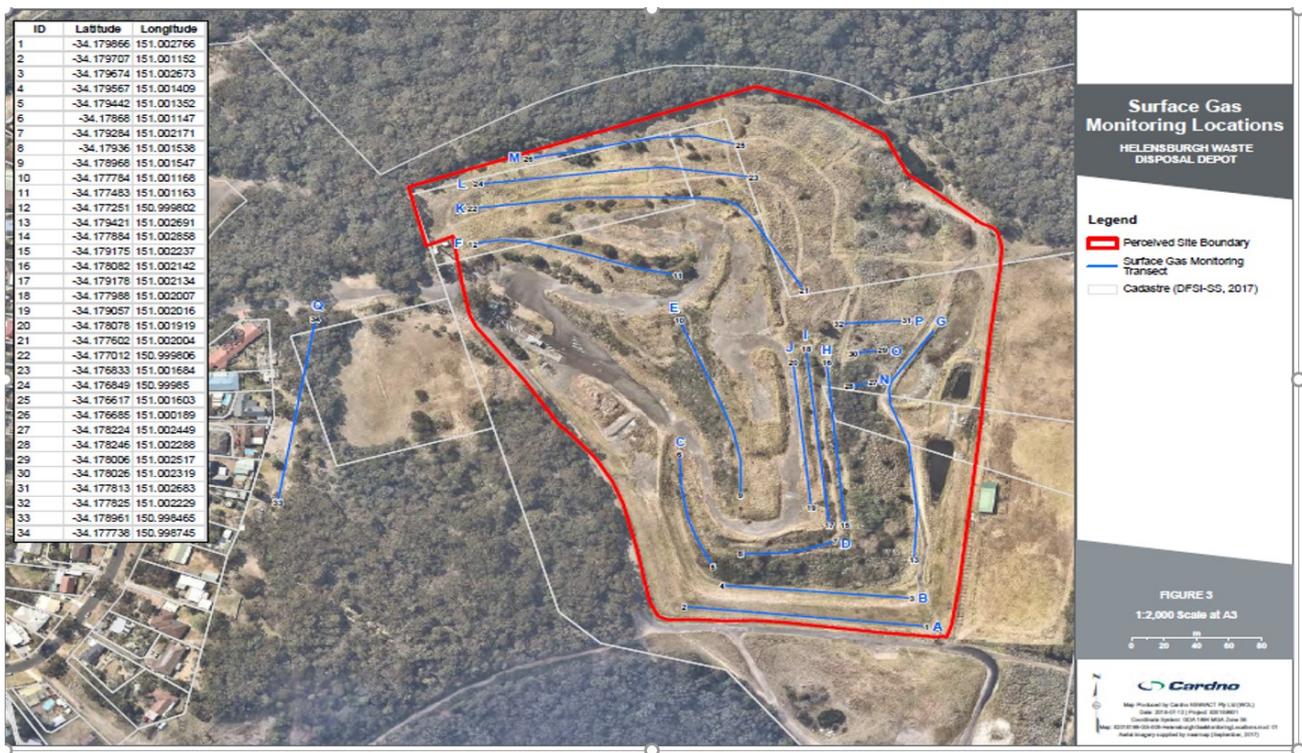
Figure 3: Surface Gas Monitoring Locations

Surface gas monitoring was completed during the reporting period to assess for potential surface emissions of landfill gases (LFG) emanating from the landfilled areas at the Site. The purpose of surface gas monitoring is to demonstrate that the cover material effectively controls the emission of landfill gas. The fieldwork methodology for surface gas monitoring is summarised below in **Table 1-3**. The location of each surface gas monitoring location is shown on **Figure 3**.
