# Brandy & Water Creek- Investigation & Design of Creek Modification

Prepared for  
Wollongong City Council

1st May 2014

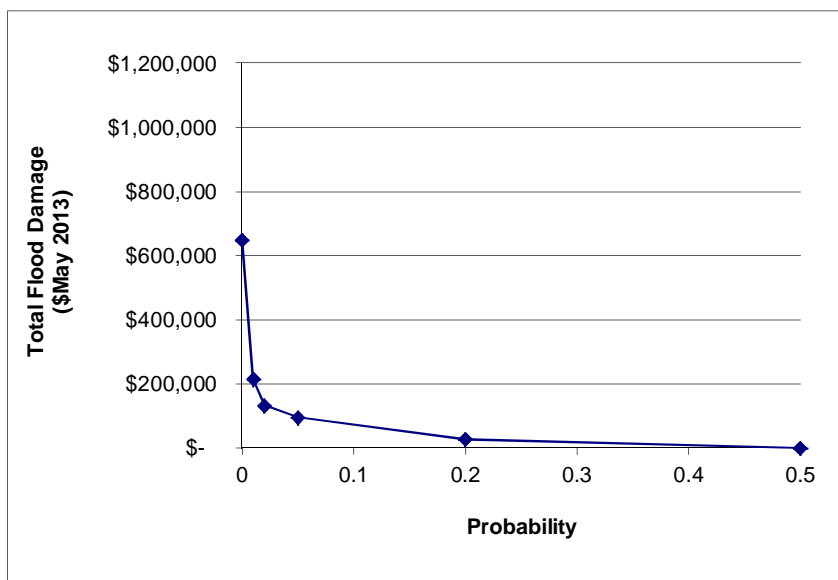
**Figure 4-1 Annual Average Damage Curves for the Study Catchment**

Average Annual Damage (AAD) is an estimation of the flood damage that a floodplain would receive on average during a single year. It is calculated on a probability approach using the flood damages calculated for each design event. A probability curve is developed based on the flood damages calculated for each design event (**Figure 4-1**). For example, the 1% AEP design event has a probability of occurring of 1% in any given year, and as such the 1% AEP flood damage is plotted at this point on the AAD curve (**Figure 4-1**). AAD is then calculated by determining the area under this curve. Further information on the calculation of AAD is provided in Appendix M of the Floodplain Development Manual (NSW Government, 2005).

For this study, the damage resulting from a 50% AEP event (~2 year ARI) was assumed to be zero for the AAD analysis. The value is based on the assumption that flows for the 50% AEP event are contained generally within the channel and thus do not result in inundation with consequent damage to properties.

In the calculation of the Annual Average Damage, the damages in the 50% AEP design event are assumed to be zero with a linear increase in damage up to the 20% AEP design event. Assuming a different design event for zero damages can significantly change the AAD (Thomson et al., 2006). Flood modelling was not undertaken for events more frequent than the 20% AEP and a 50% AEP design event was considered to be a reasonable estimate of zero property damage in the catchment.

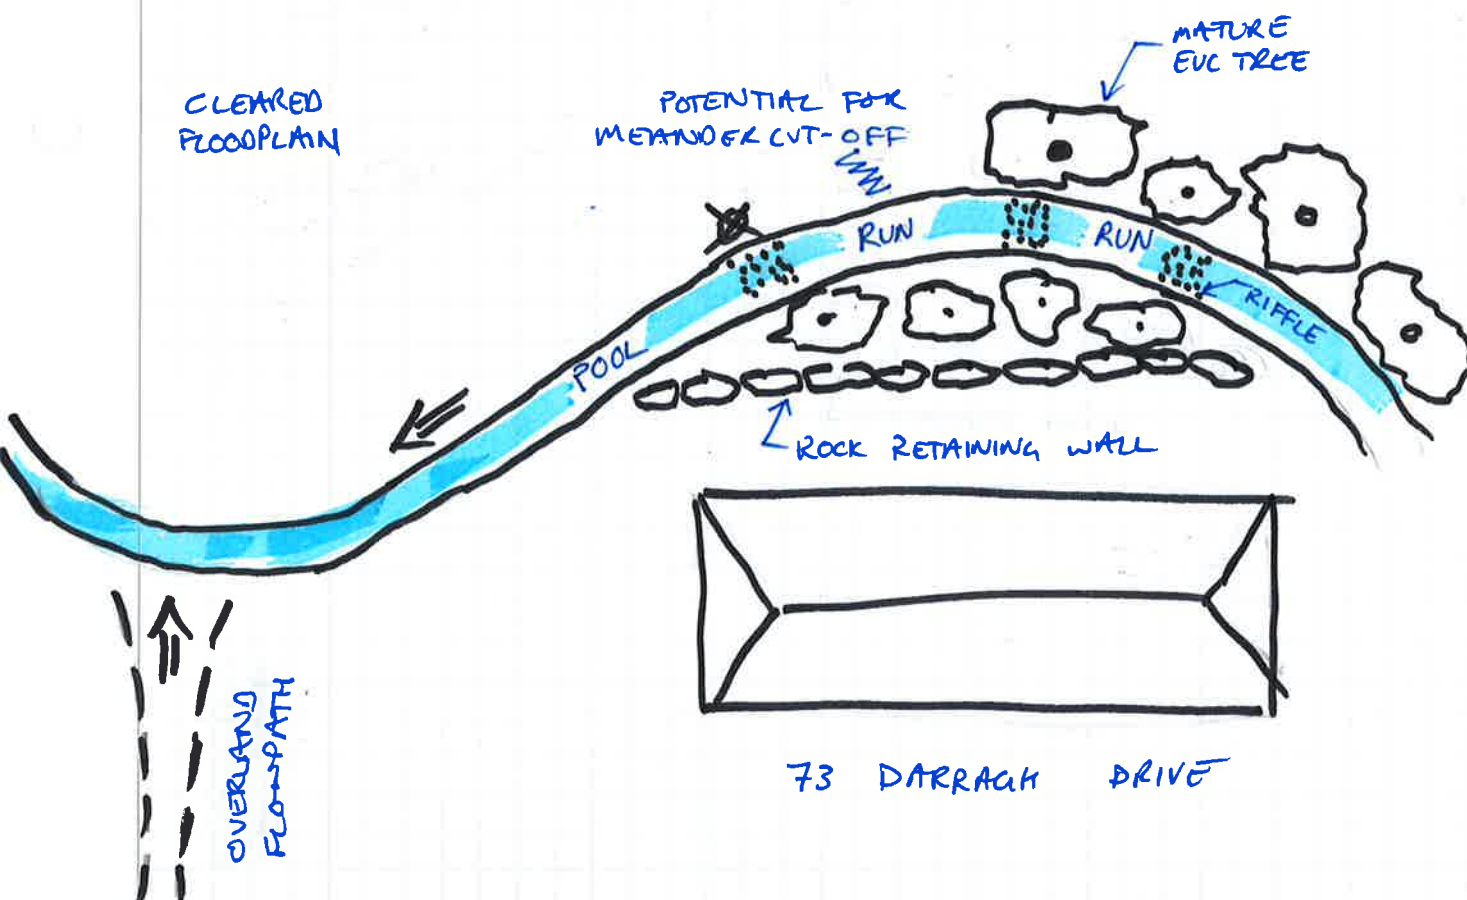
XS-2 PLAN

PROJECT BRANDY + WATER CREEK  
SKETCHES

For the creek length adjacent to Darragh Drive, the channel appears to have been stabilised and filled on the left bank. Partial to full height rock retaining walls have been built to protect houses backing onto the creek. The opposite bank comprises bushland and a steep valley wall with small floodplain pockets. An irregular shaped channel meanders alongside the backyards of Darragh Drive properties and features an S bend opposite house numbers. Geomorphic units such as sand/gravel point bars, gravel riffles, pools and runs were observed. The sketches shown in **Appendix B** illustrate the geomorphology.

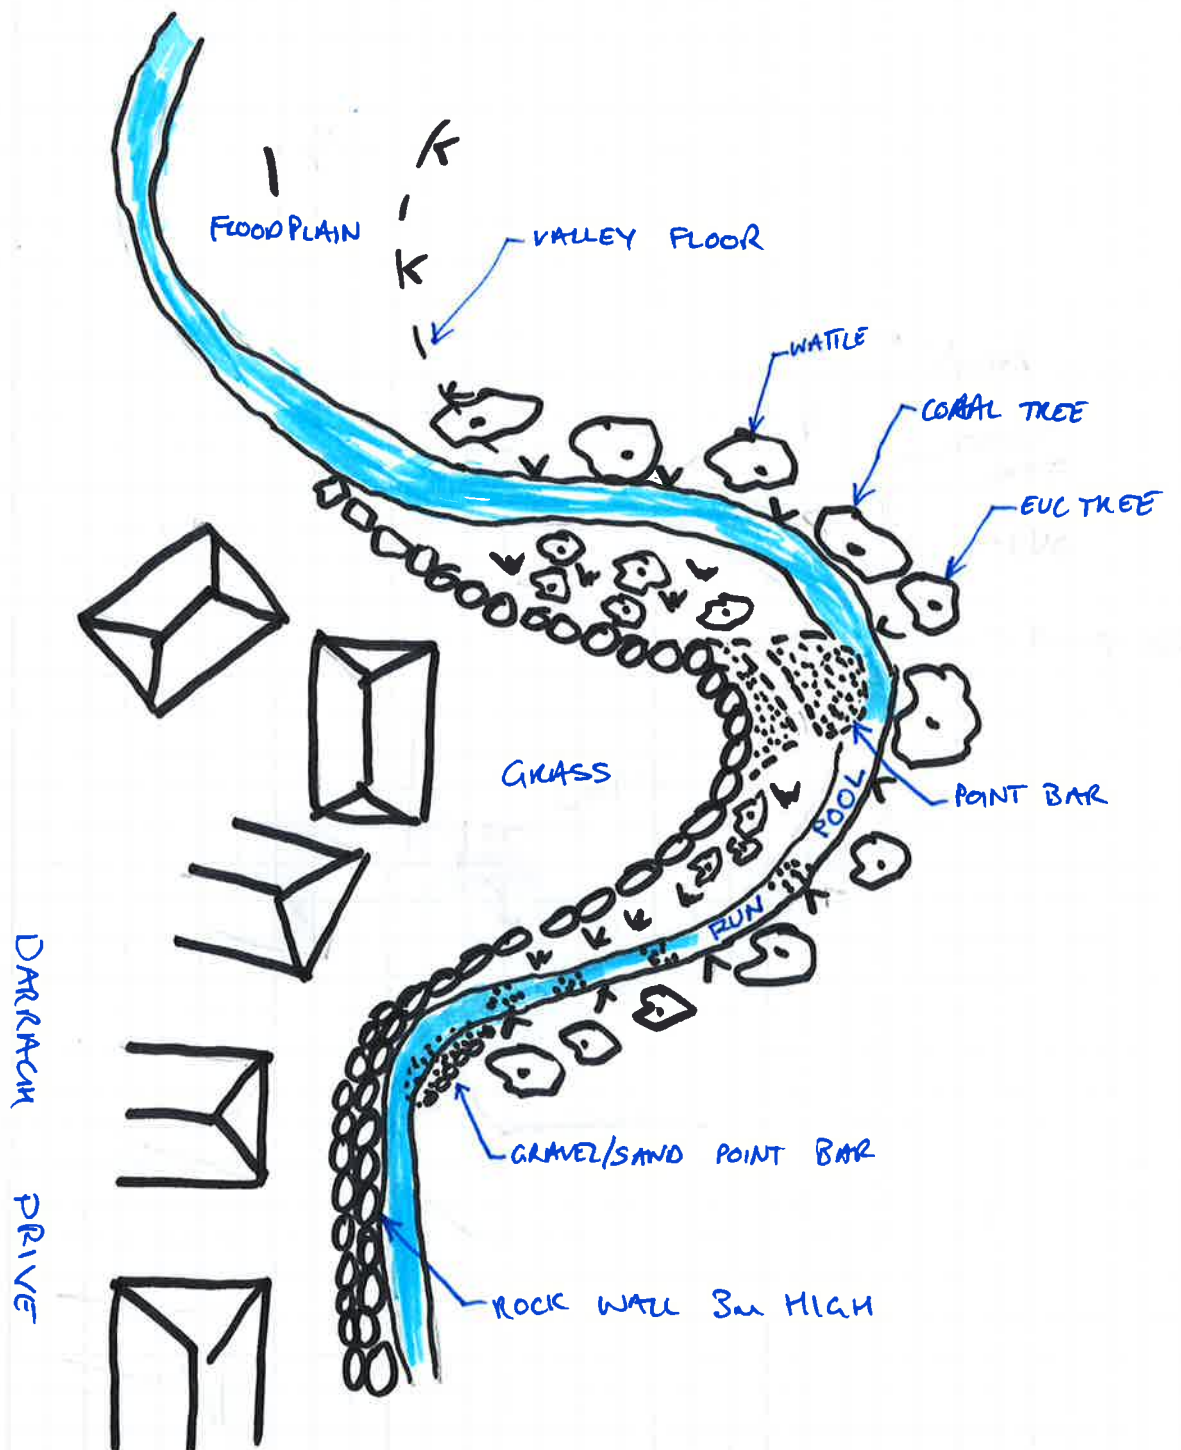
XS-3

PROJECT BRANDY + WATER CREEK  
CROSS SECTION SKETCHES

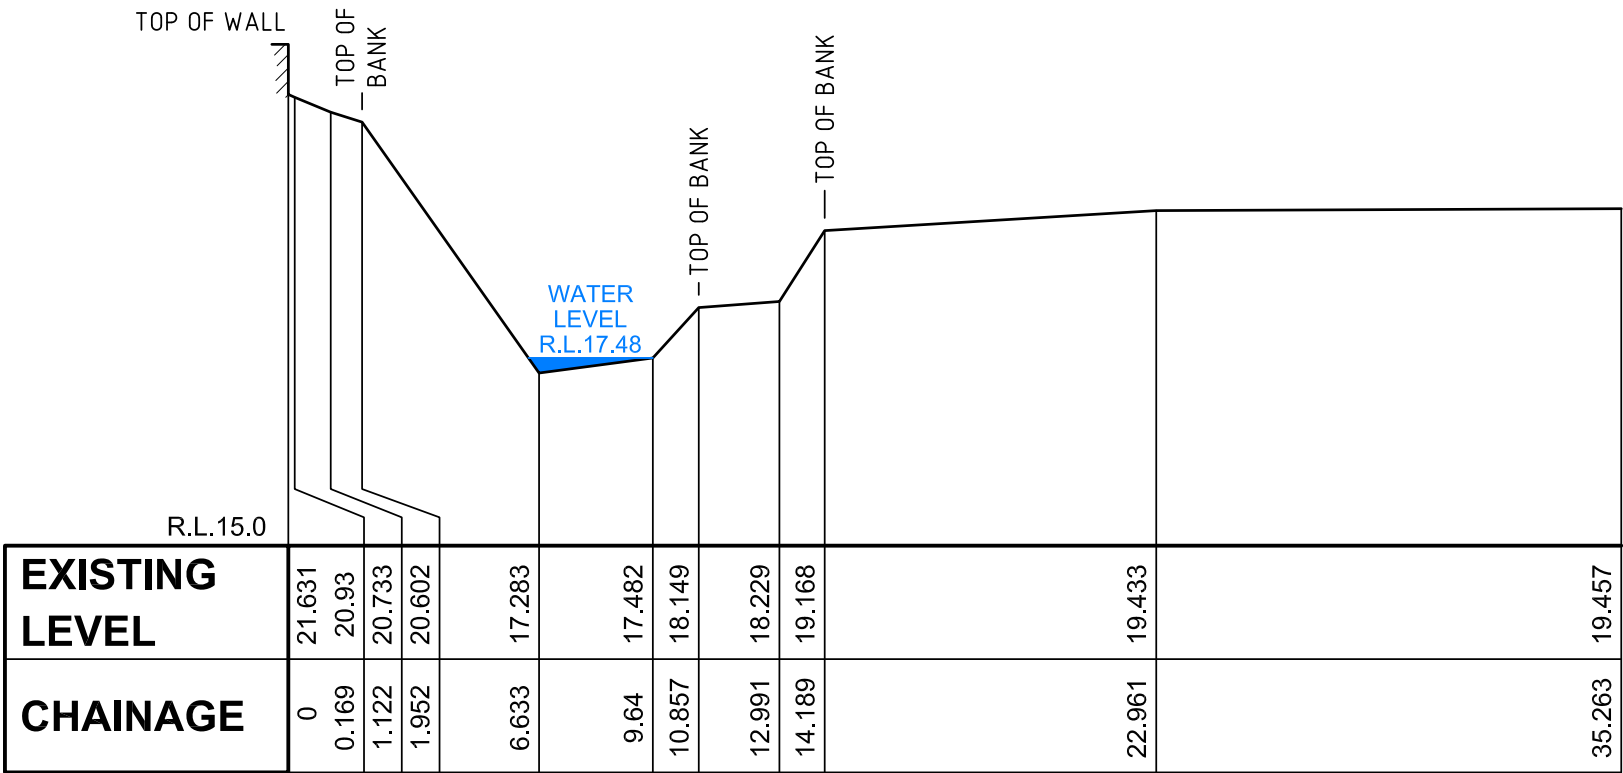
SECTION No.10  
SCALE 1:200 HORIZONTAL  
1:100 VERTICAL

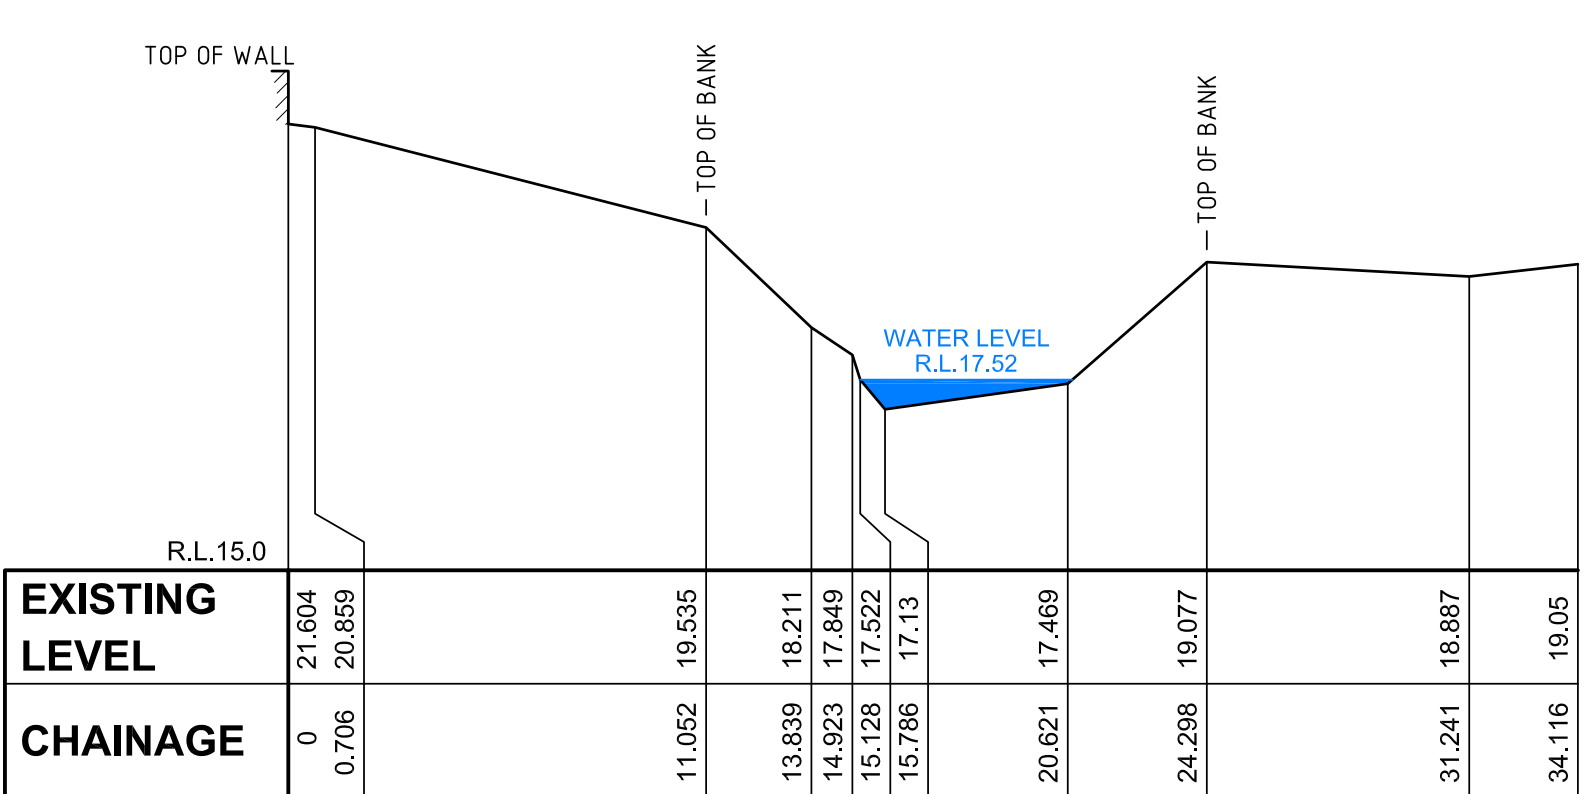
SECTION No.12  
SCALE 1:200 HORIZONTAL  
1:100 VERTICAL

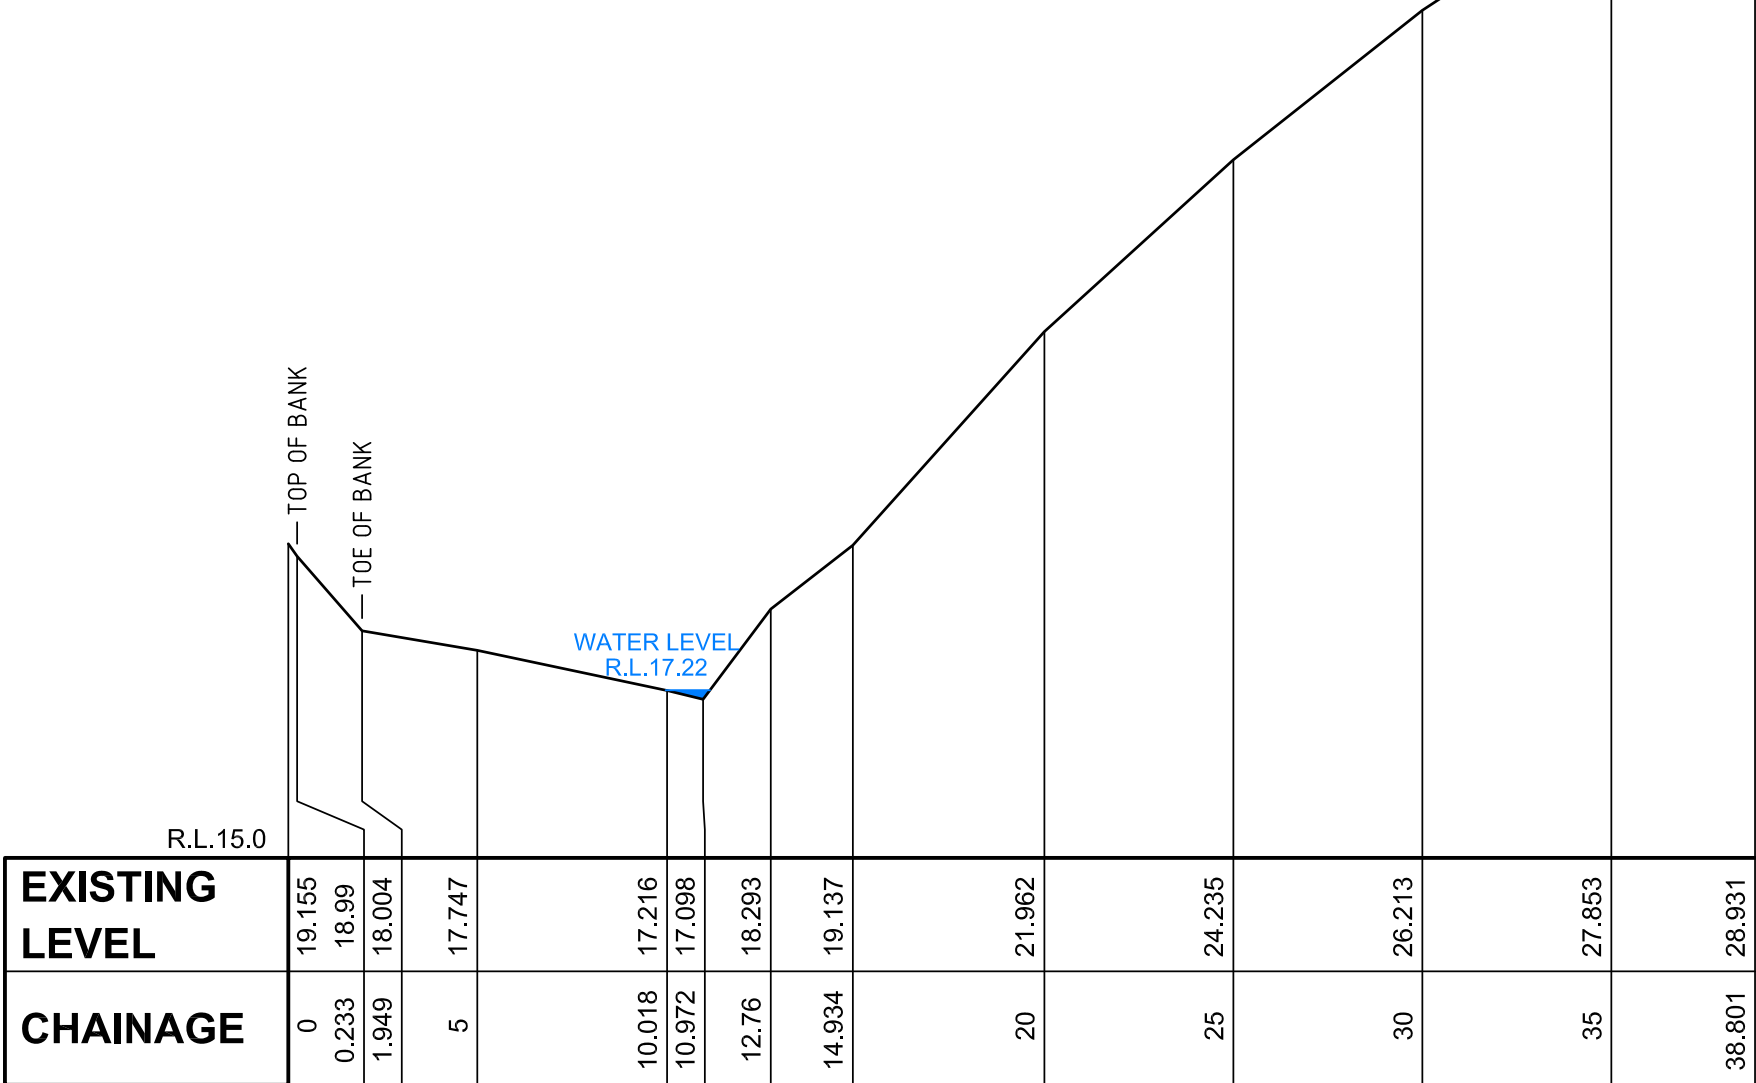
SECTION No.13  
SCALE 1:200 HORIZONTAL  
1:100 VERTICAL

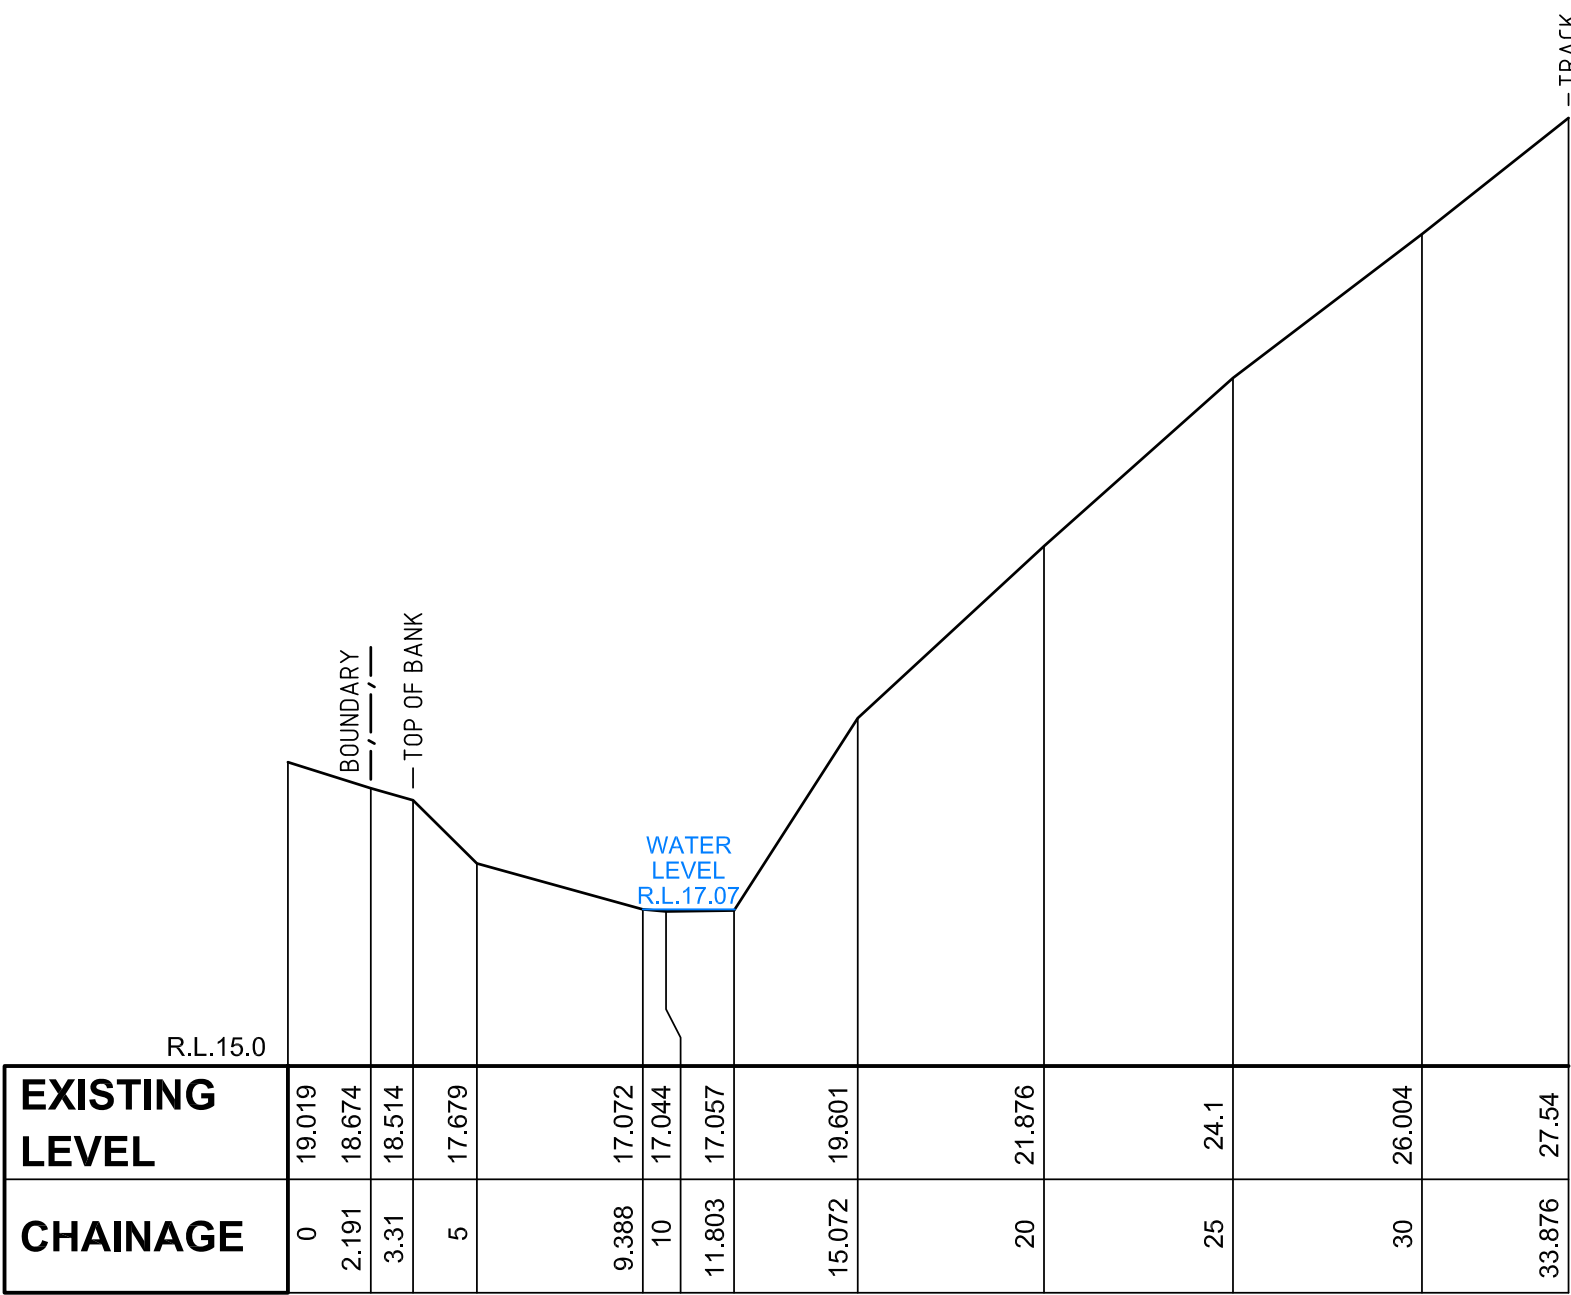
SECTION No.14  
SCALE 1:200 HORIZONTAL  
1:100 VERTICAL

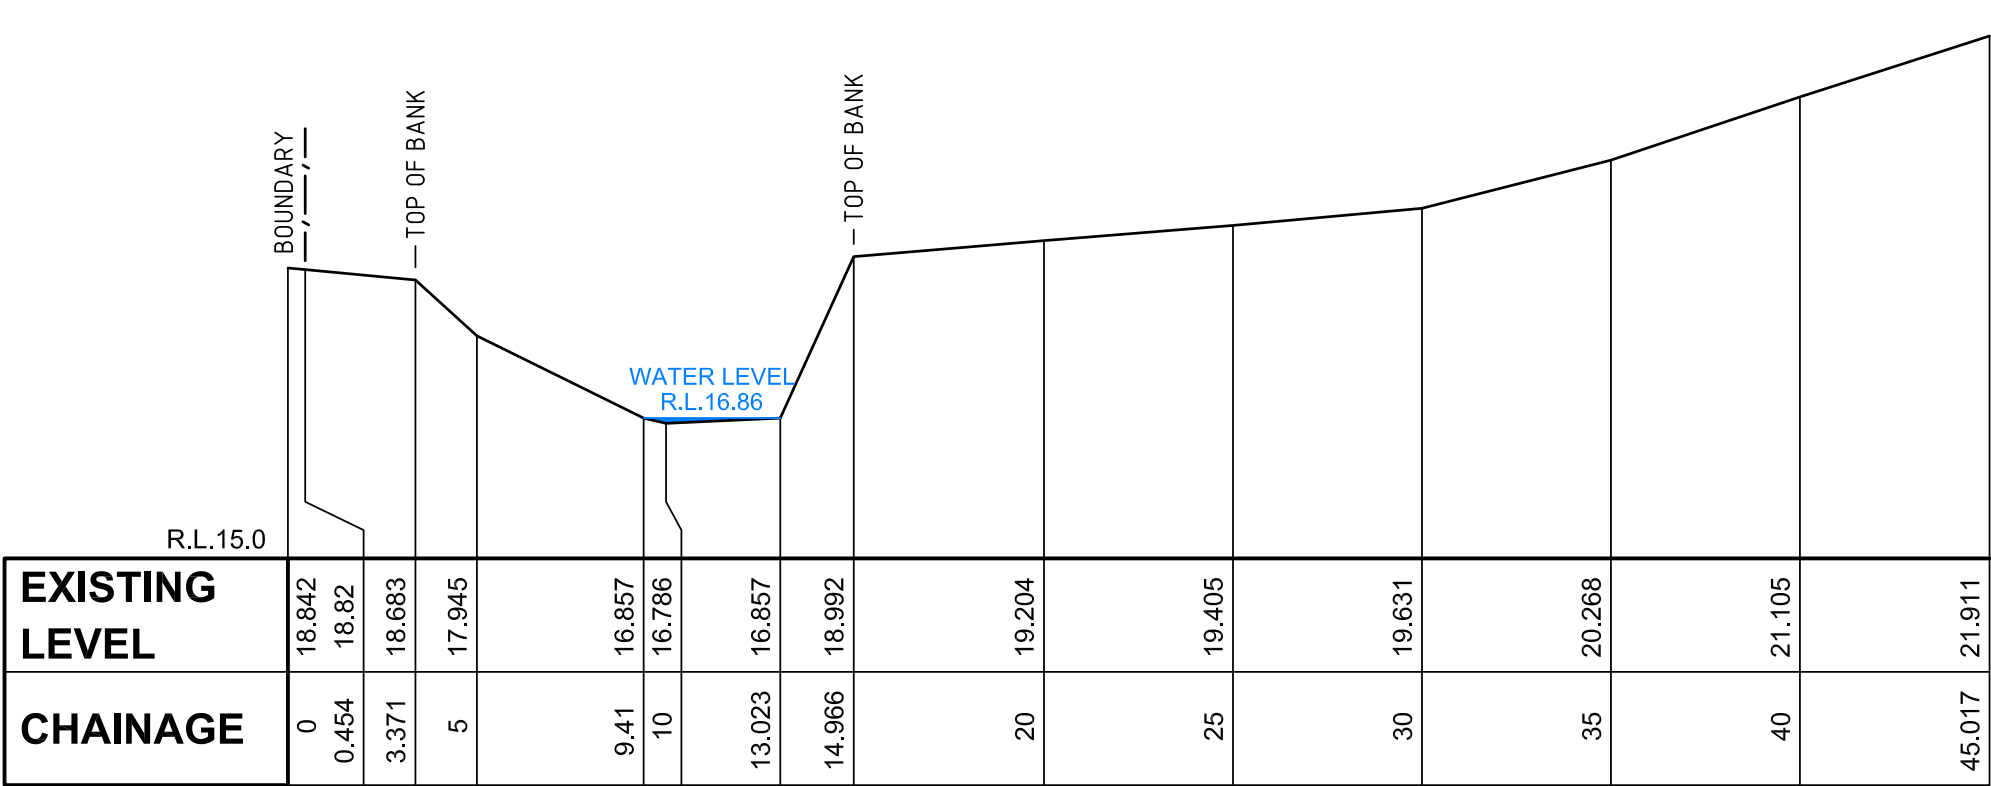
SECTION No.15  
SCALE 1:200 HORIZONTAL  
1:100 VERTICAL

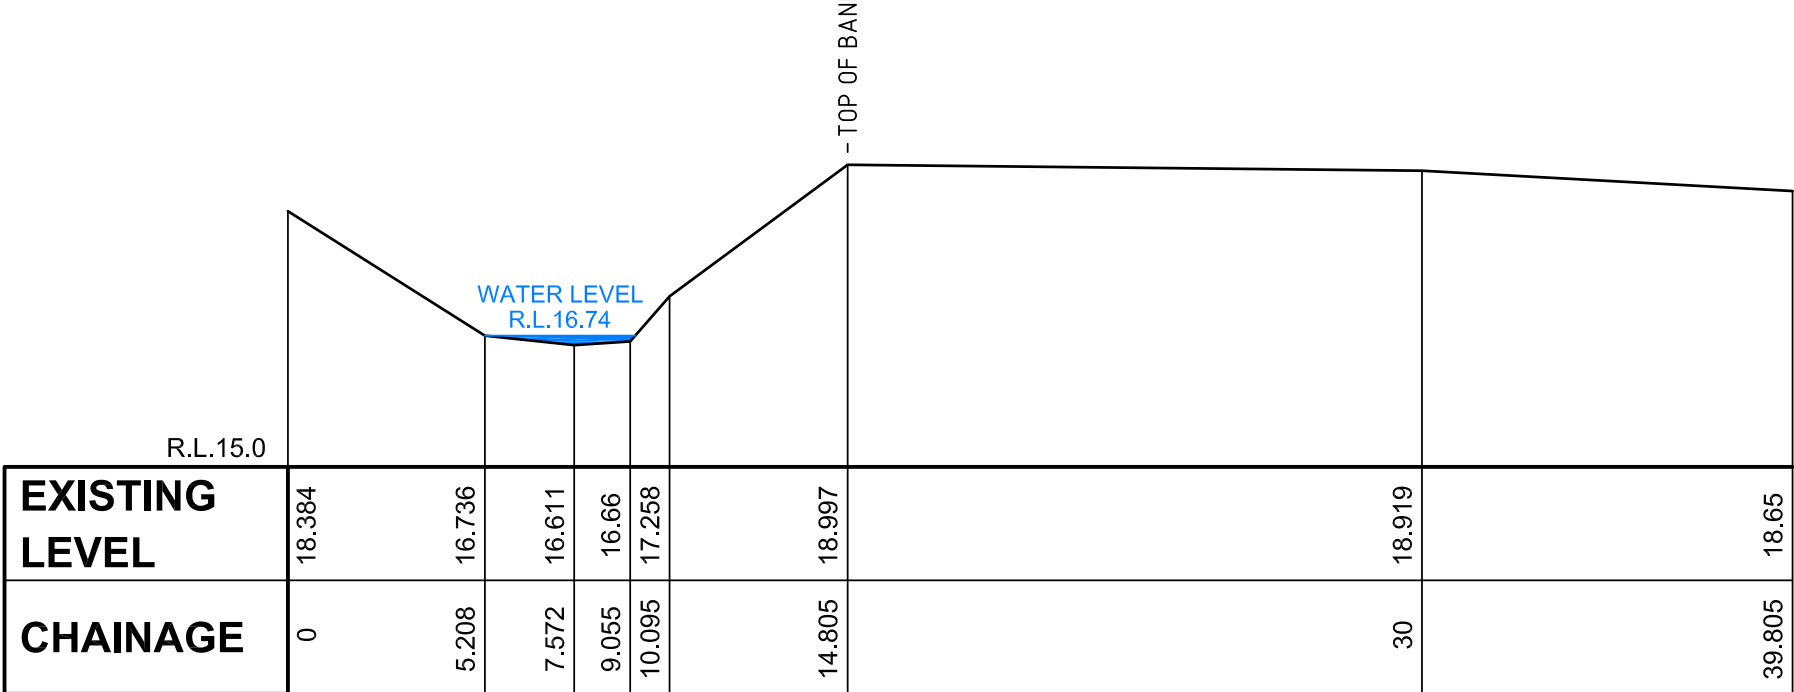
SECTION No.17  
SCALE 1:200 HORIZONTAL  
1:100 VERTICAL

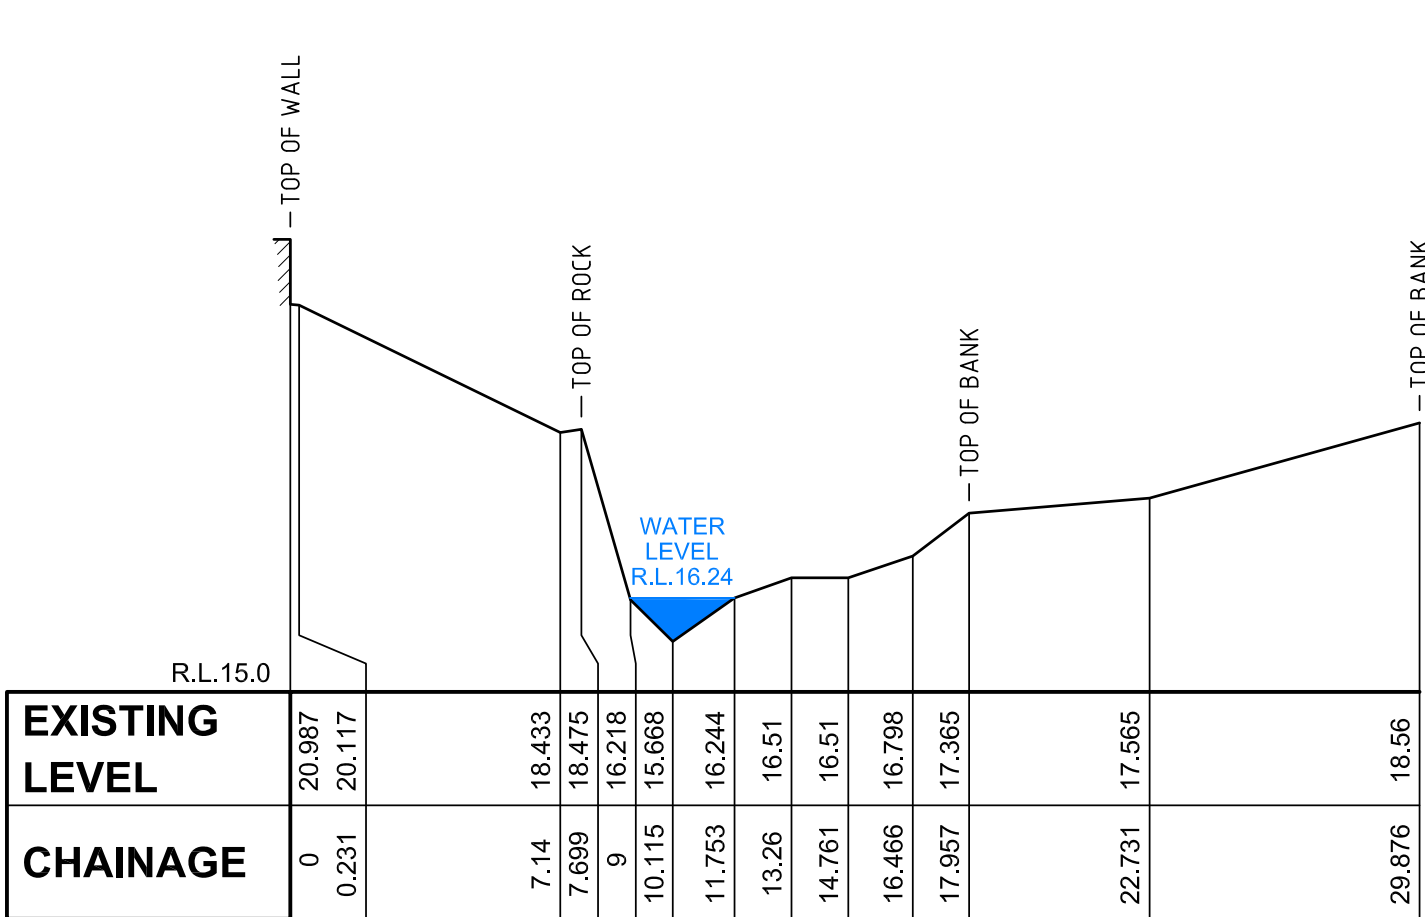
SECTION No.21  
SCALE 1:200 HORIZONTAL  
1:100 VERTICAL

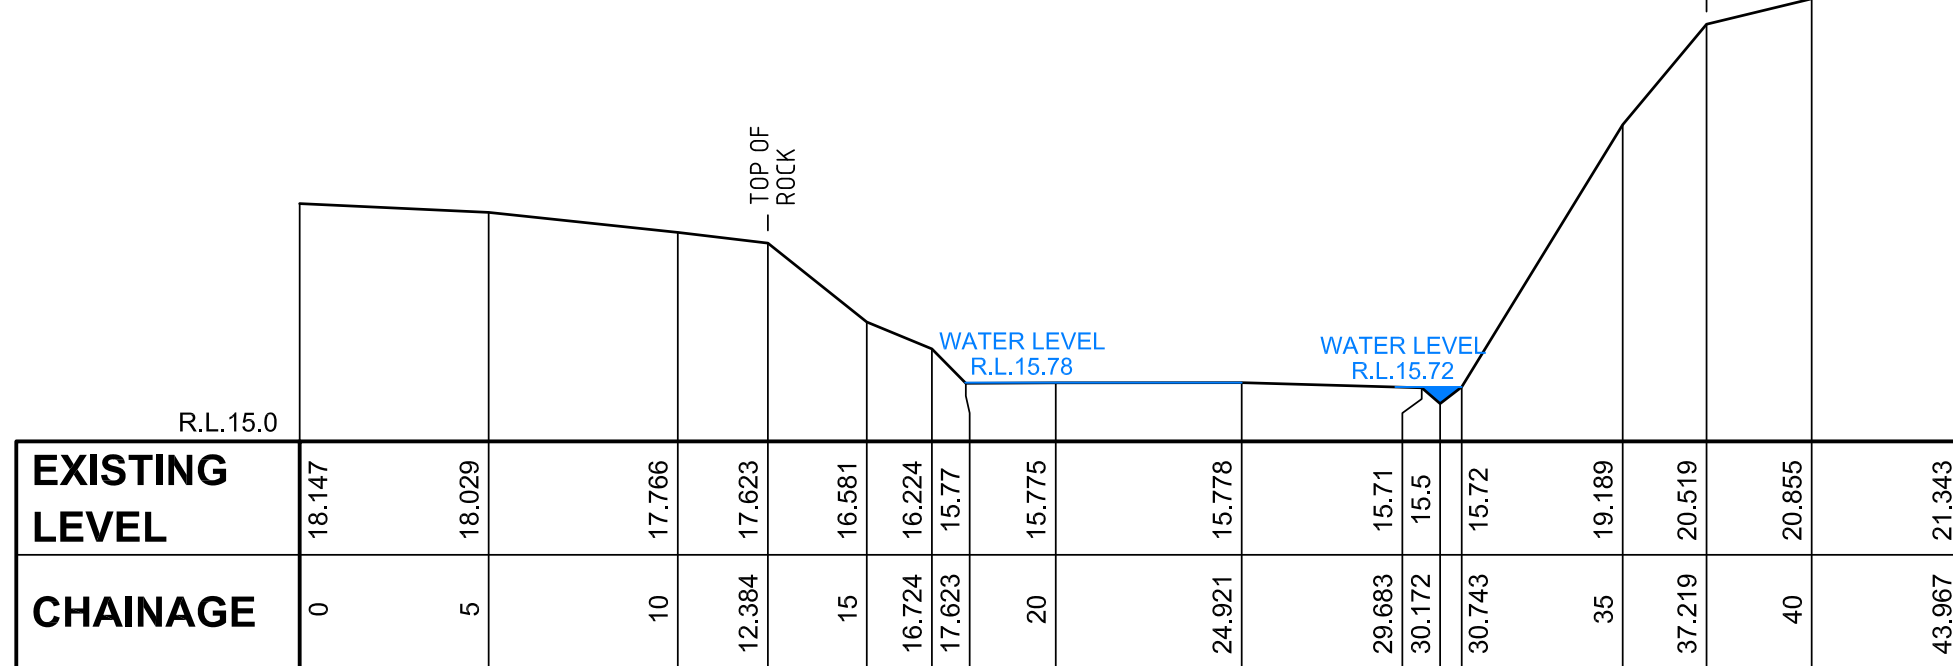
**SECTION No.24**  
SCALE 1:200 HORIZONTAL  
1:100 VERTICAL

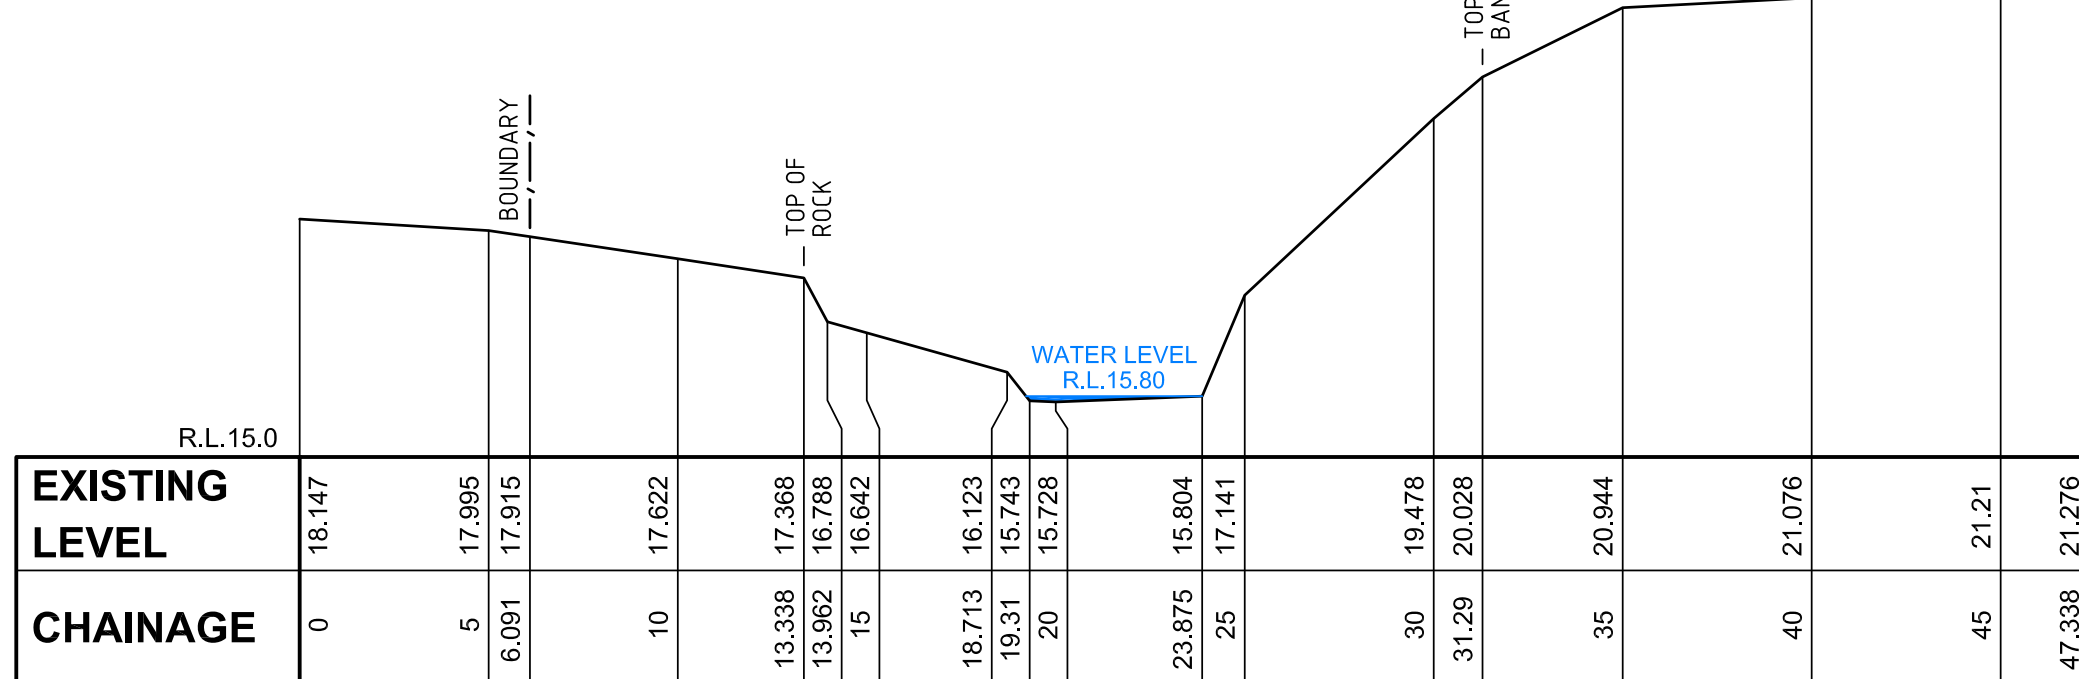
**SECTION No.25**  
SCALE 1:200 HORIZONTAL  
1:100 VERTICAL

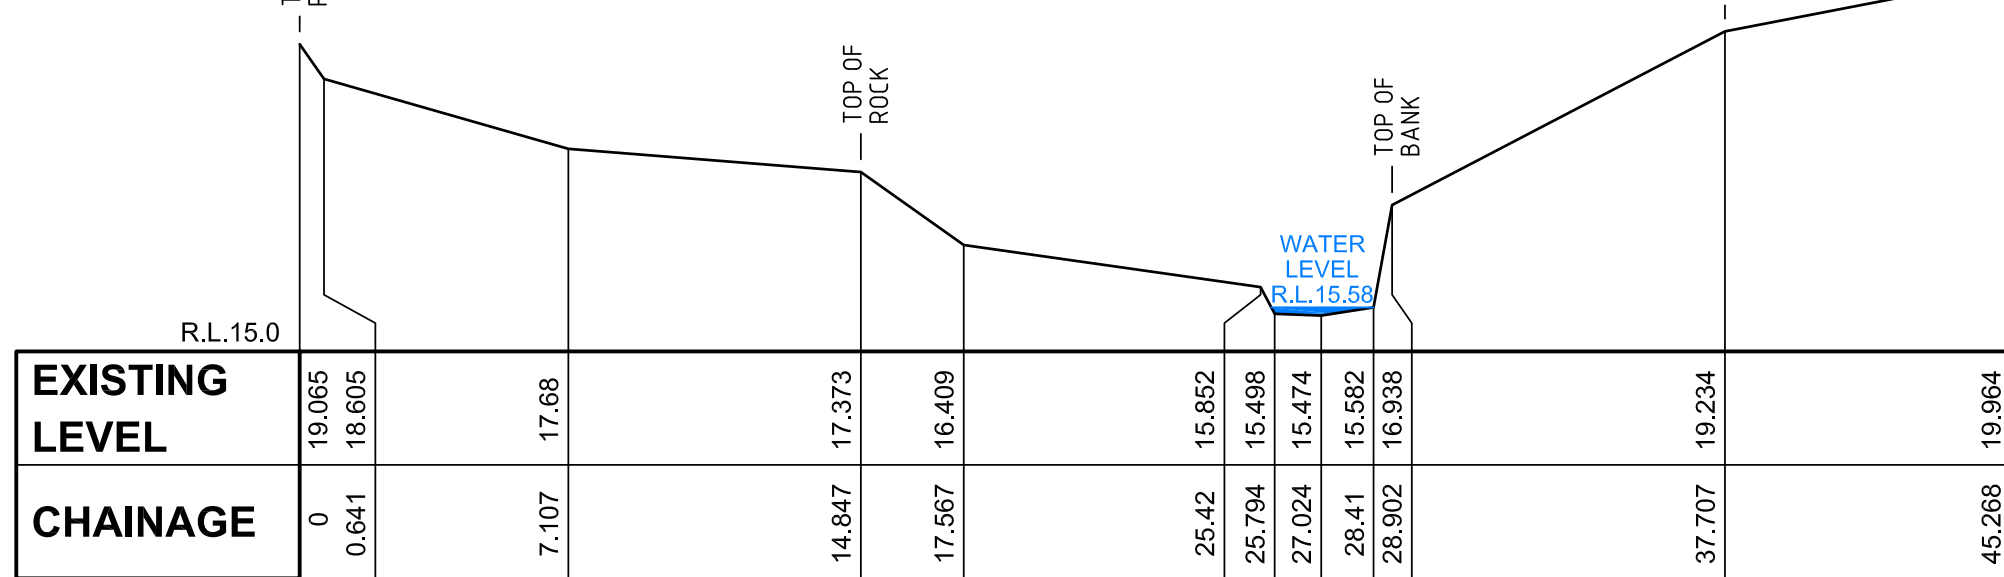
**SECTION No.26**  
SCALE 1:200 HORIZONTAL  
1:100 VERTICAL

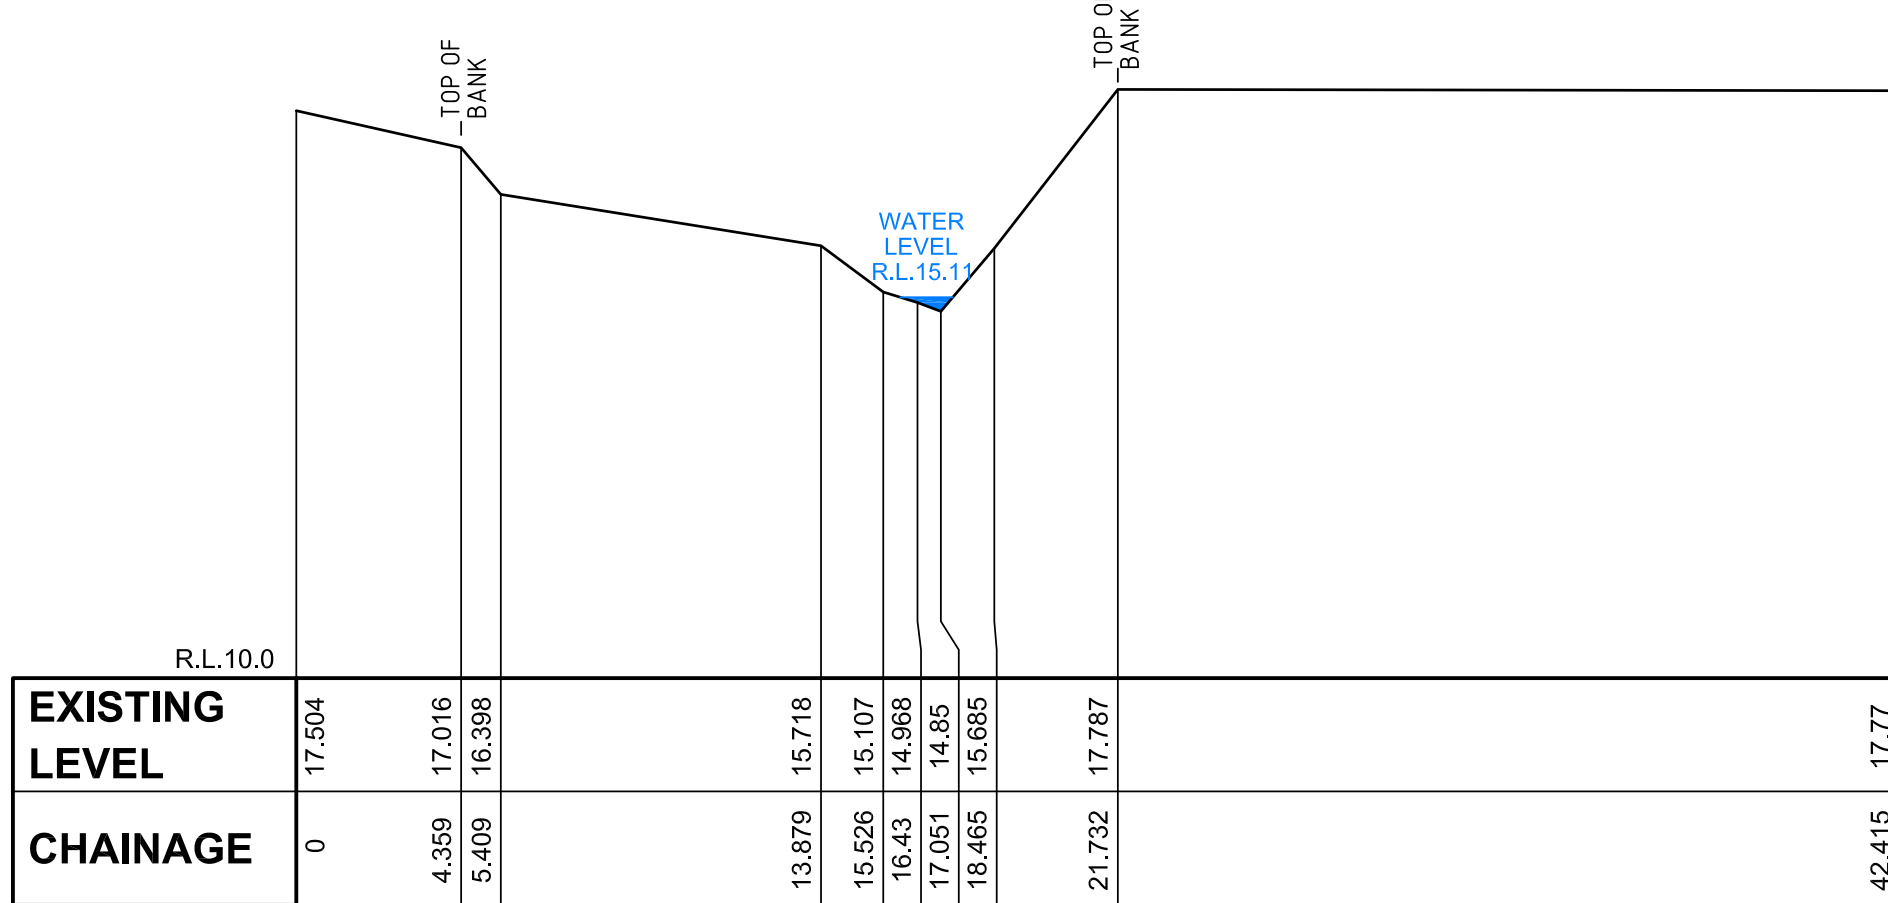
**SECTION No.27**  
SCALE 1:200 HORIZONTAL  
1:100 VERTICAL

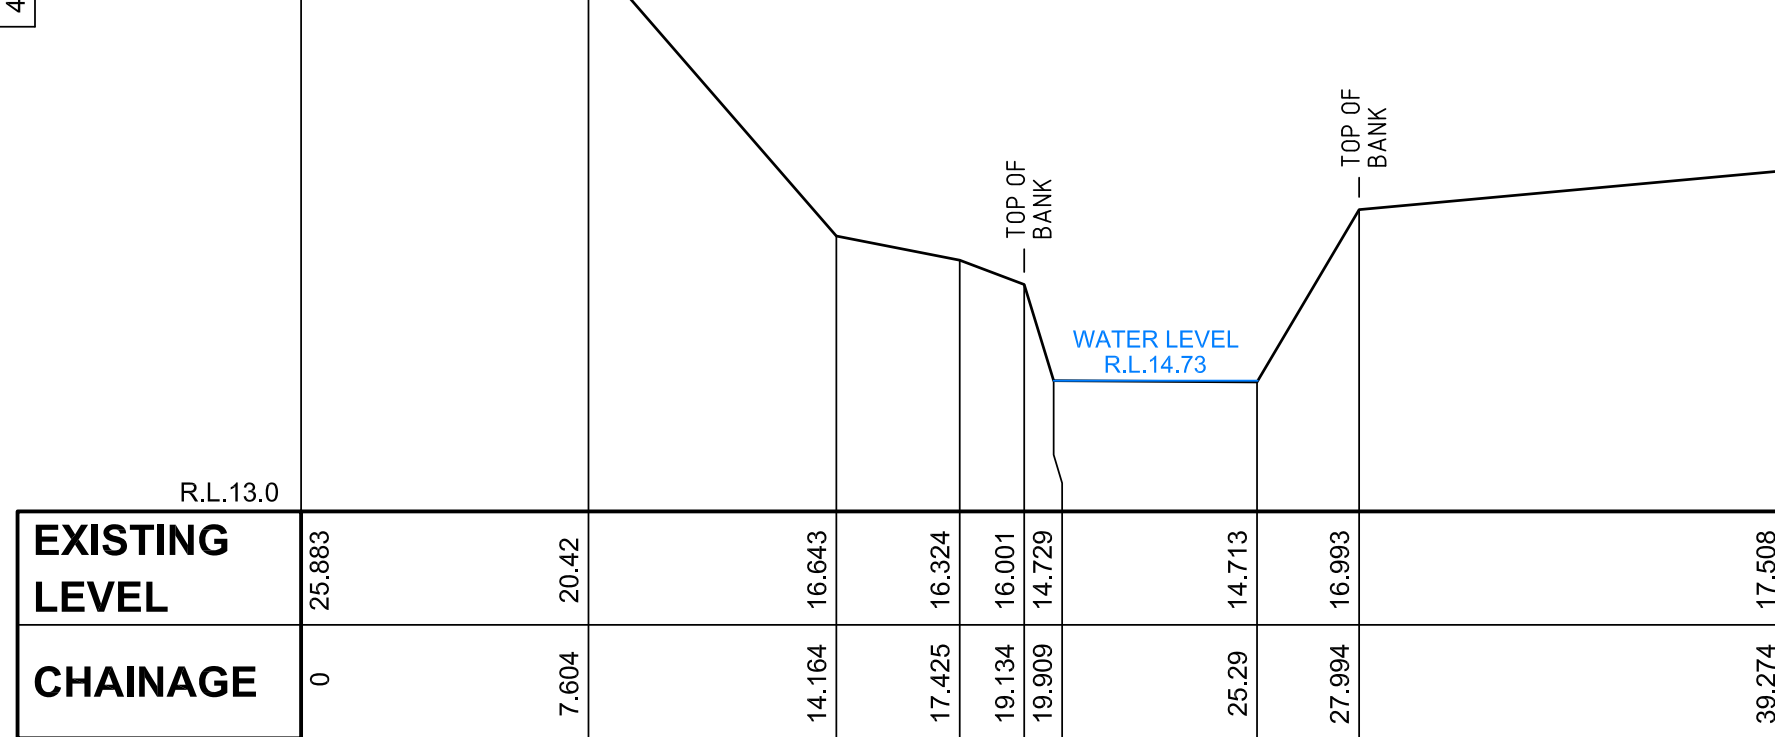
**SECTION No.30**  
SCALE 1:200 HORIZONTAL  
1:100 VERTICAL
