# Brandy & Water Creek- Investigation & Design of Creek Modification

Prepared for  
Wollongong City Council

1st May 2014

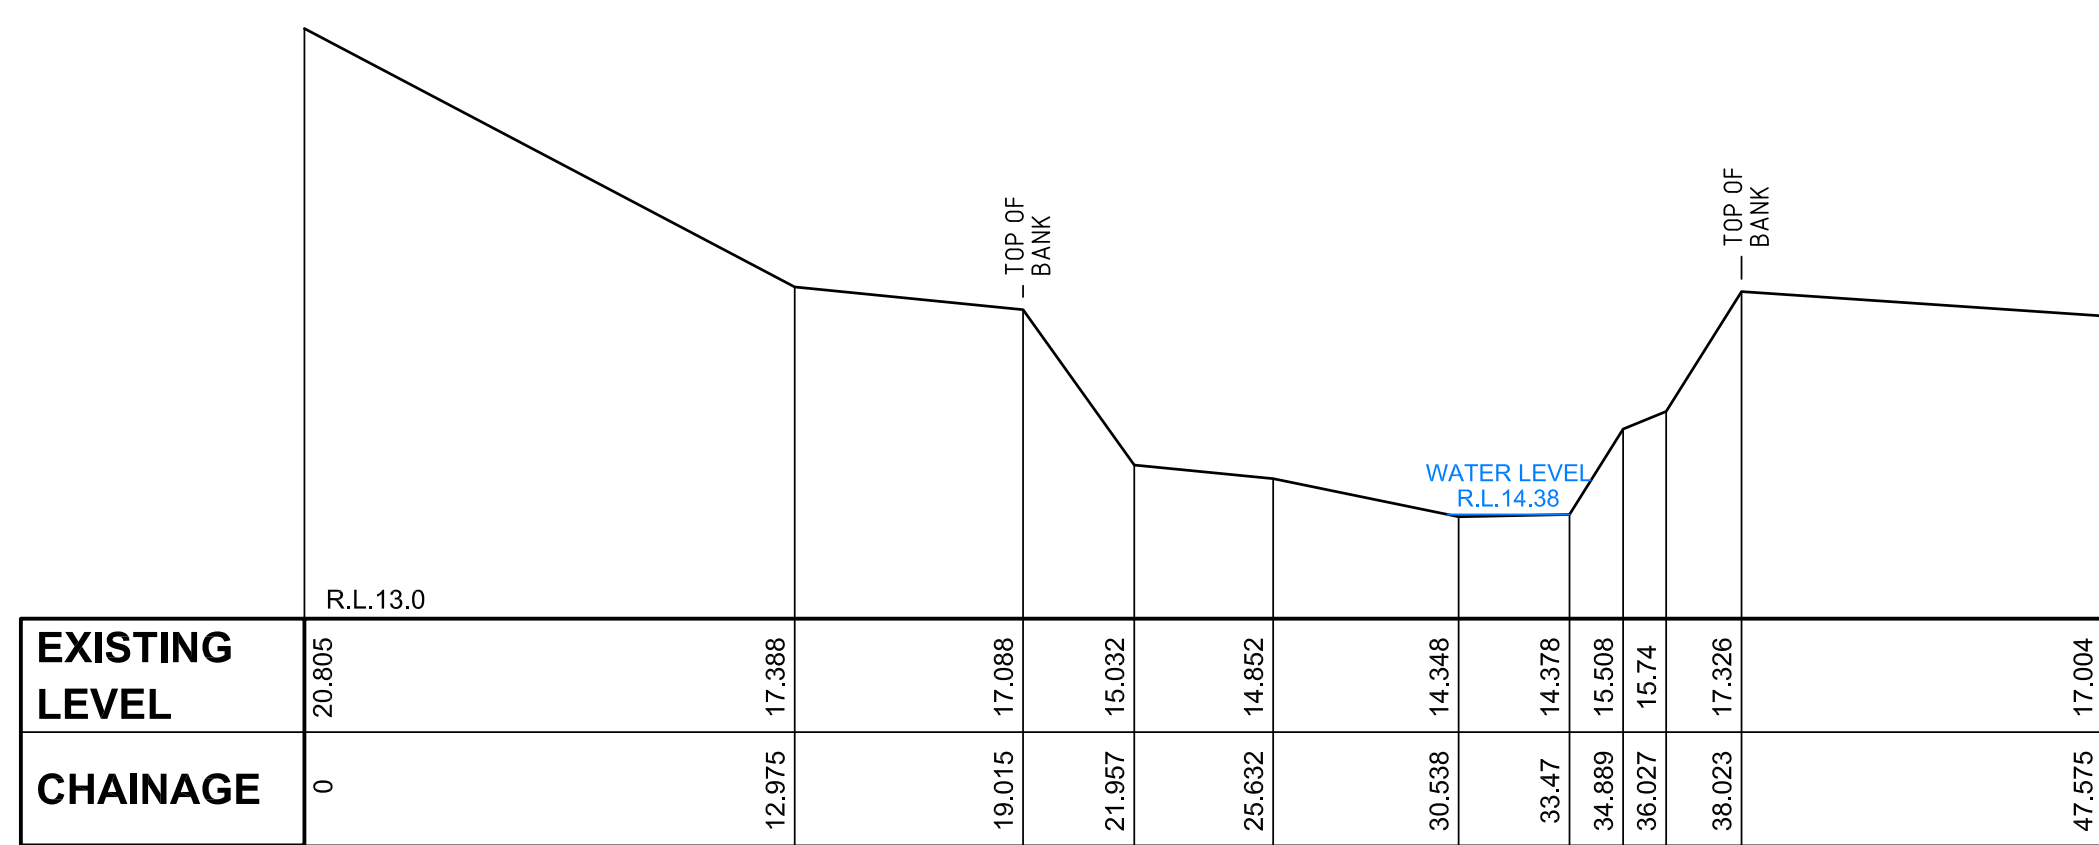
**SECTION No.32**  
SCALE 1:200 HORIZONTAL  
1:100 VERTICAL

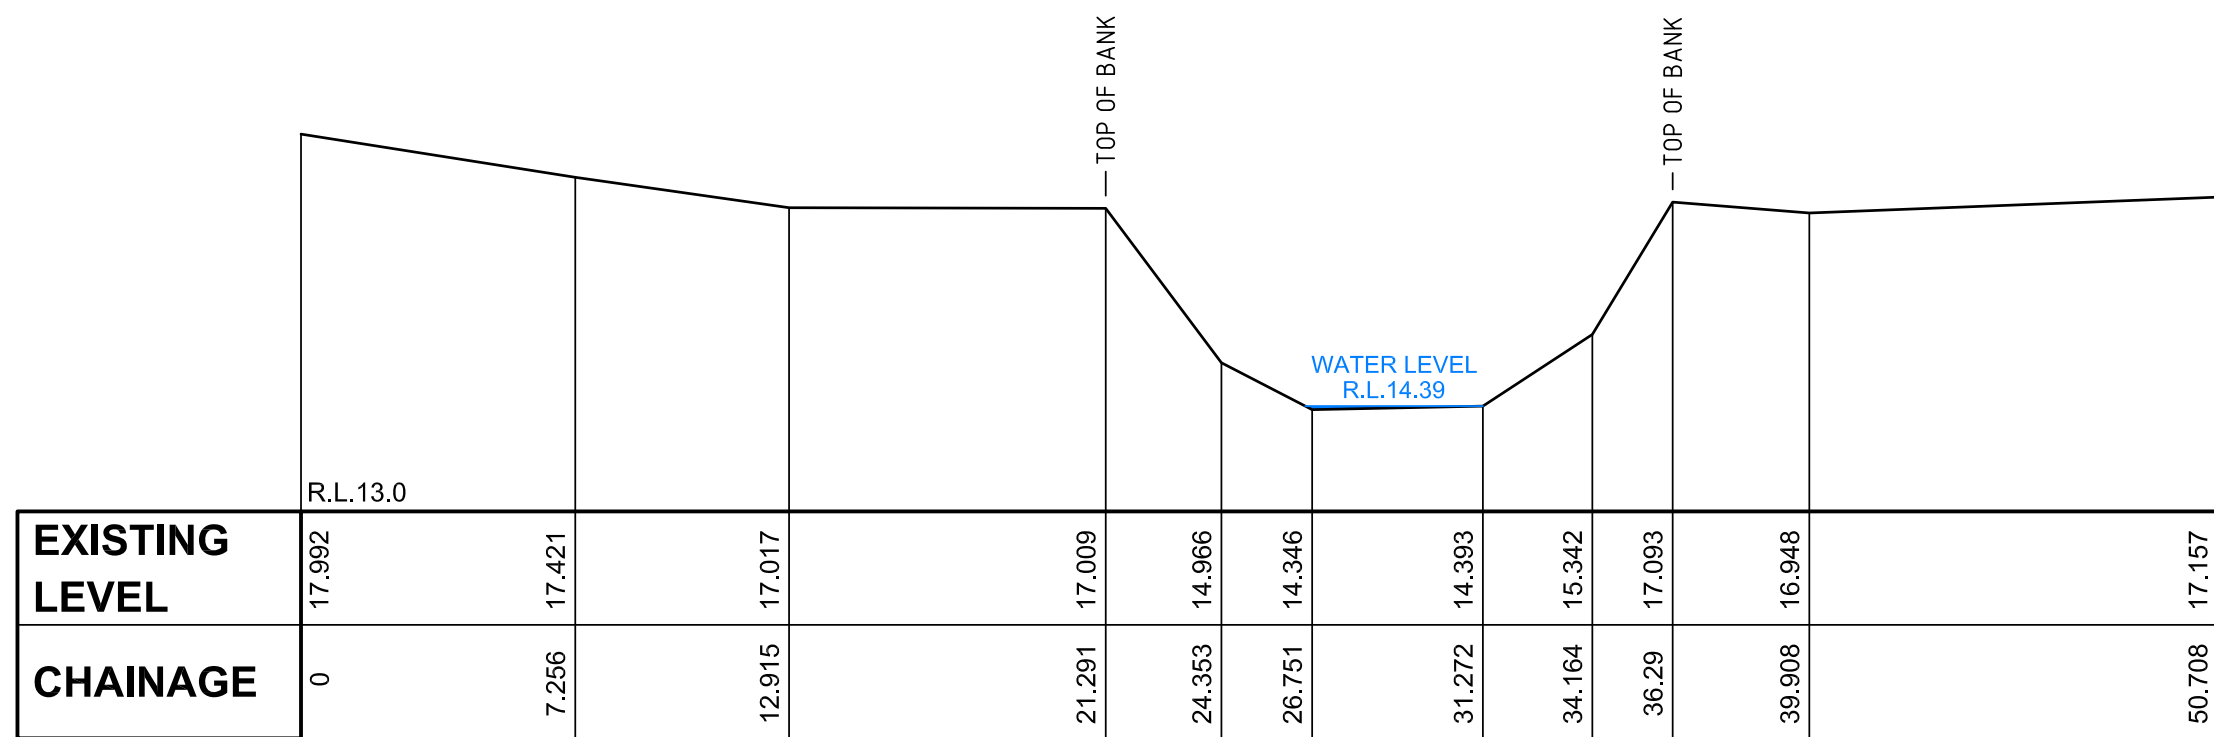
**SECTION No.33**  
SCALE 1:200 HORIZONTAL

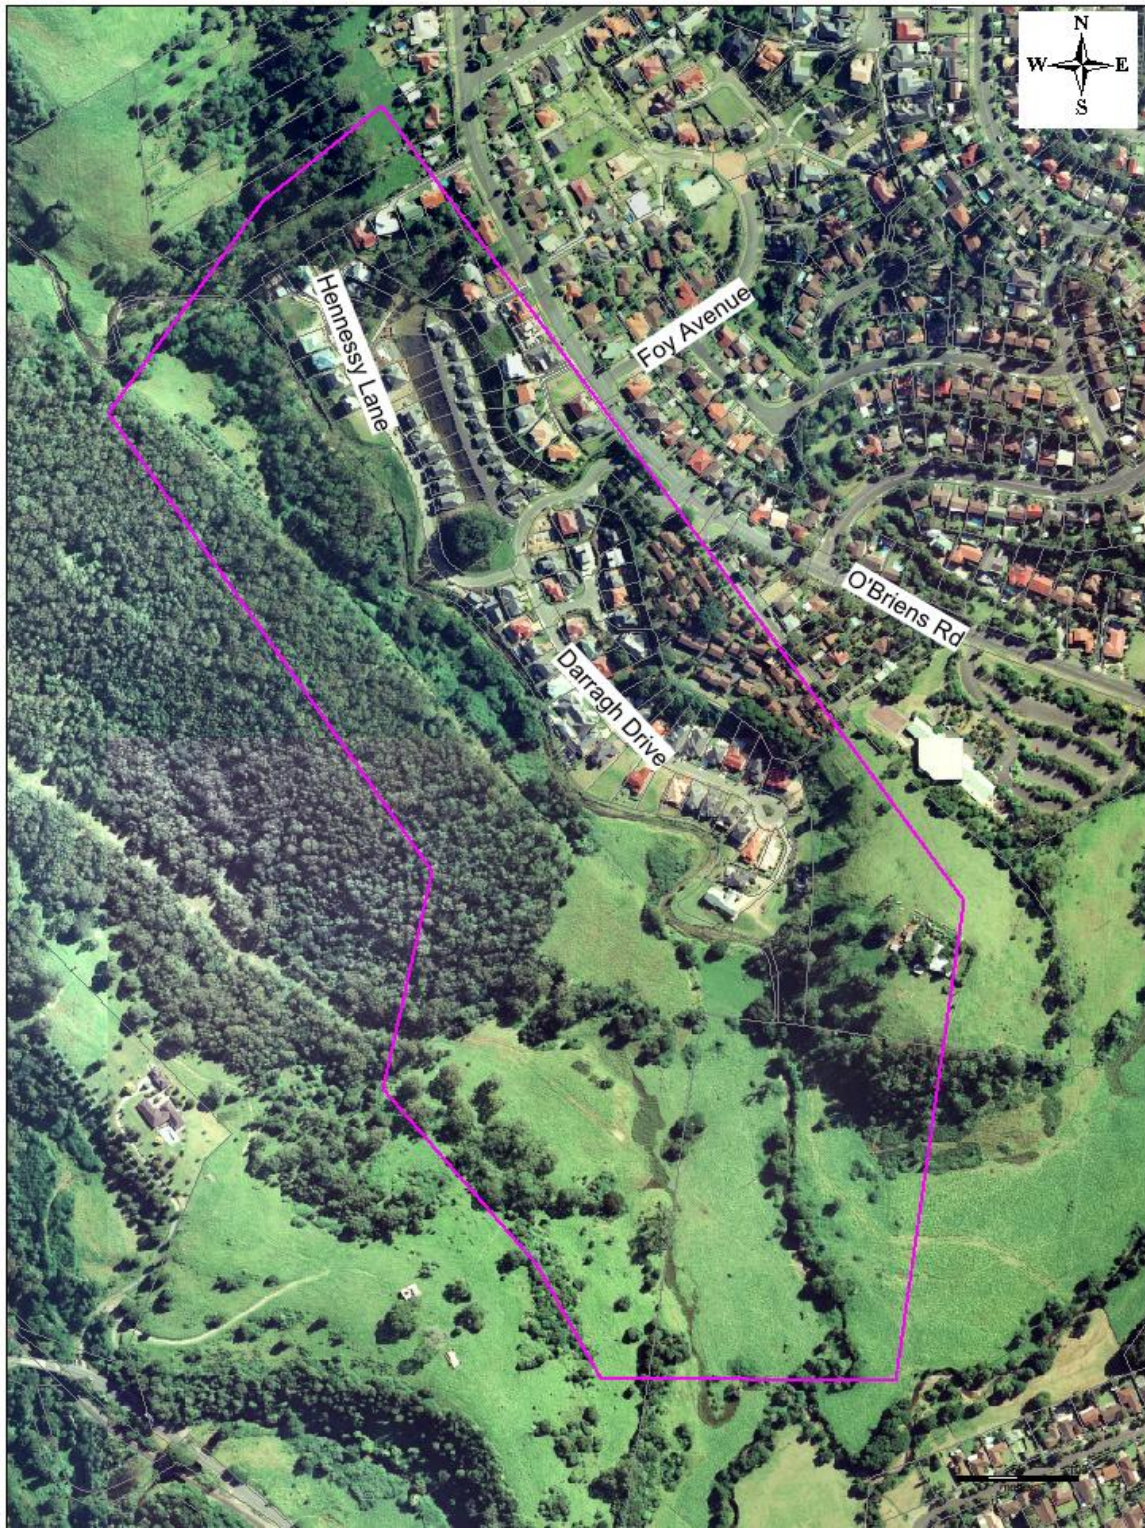
**Figure 1-1 Study Area**

One of the flooding areas identified by the Allans Creek FRMSP is along Brandy and Water Creek in the vicinity of the Darragh Drive, Figtree. This area is shown in Figure 1.1. This FRMSP identified a number of residential properties on the east bank (left bank) of Brandy and Water Creek which experience overfloor flooding in the 1% AEP. The FRMSP recommended a further investigation of options to potentially decrease the overfloor flood risk. One of the options is to lower the west bank (right bank) of the creek opposite these residential properties to increase conveyance and alleviate the potential overfloor flooding as a result.
