# HELENSBURGH WASTE DISPOSAL DEPOT ANNUAL REPORT 2024

For EPL 5861 (July 2024)

WOLLONGONG CITY COUNCIL (WASTE SERVICES)

Prepared for	NSW Environmental Protection Agency (EPA)
Project Name	Helensburgh Waste Disposal Depot Annual Report
Date	30 <sup>th</sup> July 2024
Version Number	2

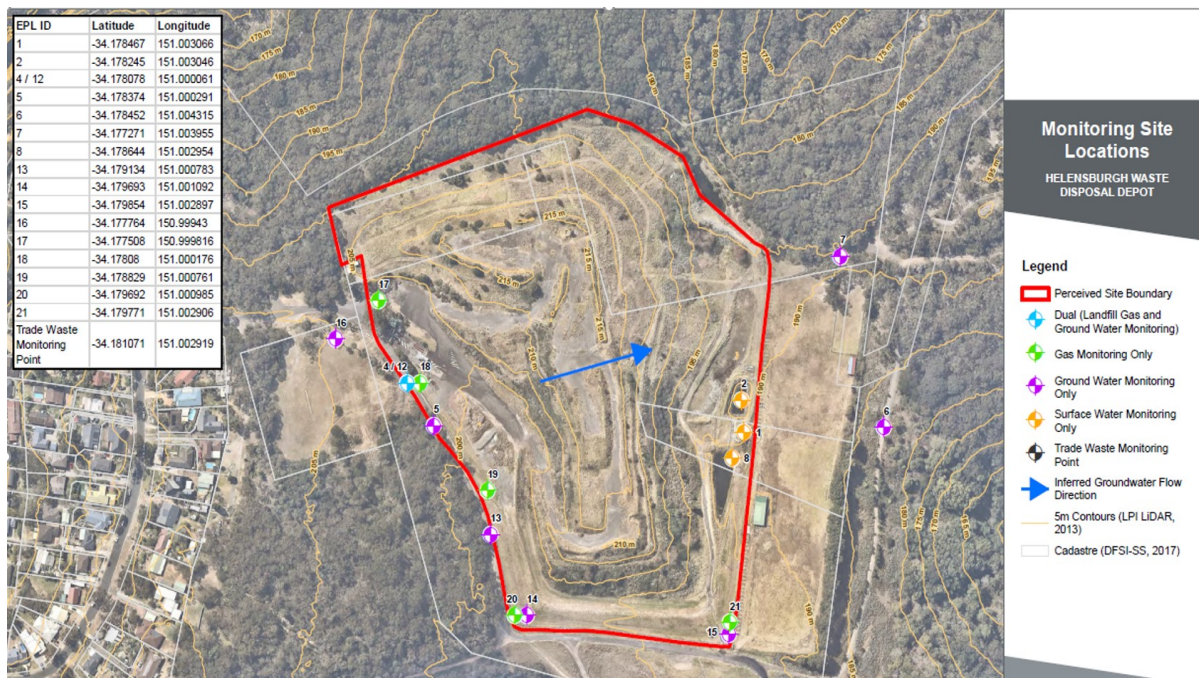
Figure 2: Monitoring Site Locations

Approximate surface contours are shown on **Figure 2**.

Subsurface gas monitoring was completed during the reporting period to assess for potential offsite migration. The fieldwork methodology for subsurface gas monitoring is summarised below in **Table 1-4**. The location of each subsurface gas monitoring location is shown on **Figure 2**.

The fieldwork methodology for stormwater monitoring is summarised below in **Table 1-5**. The location of stormwater monitoring locations is shown on **Figure 2**.

Leachate monitoring was completed periodically during the reporting period to provide data on the composition, height levels and volumes of leachate produced by the Site, and to record details about any irregular discharges or overflows of leachate from the Site. The fieldwork methodology for leachate monitoring is summarised below in **Table 1-6**. The location of leachate monitoring locations is shown on **Figure 2**.

Surface water monitoring was completed periodically during the reporting period to verify that offsite surface water bodies were not being impacted by leachate or by sediment-laden stormwater from the landfill. The fieldwork methodology for surface water monitoring is summarised below in **Table 1-7**. The location of each stormwater monitoring location is shown on **Figure 2**.

Groundwater monitoring was completed periodically during the reporting period to track groundwater quality with time and evaluate interactions with leachate and potential contaminants. The fieldwork methodology for groundwater monitoring is summarised below in **Table 1-8**. The location of each groundwater monitoring location is shown on **Figure 2**.

Monitoring of trade wastewater was completed periodically during the reporting period to confirm that water quality parameters of wastewater discharge were within the acceptable criteria. Discharge of trade waste to sewer was undertaken by Council in accordance with the *Consent to Discharge Industrial Trade Wastewater* (Sydney Water 2023) (the *Consent*). The fieldwork methodology for trade wastewater monitoring is summarised below in **Table 1-9**. The trade waste monitoring location is shown on **Figure 2**.

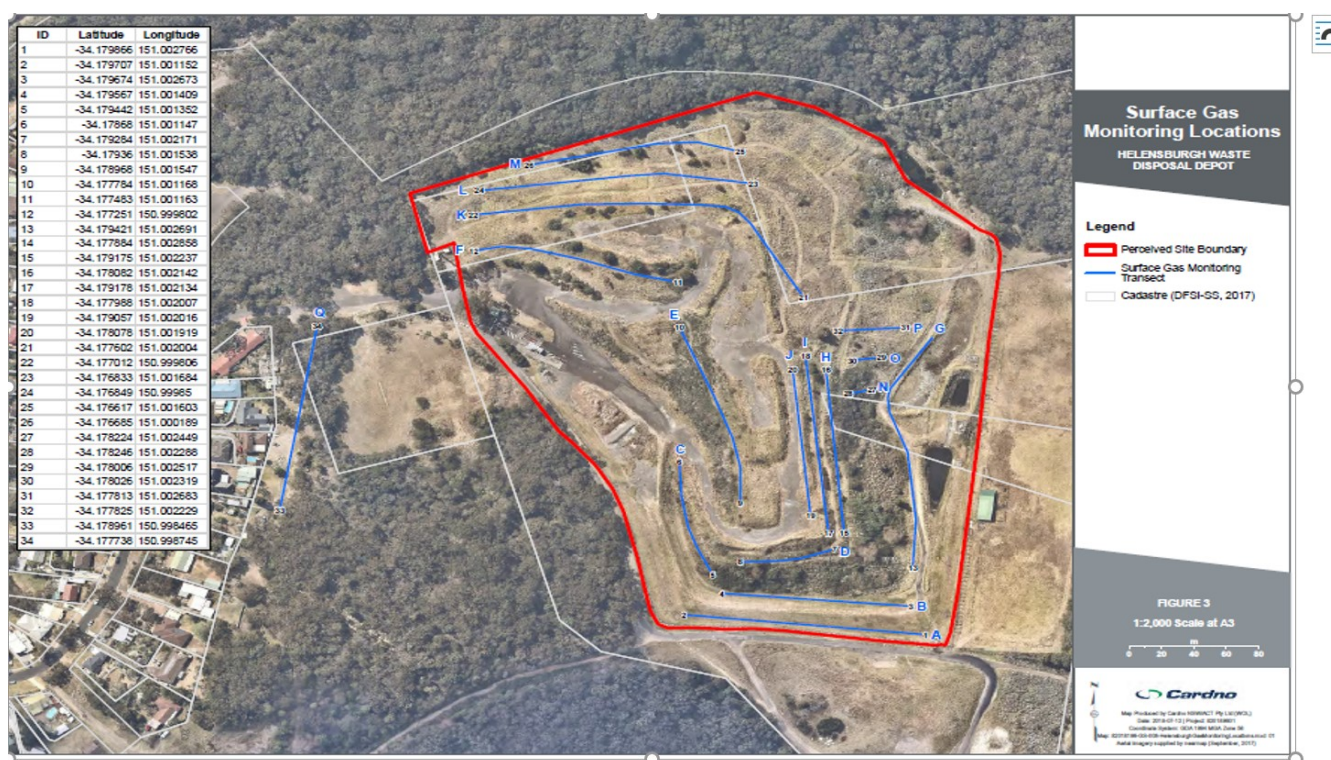
Figure 3: Surface Gas Monitoring Locations

Surface gas monitoring was completed during the reporting period to assess for potential surface emissions of landfill gases (LFG) emanating from the landfilled areas at the Site. The purpose of surface gas monitoring is to demonstrate that the cover material effectively controls the emission of landfill gas. The fieldwork methodology for surface gas monitoring is summarised below in **Table 1-3**. The location of each surface gas monitoring location is shown on **Figure 3**.

The highest reported concentration of methane was 8.4 ppm measured at Point 6 of transect J during the August 2023 monitoring event. An anomalous value of 26.9 ppm was also noted. However, this is well below the threshold level for further investigation and corrective action of 500 ppm.
