Wollongong City Council

Wollongong Dune Management Strategy for the Patrolled Swimming Areas of 17 Beaches

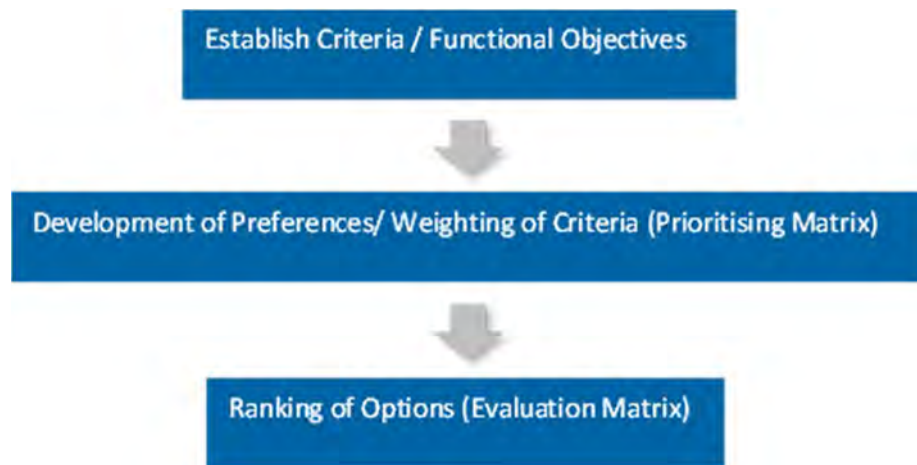
Figure 4 Option evaluation process

Following the development and agreement of the shortlist of options, a Multi-Criteria Analysis (MCA) was carried out in order to identify the most effective management options for each beach. An overview of the evaluation process for the MCA undertaken is shown below (Figure 4) and described in detail in the following sections.

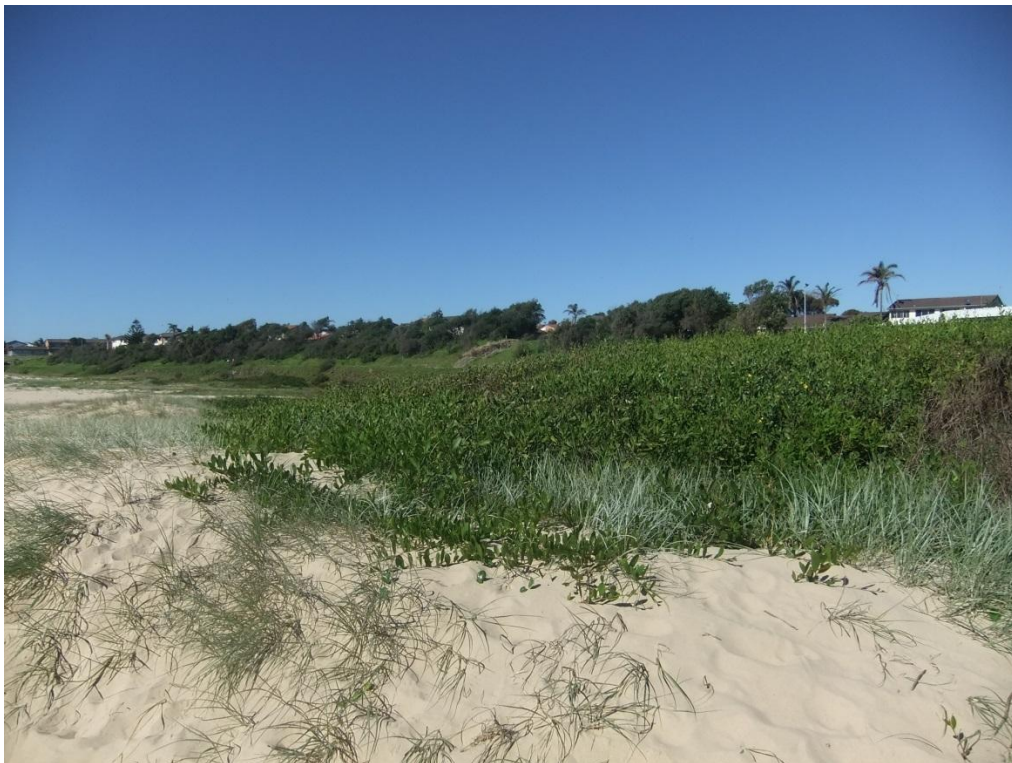
Figure 7 Zonation on foredune at Bellambi

Coastal Wattle, growing in foredunes (Figure 7), cannot be considered an environmental weed in the Wollongong LGA because it is not growing outside its range. Further explanation follows.

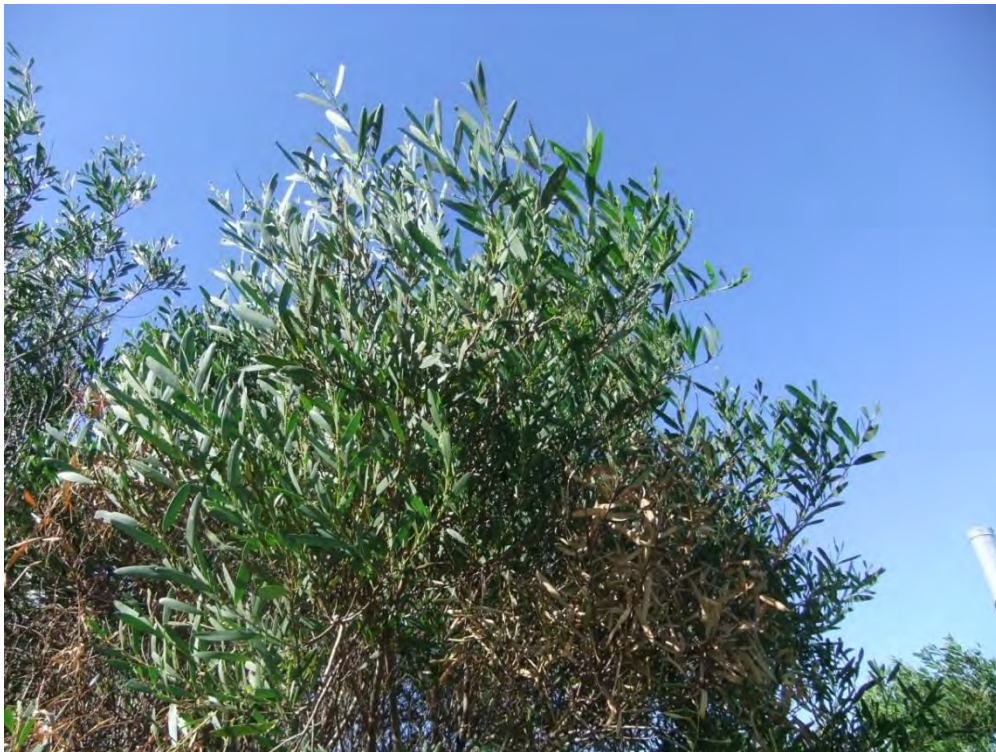
Figure 9 Foliage of *A. longifolia* subsp. *longifolia*. Note lanceolate phyllodes with acute apices.

The phyllodes of *A. longifolia* subsp. *longifolia* are 5-20cm long and 5-15mm wide, generally broadest near the middle, mostly thin and narrowing gradually towards the apex (Figures 8 and 9).

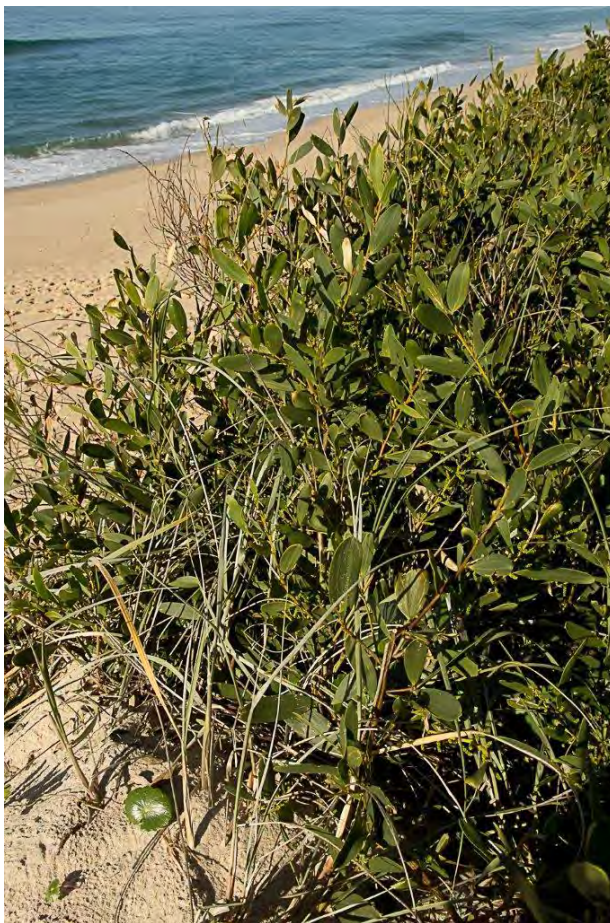
Figure 10 Foliage of *A. longifolia* subsp. *sophorae*. Note oblanceolate phyllodes and rounded apices.

The phyllodes of *A. longifolia* subsp. *sophorae* are 5-12cm long and 10-30mm wide, thick, broadest above the middle and narrowing abruptly towards the apex (Figures 8 and 10).

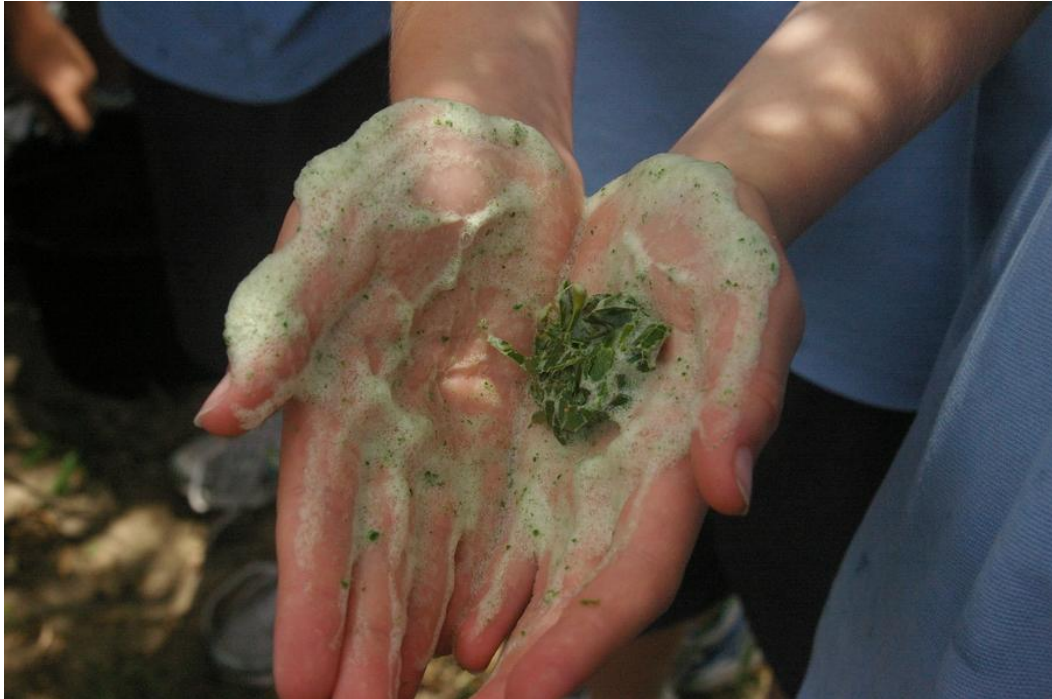
Figure 11 Uses of *A. longifolia* subsp. *sophorae*

Ray (Dootch) Kennedy (pers. comm.) has demonstrated that the indigenous people used the phyllodes to make soap (Figure 11).

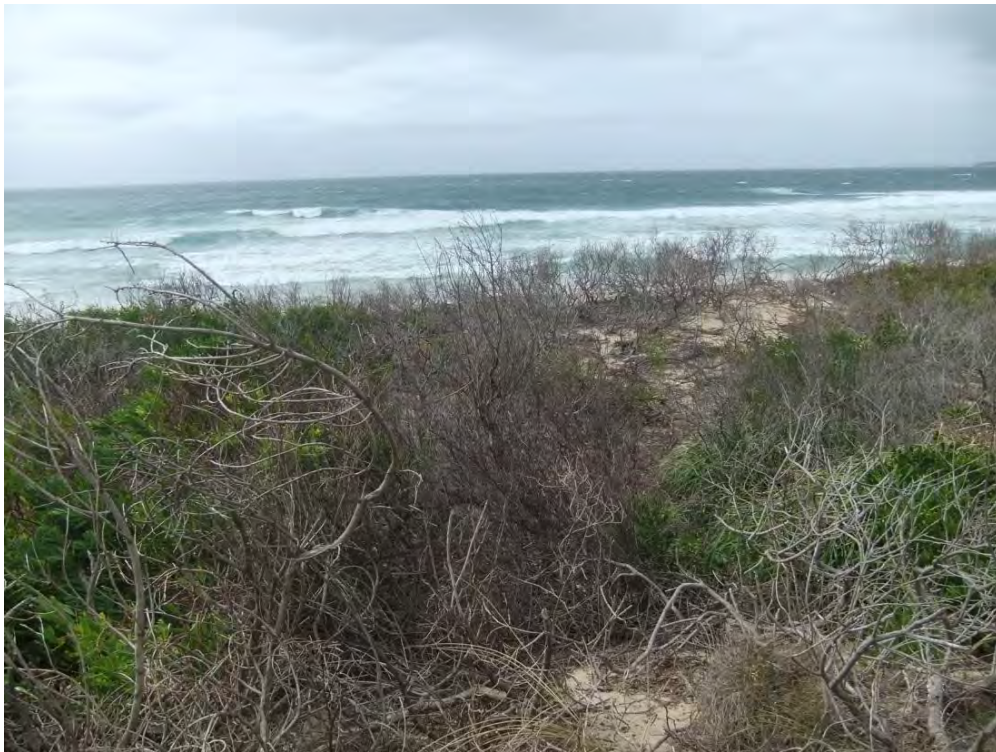
Figure 12 Die-back of Coastal Wattle on dune crest at Towradgi

- There are large patches of *A. longifolia* subsp. *sophorae* in dunes at most Wollongong beaches. It is, apparent that both *A. longifolia* subsp. *sophorae* and *A. longifolia* subsp. *longifolia* are susceptible to storm damage and other disturbance and tend to die back completely. Large patches of dead wattle were evident at Towradgi beach, at the time of the survey (Figure 12). These dead patches require monitoring, in order to determine the rate and extent of recruitment by indigenous and exotic plant species.

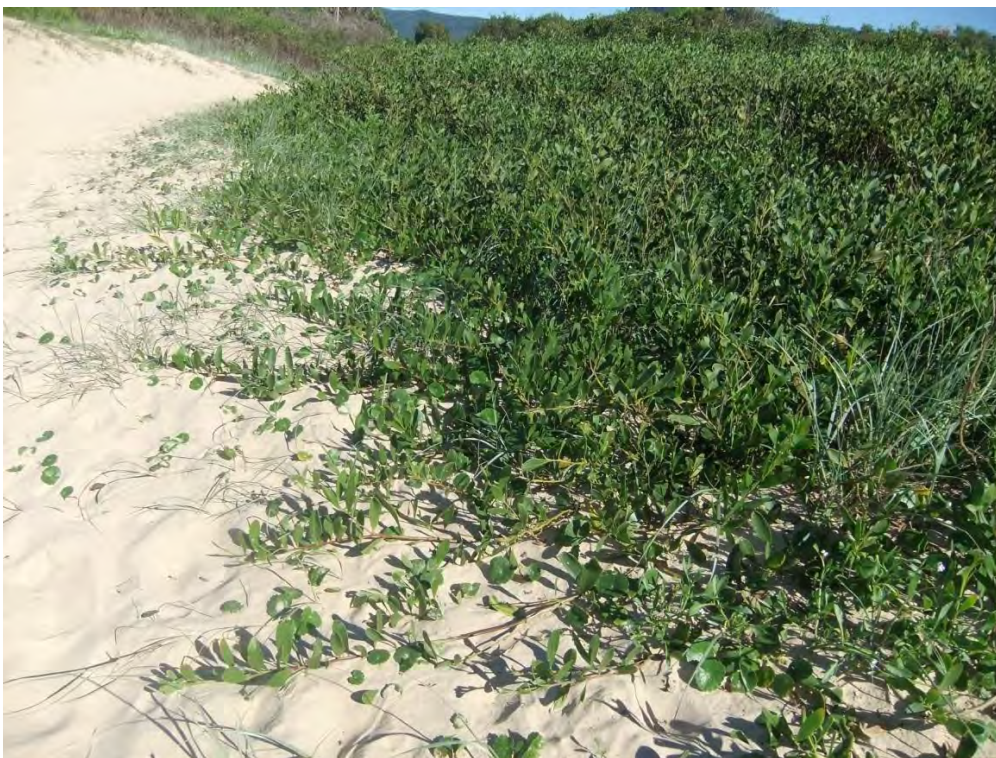
Figure 13 *A. longifolia* subsp. *sophorae* at Bellambi, spreading onto track edge

- In some areas, e.g. Corrimal, Towradgi, Fairy Meadow, Woonona and Bulli beaches, subspecies of *A. longifolia* have extended beyond the original planting area. It may be necessary for some trimming to be carried out where the spread of vegetation interferes with beach amenity or access (Figure 13), however it is likely that the spreading growth will dieback due to salt spray (Figure 14).

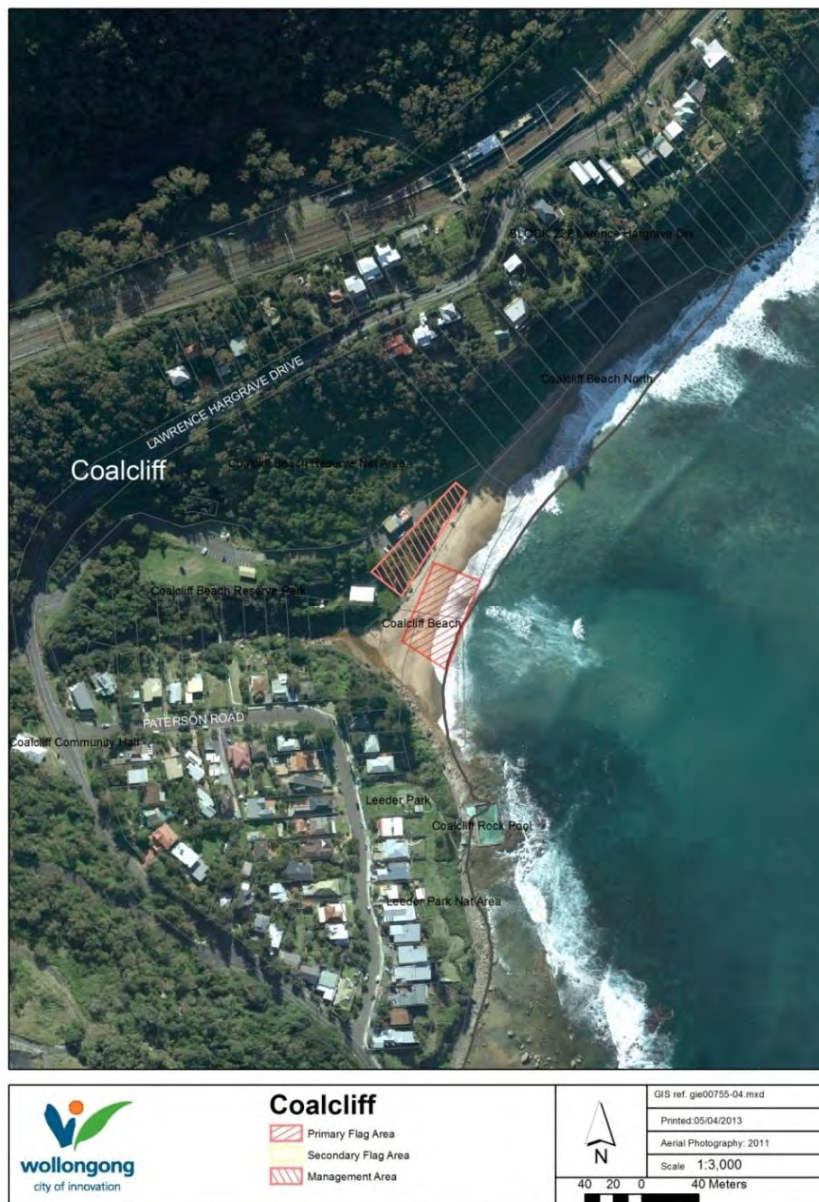
Figure 16 Map illustrating the dune management area and patrolled area – Coalcliff

Figure 16 illustrates the dune management area as advised by Council and the patrolled area as advised by the lifeguards.

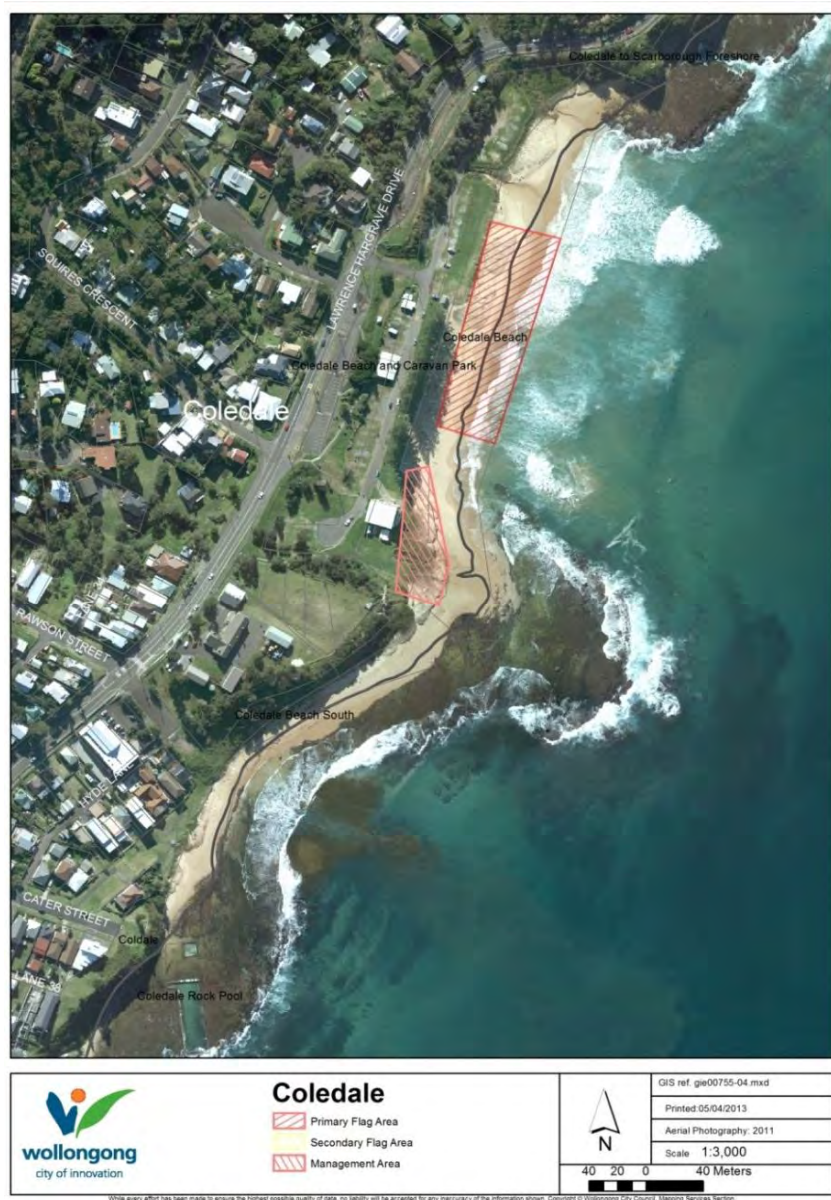
Figure 18 Map illustrating the dune management area and patrolled area – Coledale

Figure 18 illustrates the dune management area as advised by Council and the patrolled area as advised by the lifeguards.

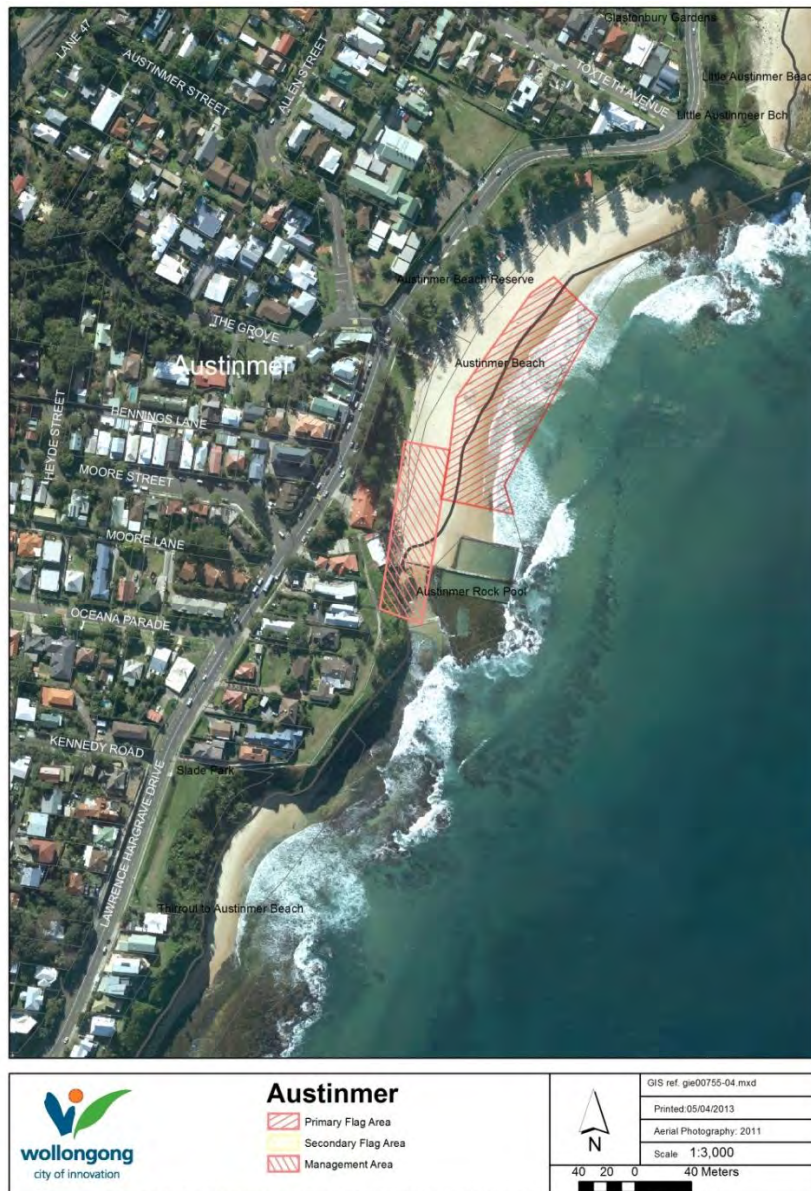
Figure 19 Map illustrating the dune management area and patrolled area – Austinmer

Figure 19 illustrates the dune management area as advised by Council and the patrolled area as advised by the lifeguards.

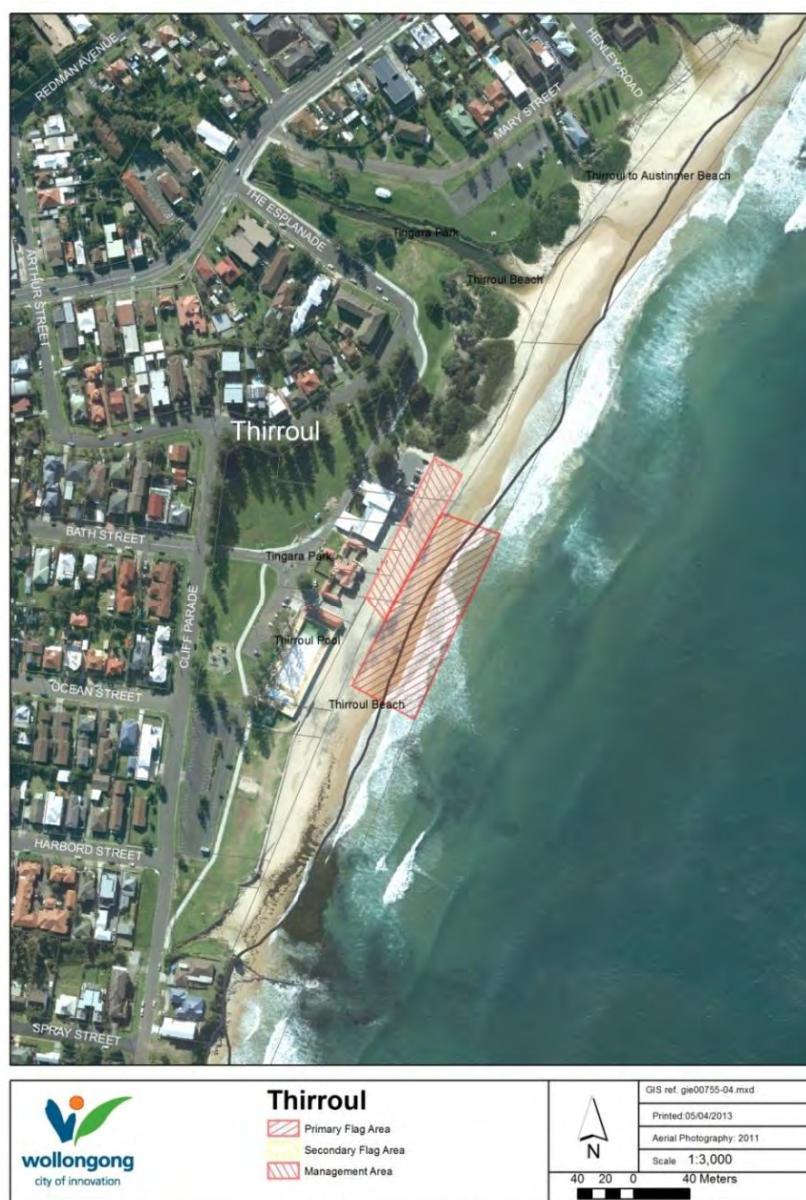
Figure 20 Map illustrating the dune management area and patrolled area – Thirroul

Figure 20 illustrates the dune management area as advised by Council and the patrolled area as advised by the lifeguards.

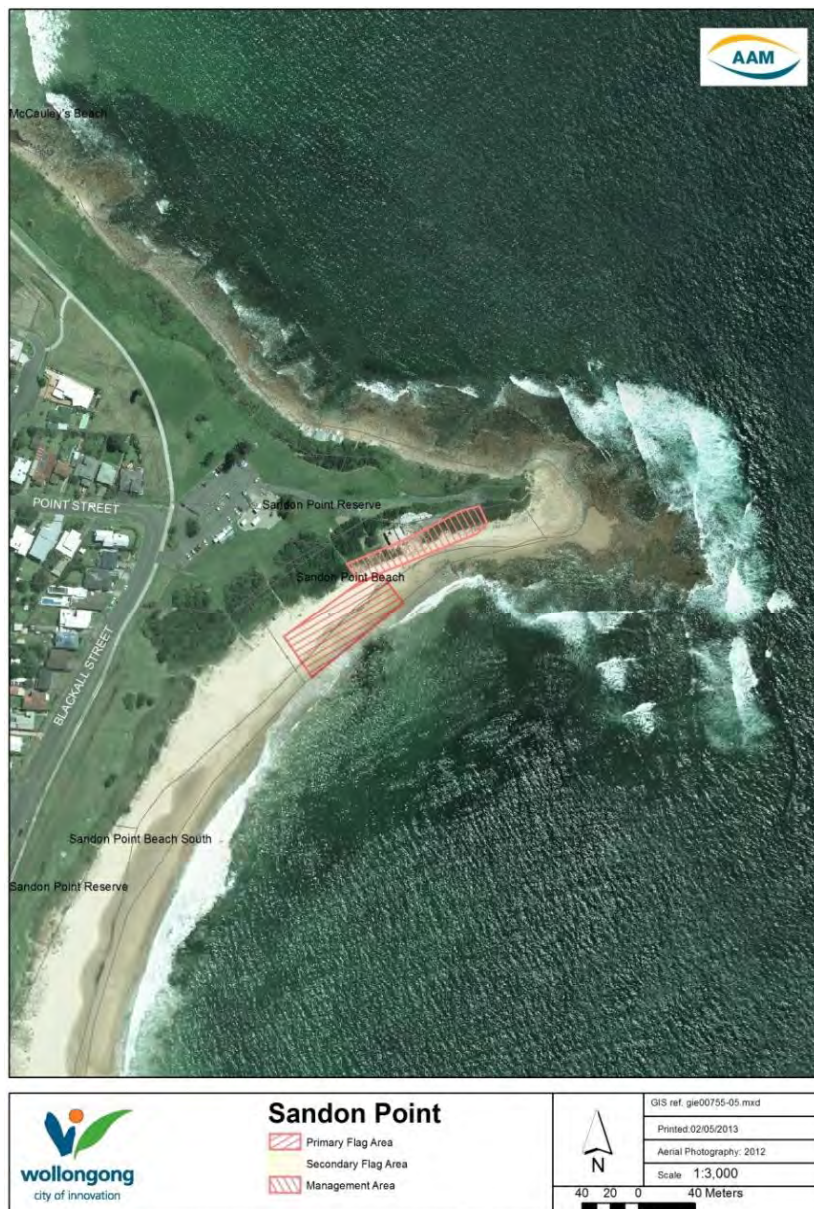
Figure 21 Map illustrating the dune management area and patrolled area – Sandon Point

Figure 21 illustrates the dune management area as advised by Council and the patrolled area as advised by the Lifeguards.

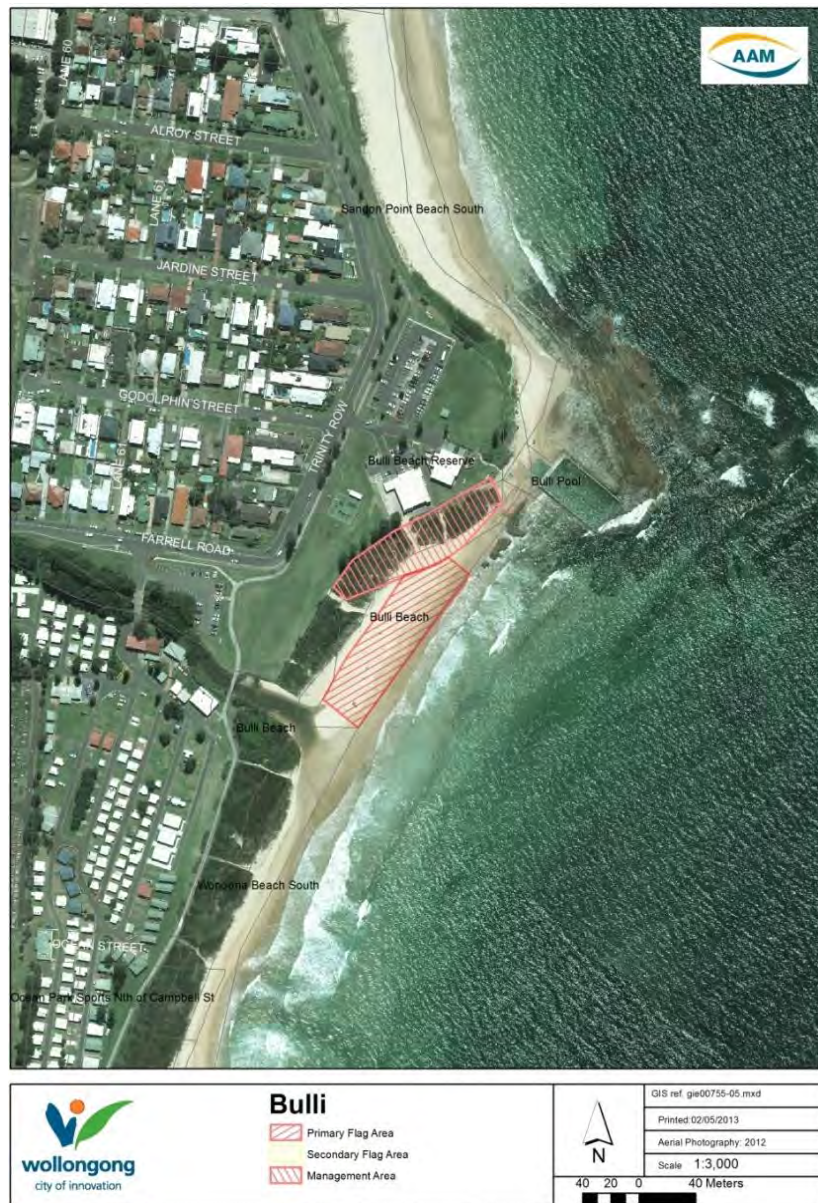
Figure 22 Map illustrating the dune management area and patrolled area – Bulli

During the site visits undertaken for this study, Bulli Beach was characterised by a well-established dune system and wide beach. Steep scarping after storm events was noted on the northern portion of the beach.

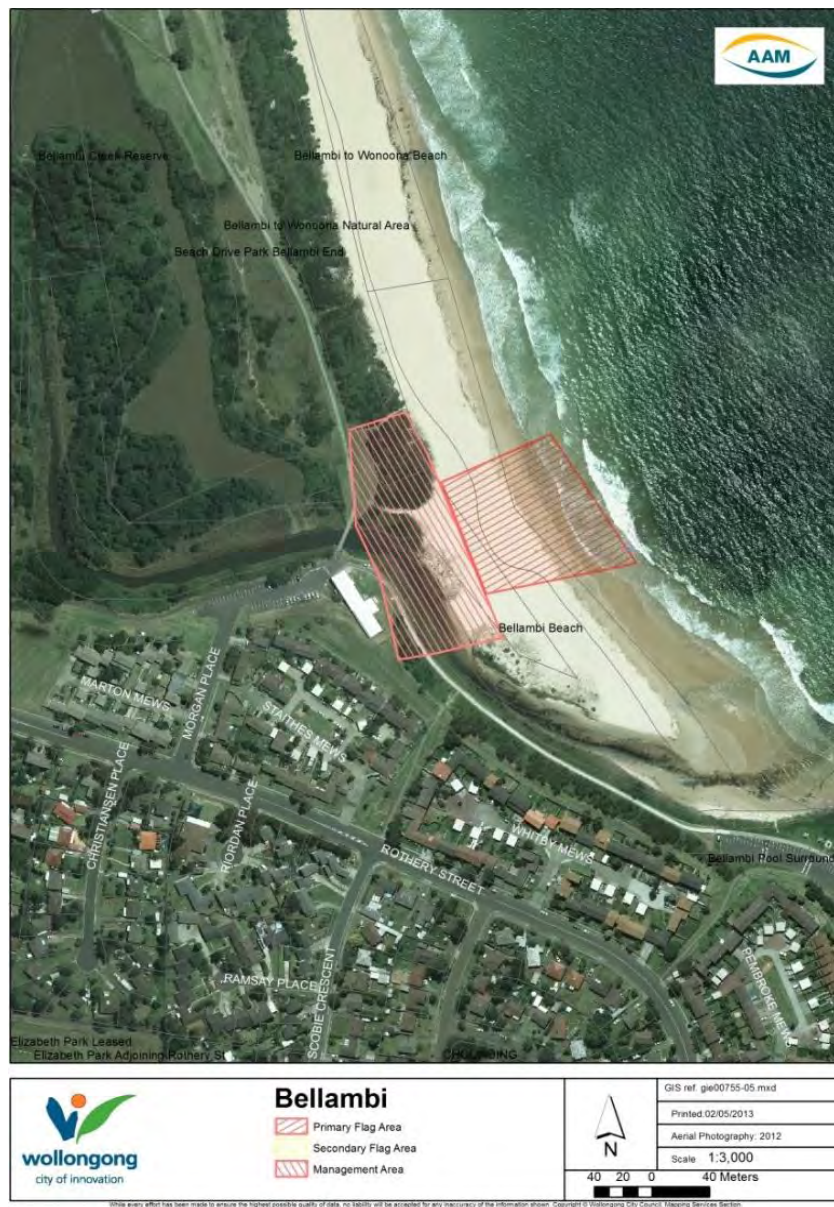
Figure 24 Map illustrating the dune management area and patrolled area – Bellambi

Figure 24 illustrates the dune management area as advised by Council and the patrolled area as advised by the lifeguards.

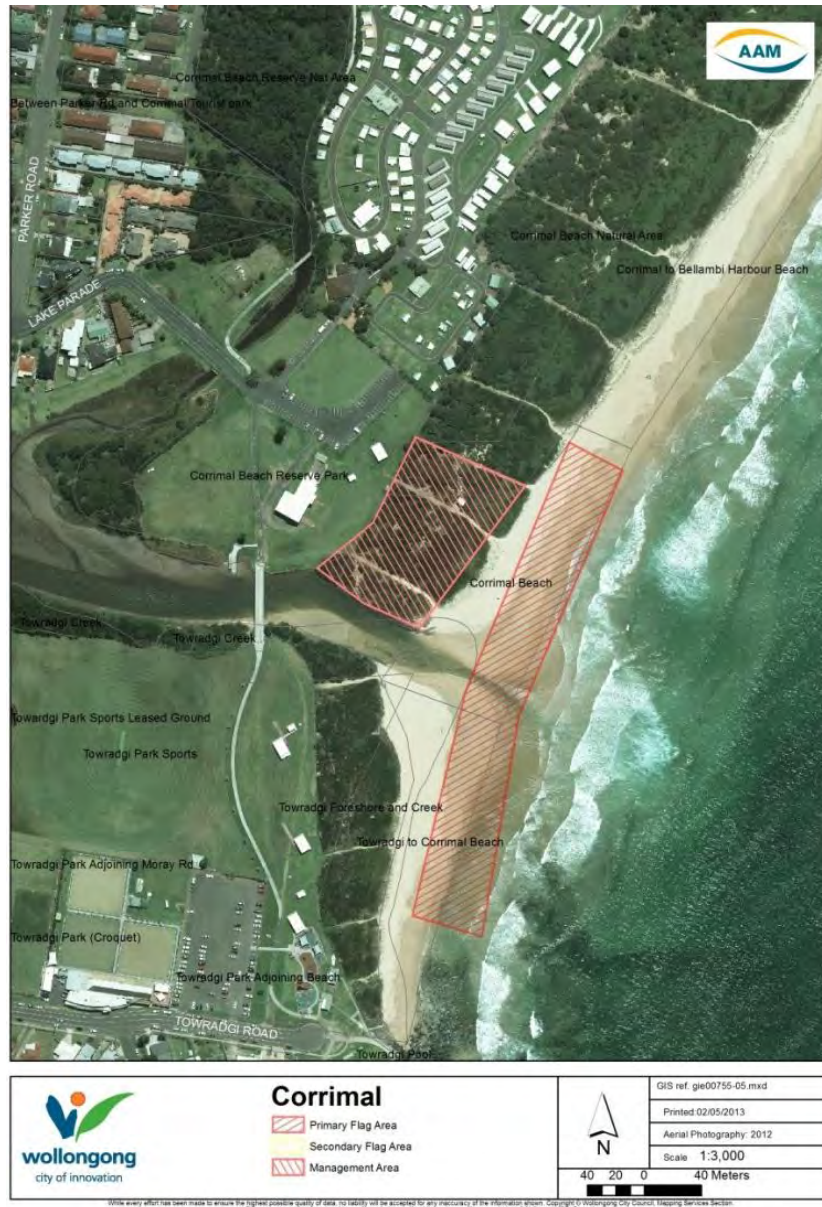
Figure 25 Map illustrating the dune management area and patrolled area – Corrimal

Figure 25 illustrates the dune management area as advised by Council and the patrolled area as advised by the lifeguards.

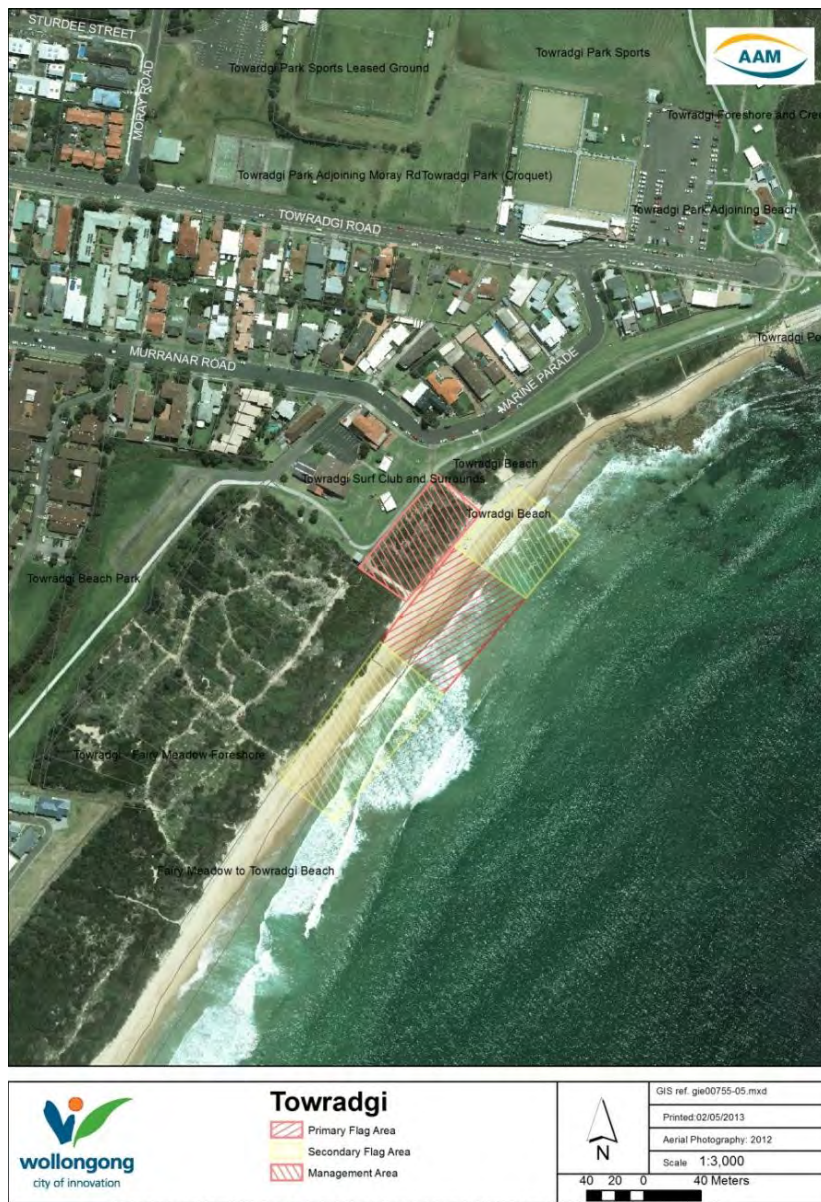
Figure 26 Map illustrating the dune management area and patrolled area – Towradgi

During the site visits undertaken for this study, Towradgi Beach was characterised by a stable dune system that had been subjected to storm erosion. Steep scarps had formed at the seaward vegetation line and at the berm as a result of storm events. At high tide, minimal or no beach width was reported.

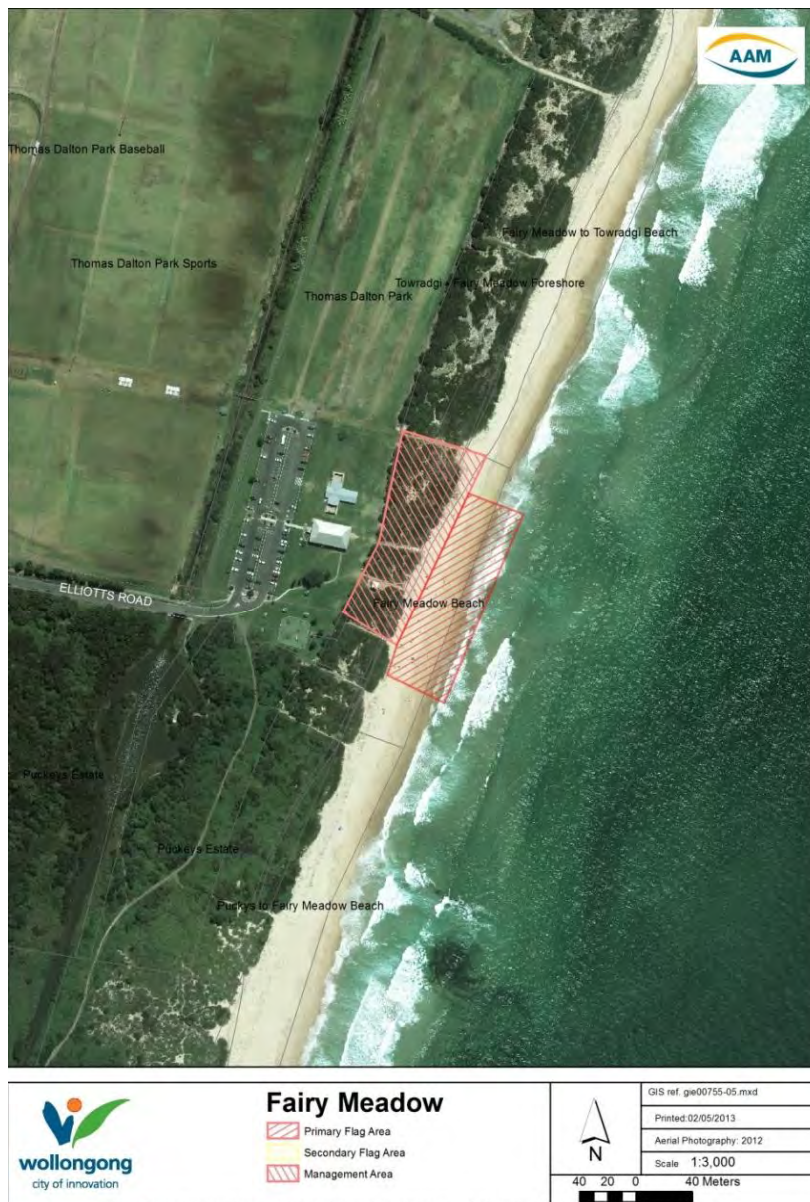
Figure 27 Map illustrating the dune management area and patrolled area – Fairy Meadow

Figure 27 illustrates the dune management area as advised by Council and the patrolled area as advised by the lifeguards.

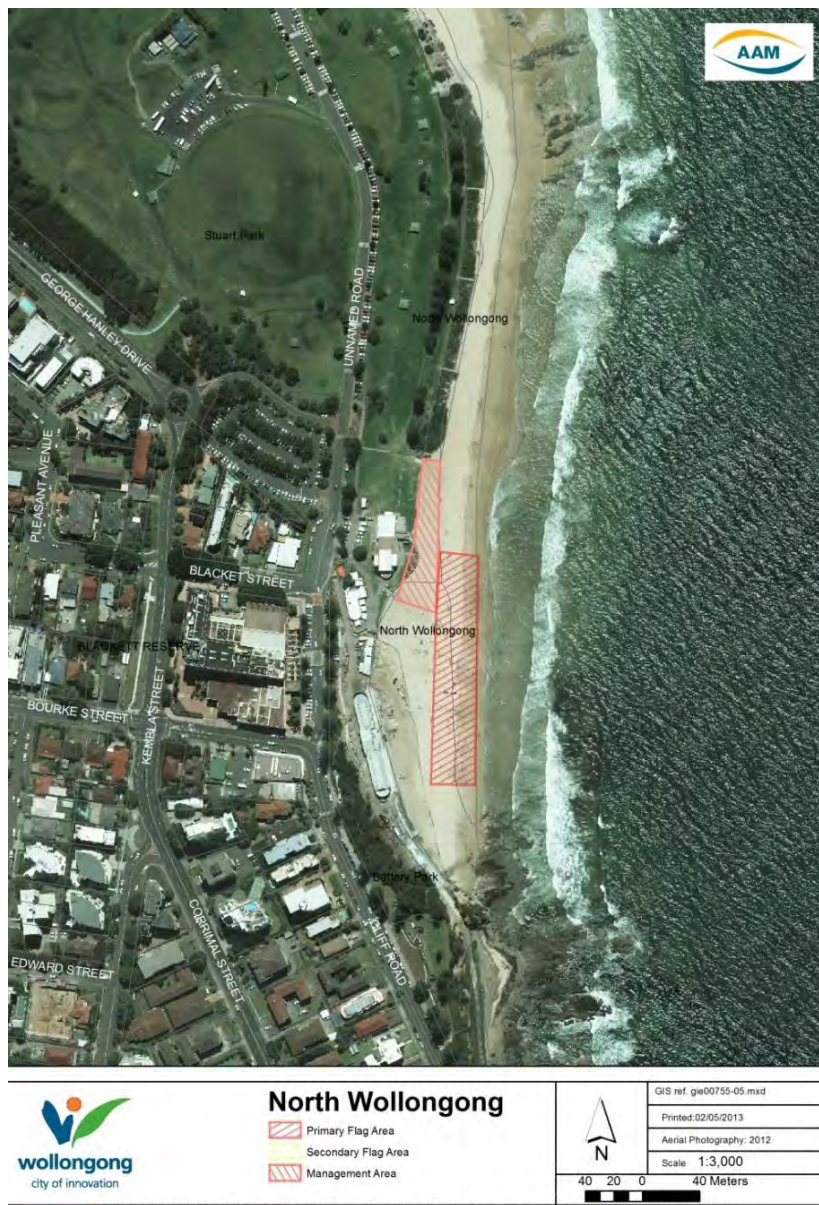
Figure 28 Map illustrating the dune management area and patrolled area – North Wollongong

Figure 28 illustrates the dune management area as advised by Council and the patrolled area as advised by the lifeguards.

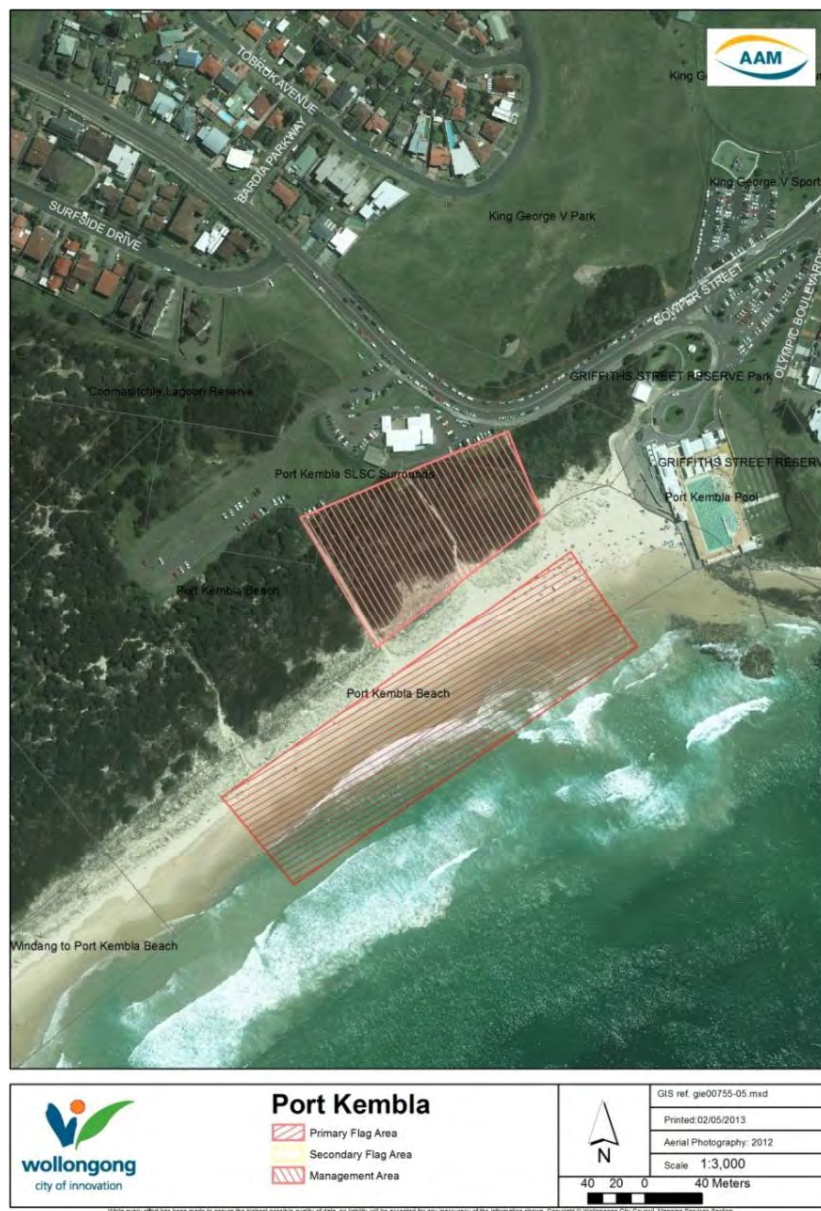
Figure 30 Map illustrating the dune management area and patrolled area – Port Kembla

During the site visits undertaken for this study, Port Kembla Beach was characterised by scarps after storm events, which were undergoing recovery with a gently sloping beach and beach berm. At high tide, the beach width was reported to be minimal.

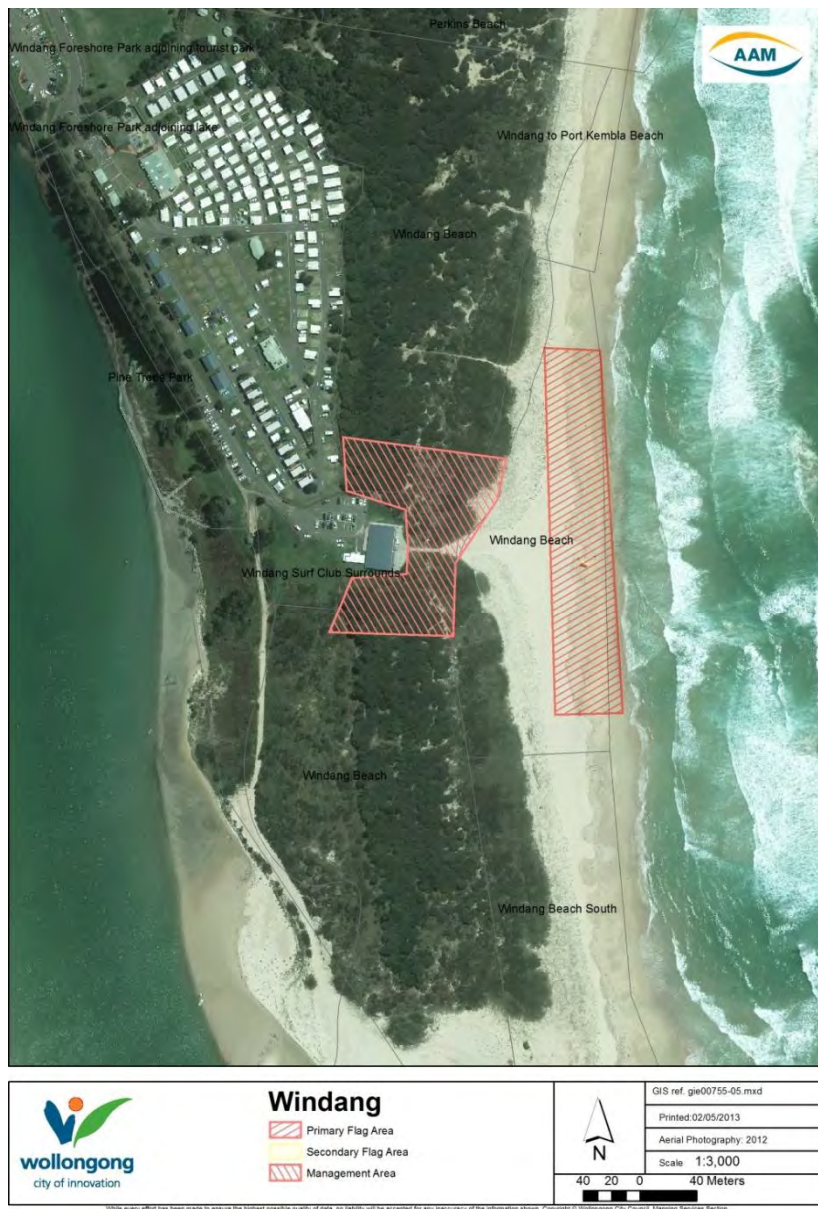
Figure 31 Map illustrating the dune management area and patrolled area – Windang

Figure 31 illustrates the dune management area as advised by Council and the patrolled area as advised by the lifeguards.

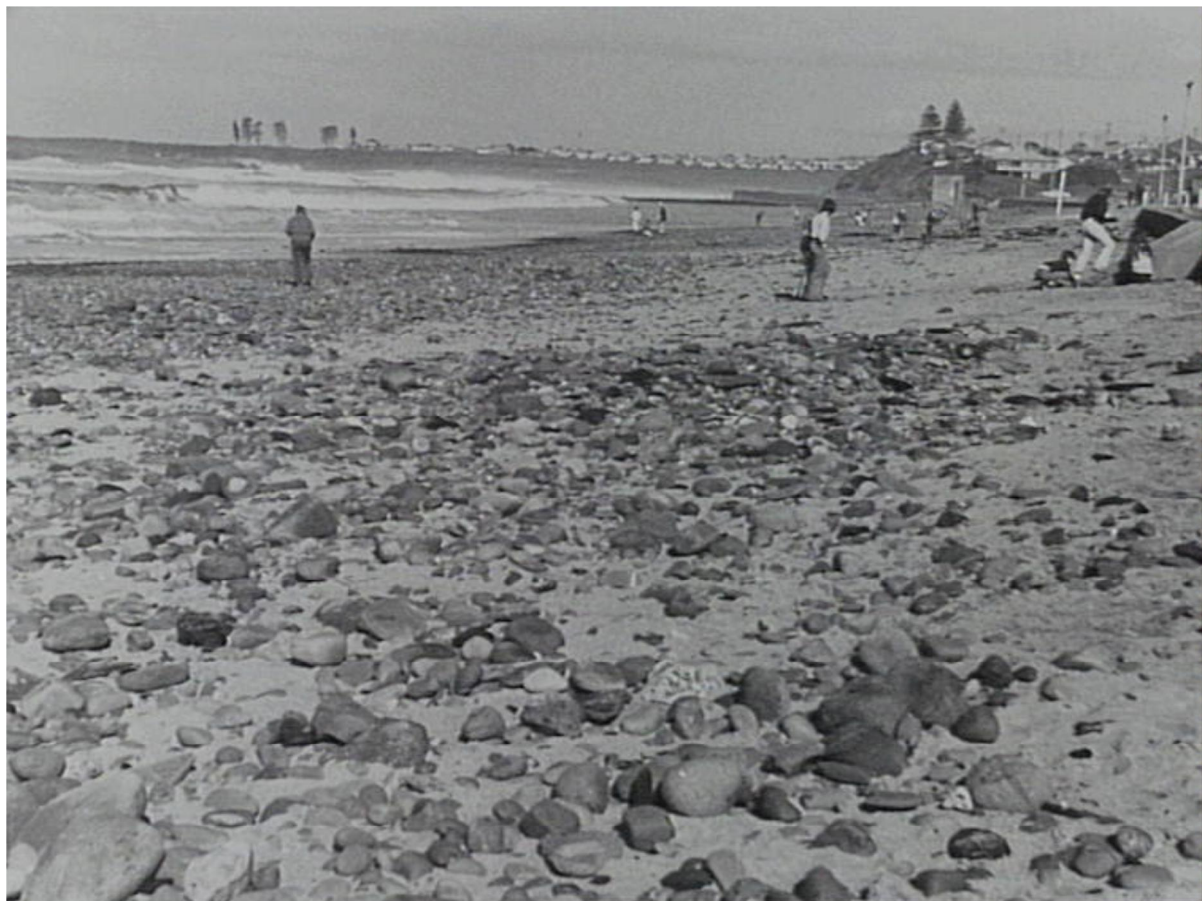
Photo 9 Thirroul Beach, 1974 (exposed pebbles, Bayley 1974)

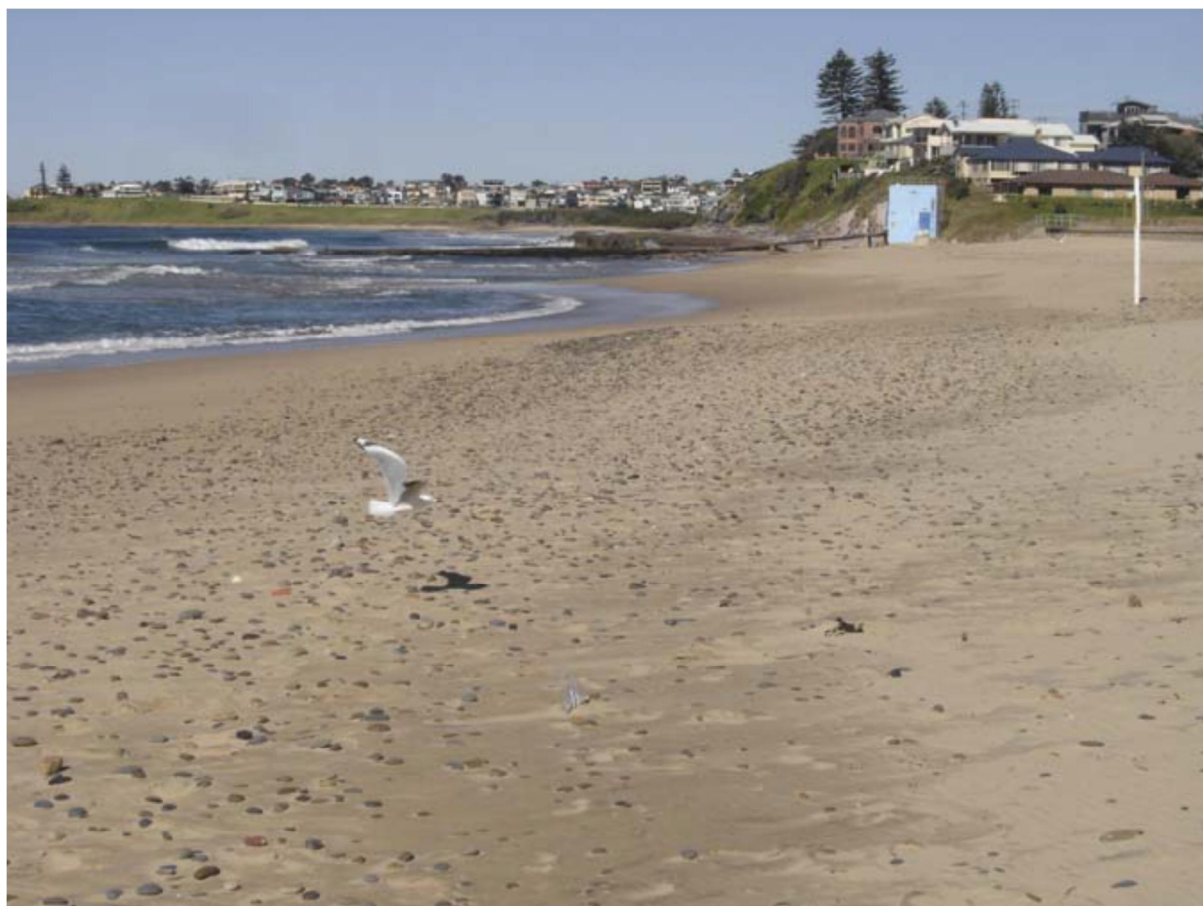
Photo 10 Thirroul Beach, 2008 (exposed pebbles, courtesy of S Tedder, 2008)

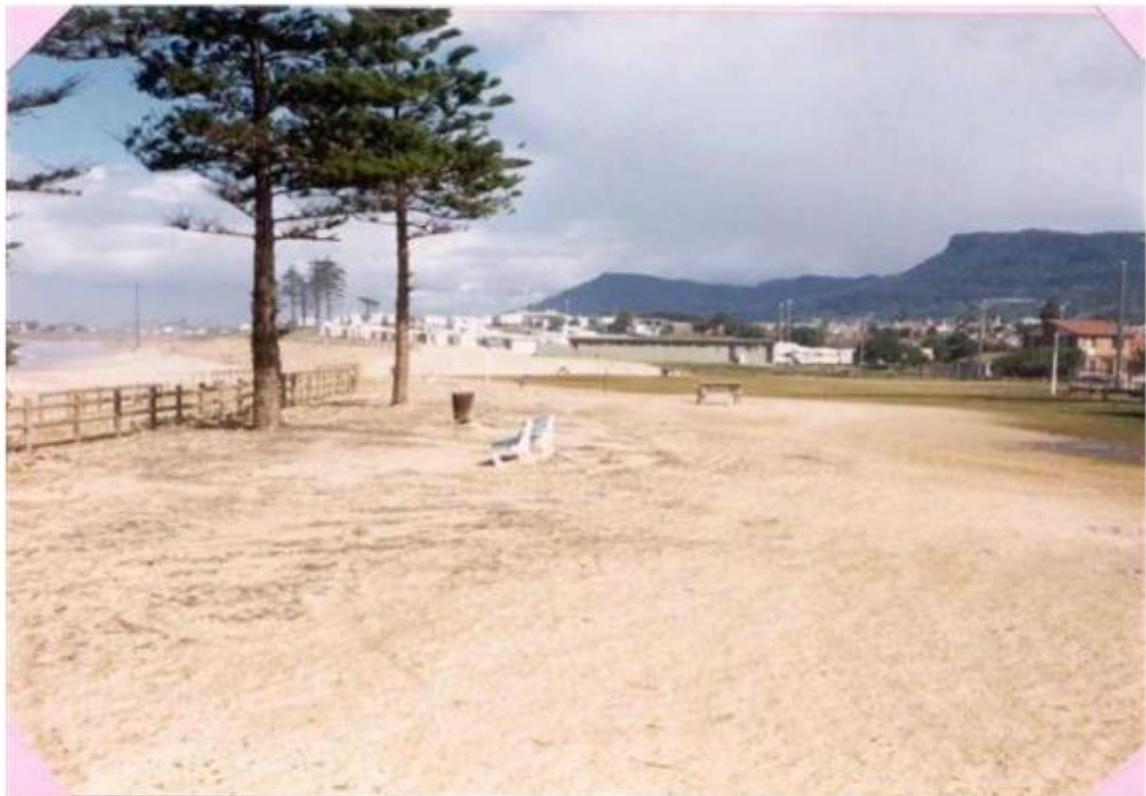
Photo 14 Bulli Beach, 1986 (windblown sand)

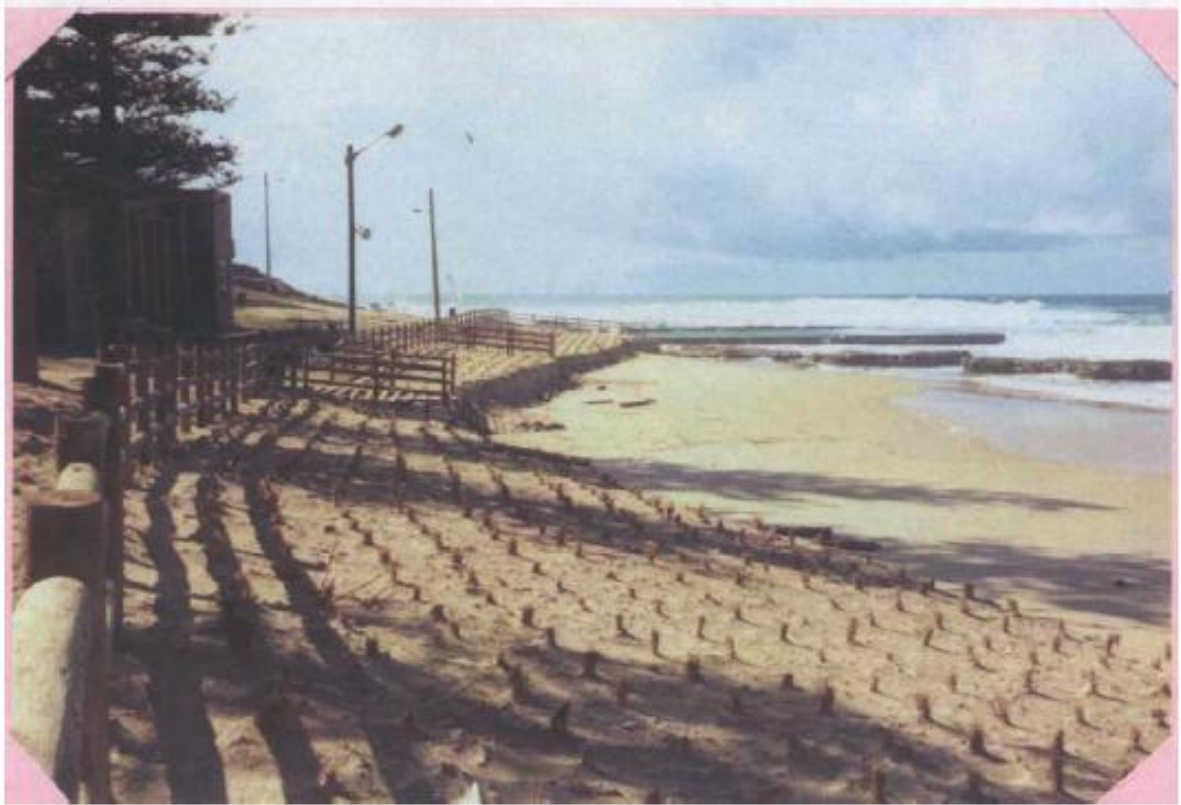
Photo 15 Bulli Beach, 1986 (dune stabilisation, courtesy of Ian Foreman, 1986)
