Wollongong City Council

Wollongong Dune Management Strategy for the Patrolled Swimming Areas of 17 Beaches

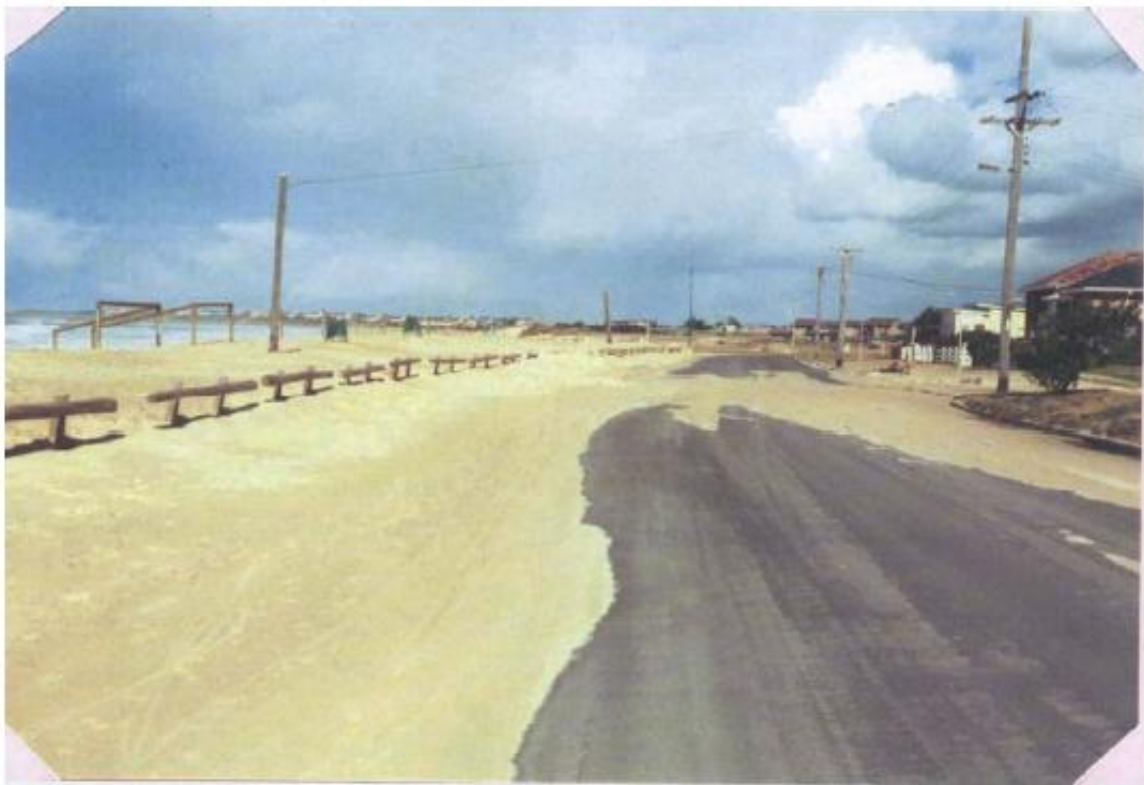
Photo 18 Woonona Beach, 1986 (sand on road, courtesy of Ian Foreman)

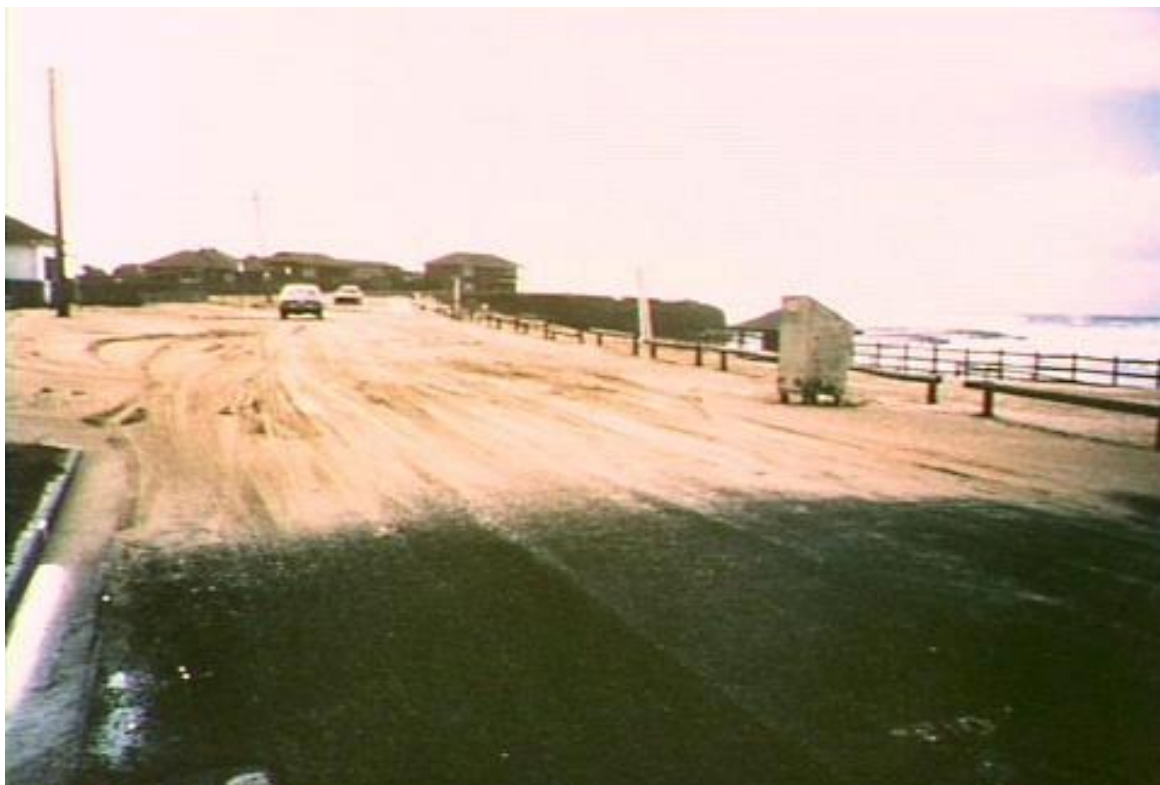
Photo 19 Woonona Beach, 1986 (sand on road)

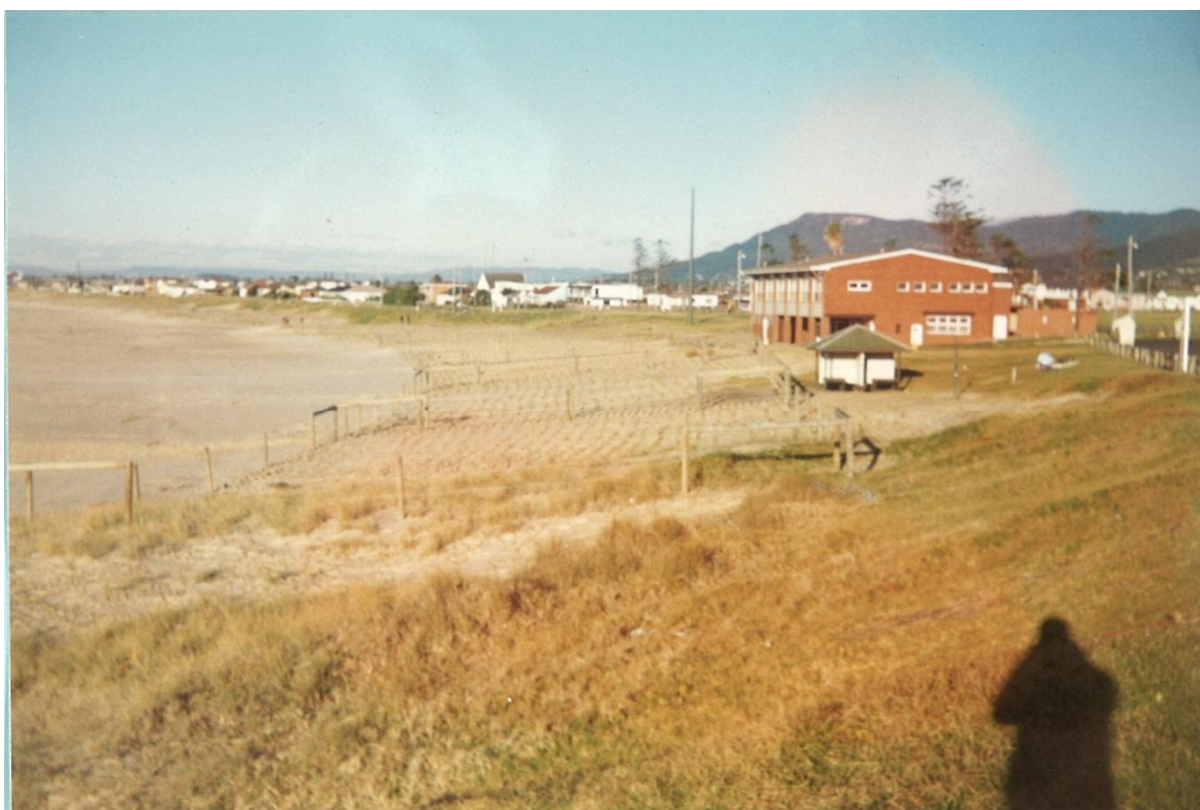
Photo 20 Woonona Beach 1986 (dune stabilisation works)

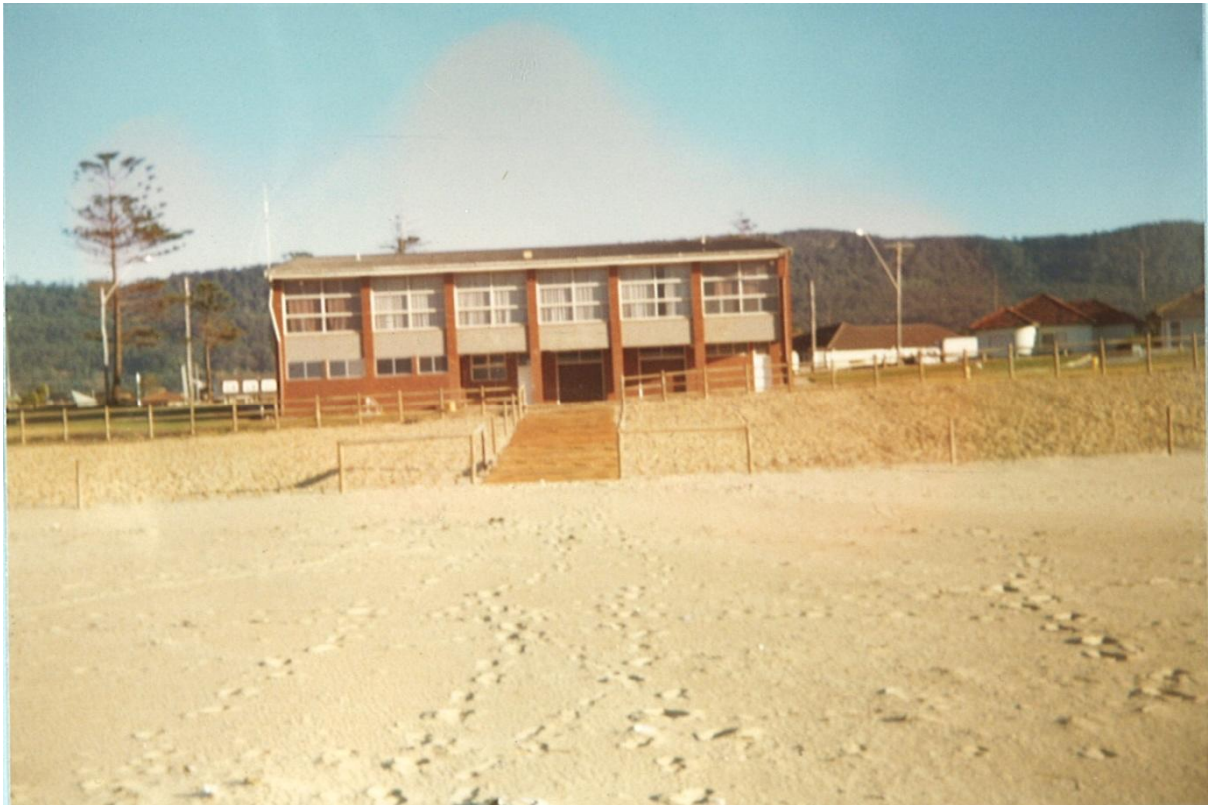
Photo 21 Woonona Beach 1986 (dune stabilisation works)

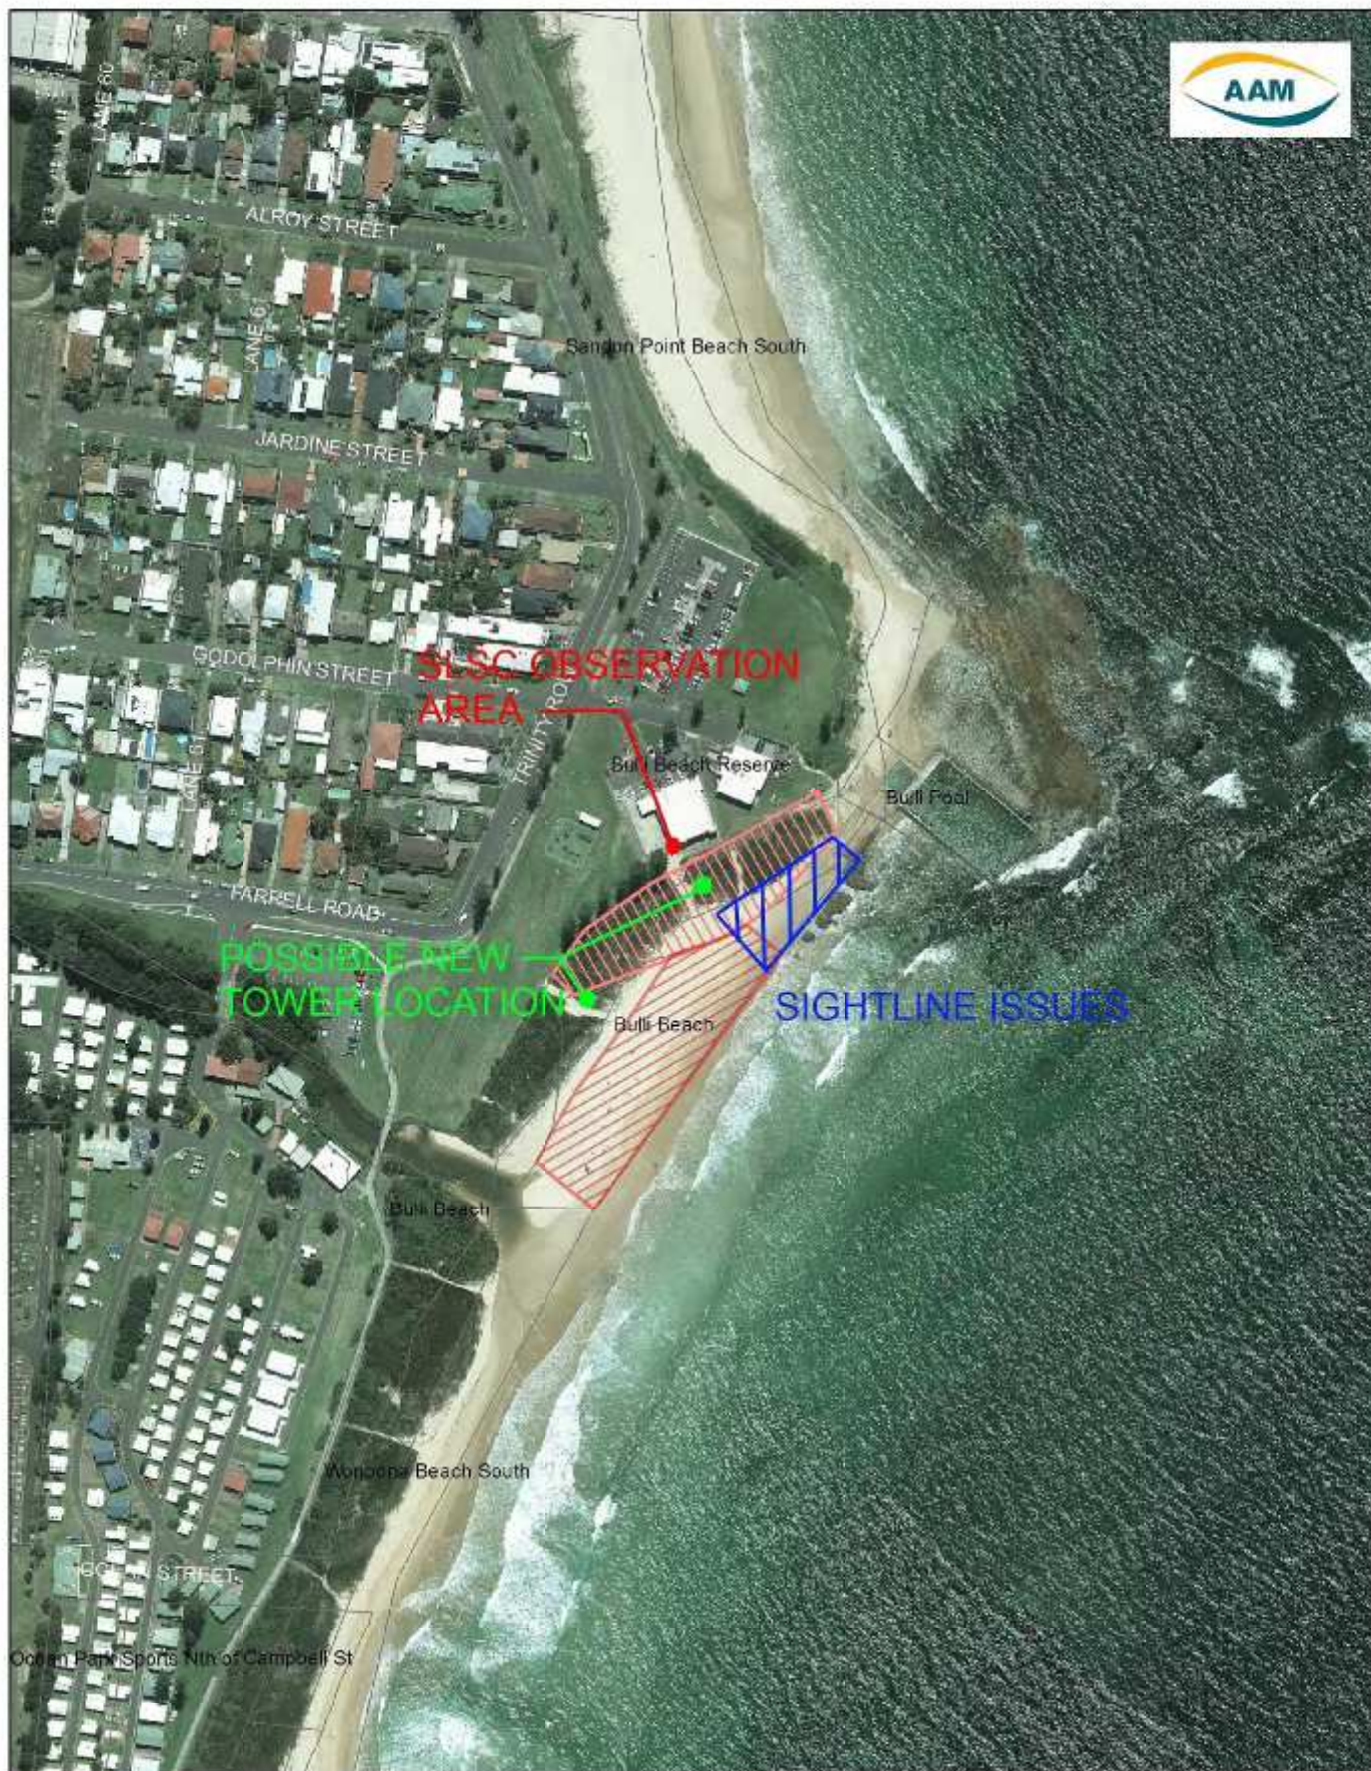
Bulli

- Primary Flag Area
- Secondary Flag Area
- Management Area

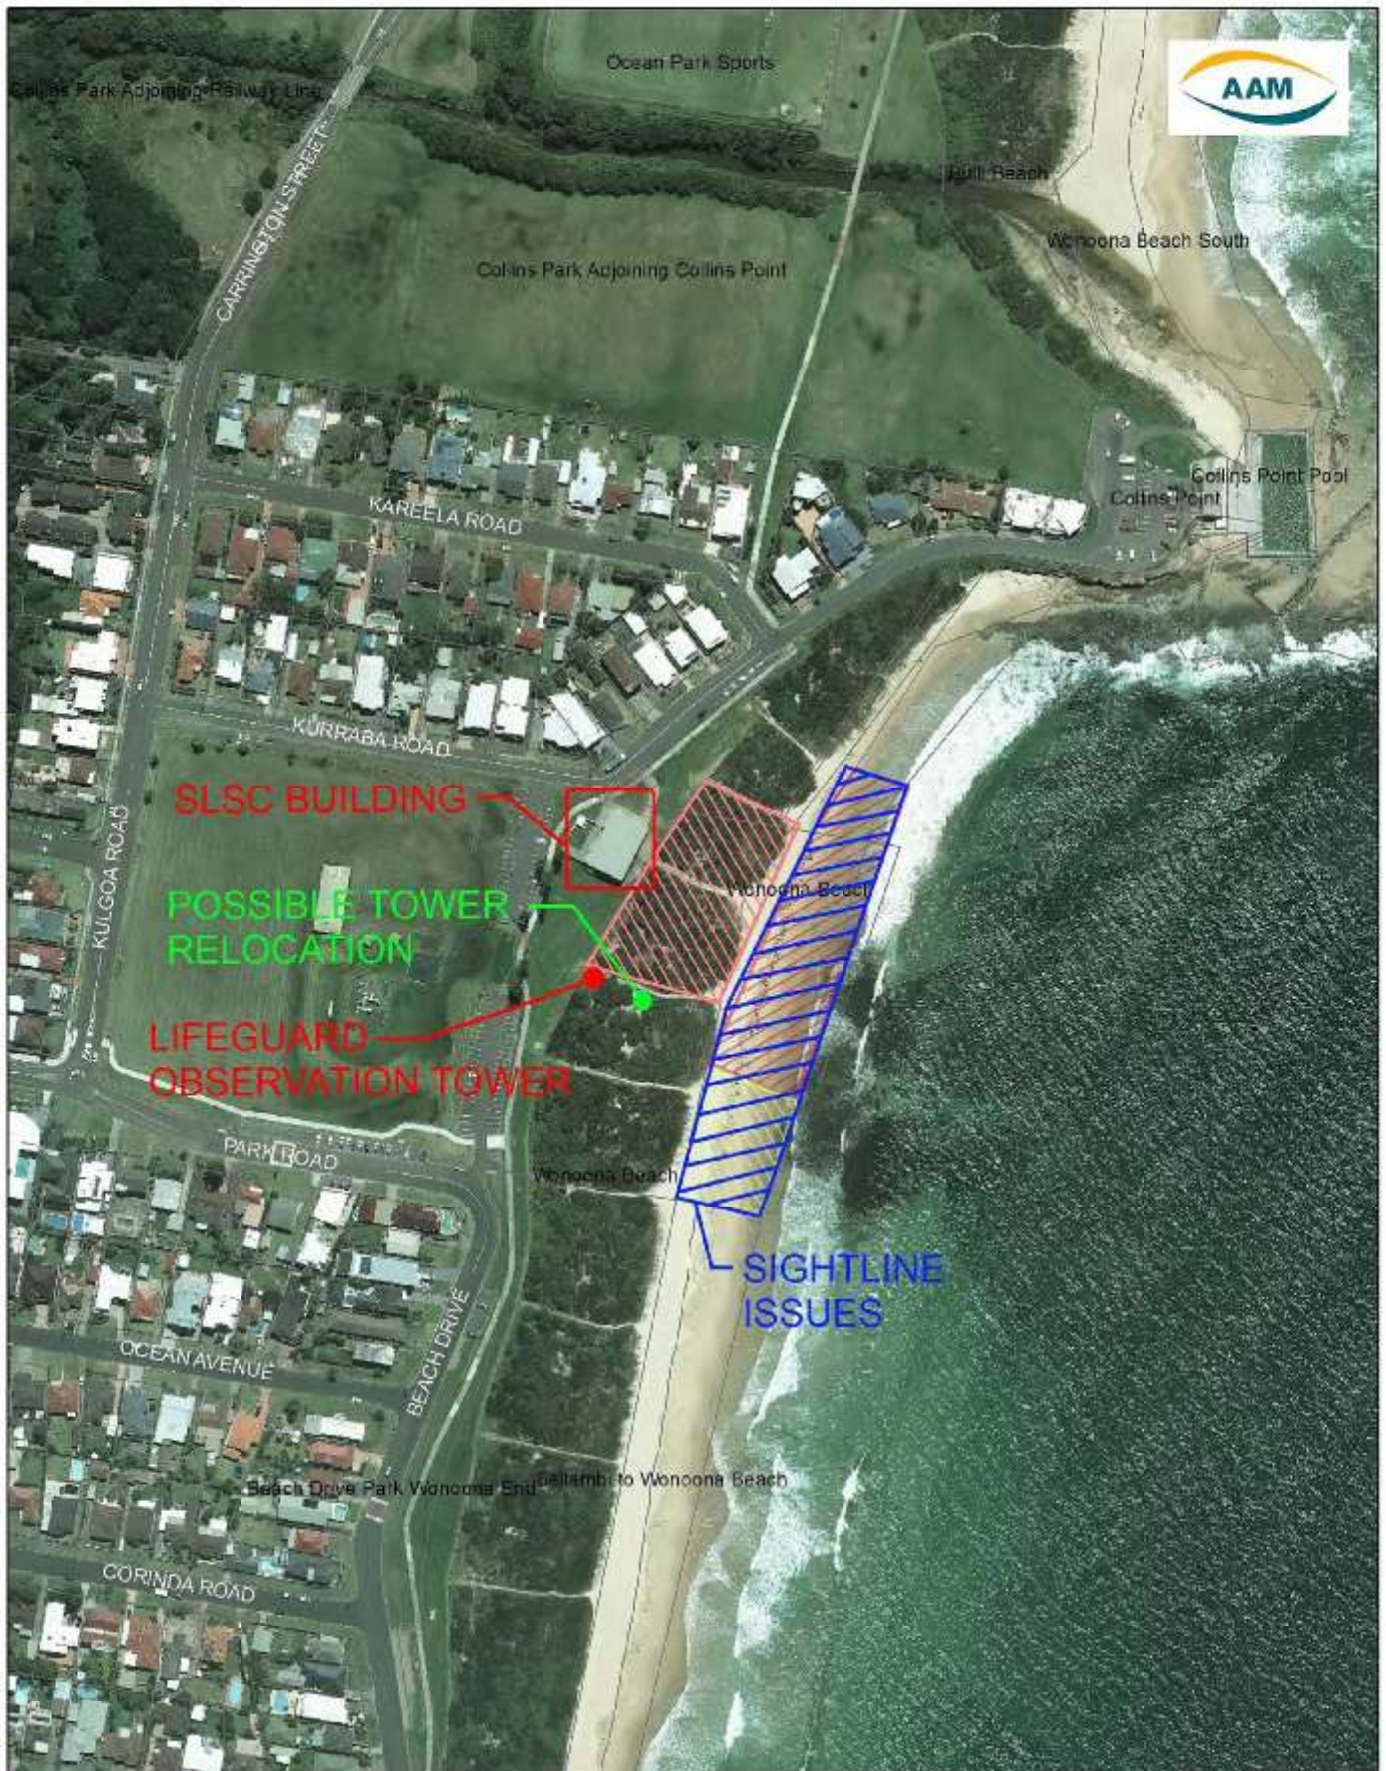
Woonona

- Primary Flag Area
- Secondary Flag Area
- Management Area

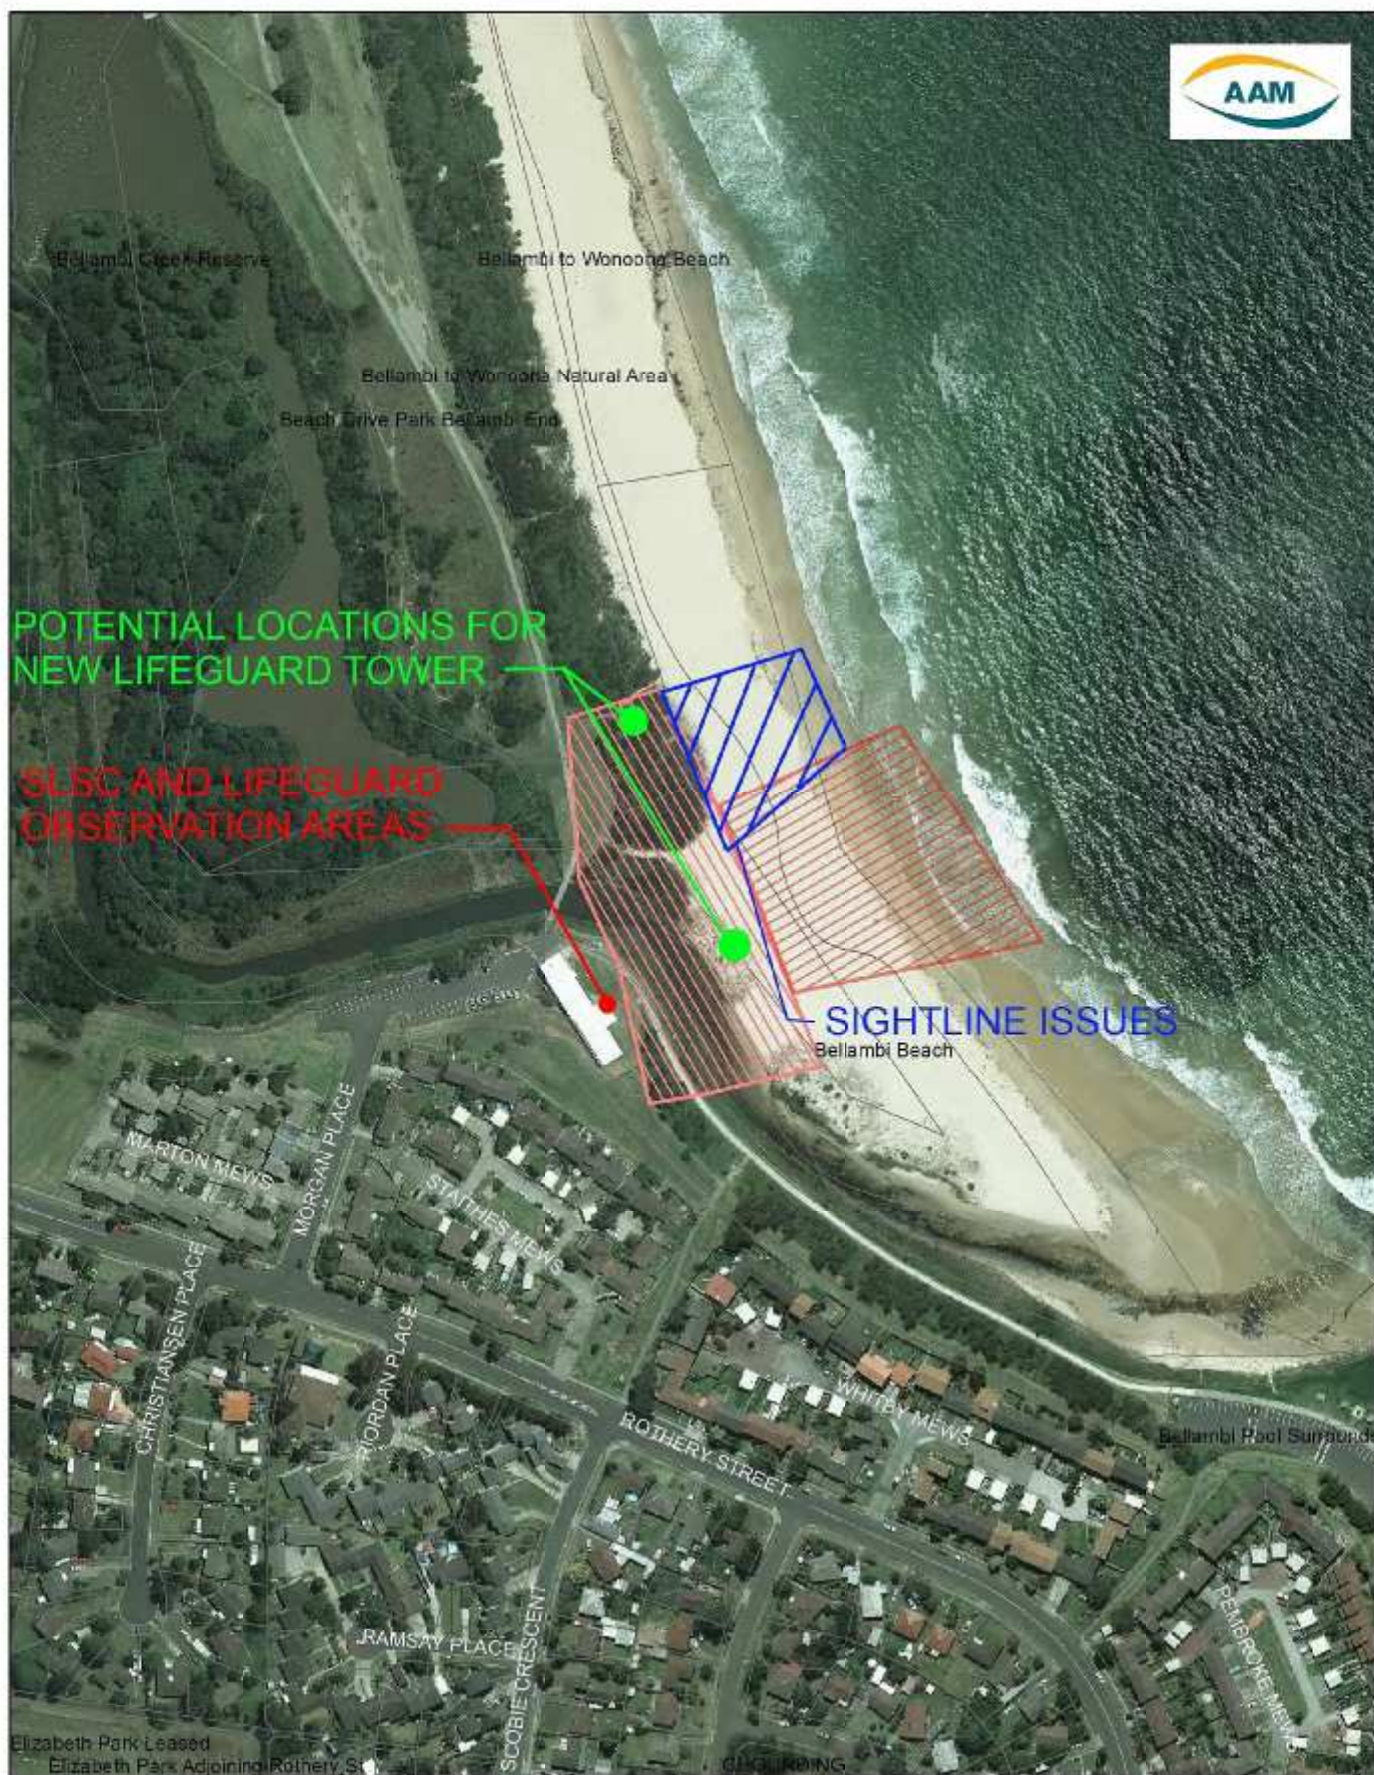
Bellambi

Note: Sightline issues shown on the following map are from the SLSC. View of the beach from the lifeguard observation tower is also obstructed but not to as great an extent as from the SLSC.

- Primary Flag Area
- Secondary Flag Area
- Management Area

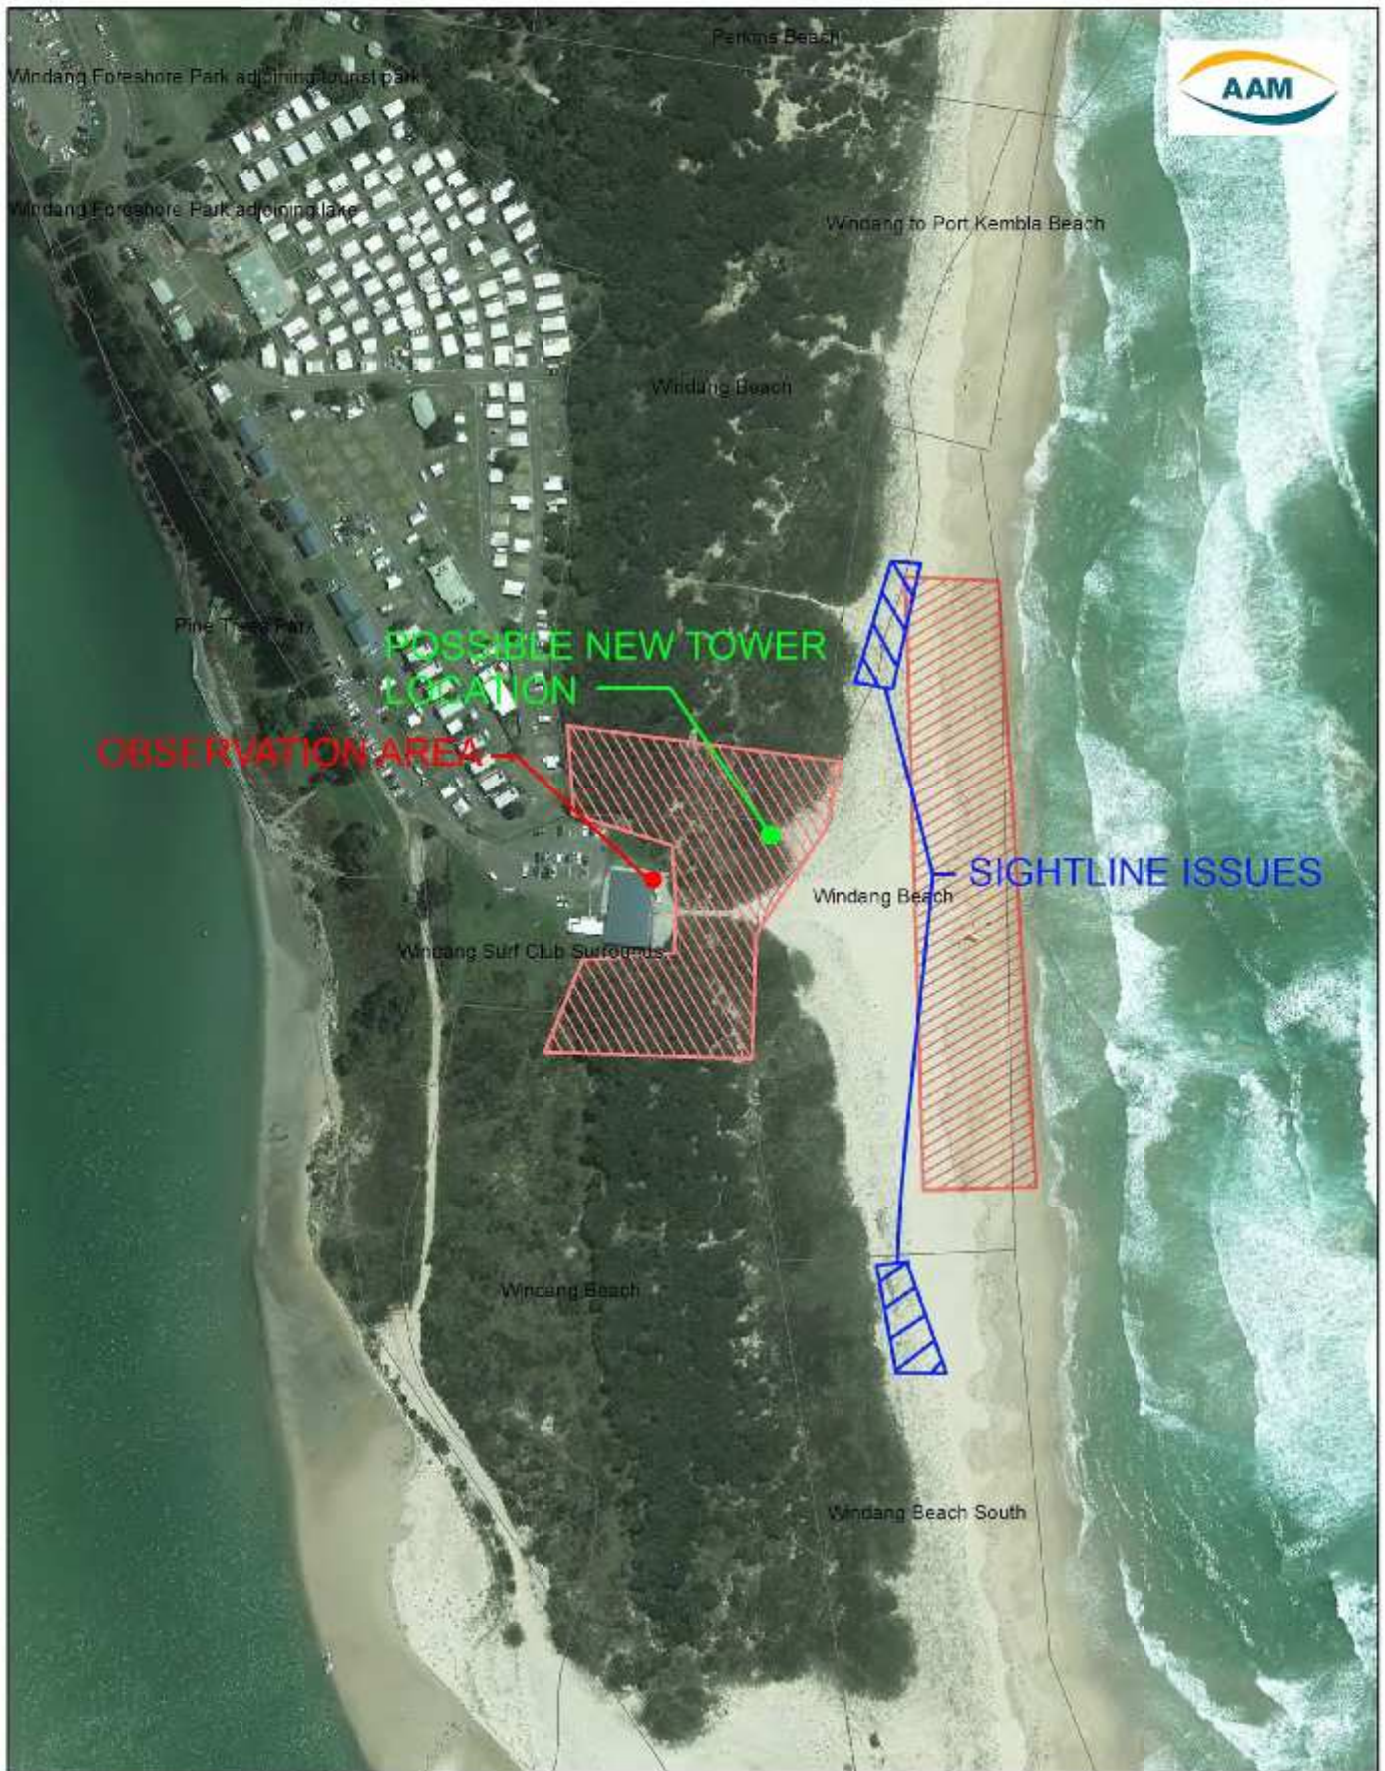
Note: Sightline issues shown on the following map are from the SLSC. The lifeguard observation tower has a clear view of the beach.

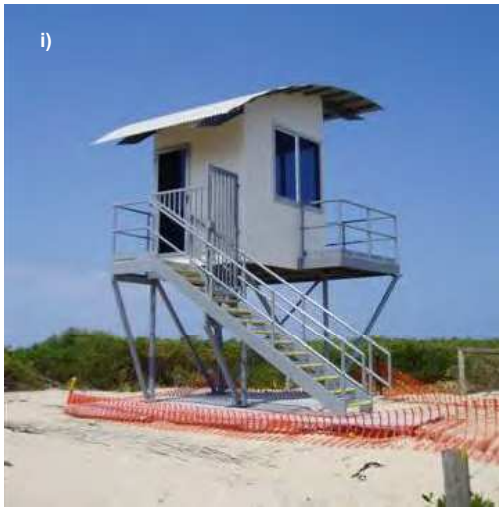
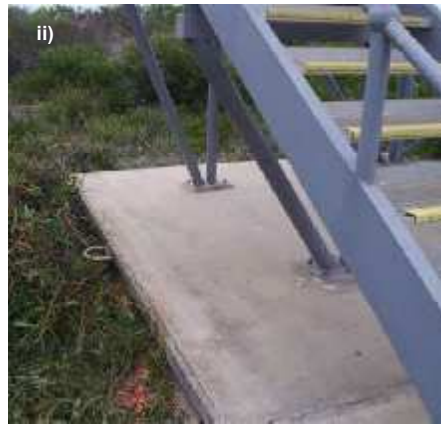
Figure 2. i) Patrol tower at Corrimal Beach ii) Precast footing showing hooks to drag the structure.

- A floor plan of approximately 2.5m x 2.5m with floor level approximately 2-3m above ground level.
- Space to comfortably accommodate 2-3 people, a desk and seating area and an undercover deck area.
- Towers are made of aluminium with a small precast concrete pad footing shaped like skis with hooks to enable them to be dragged to a different location on the beach (Figure 2ii).
