# HELENSBURGH WASTE DISPOSAL DEPOT ANNUAL REPORT 2025

WASTE SERVICES JULY 2025

| Project Name | Helensburgh Waste Disposal Depot Annual Report |

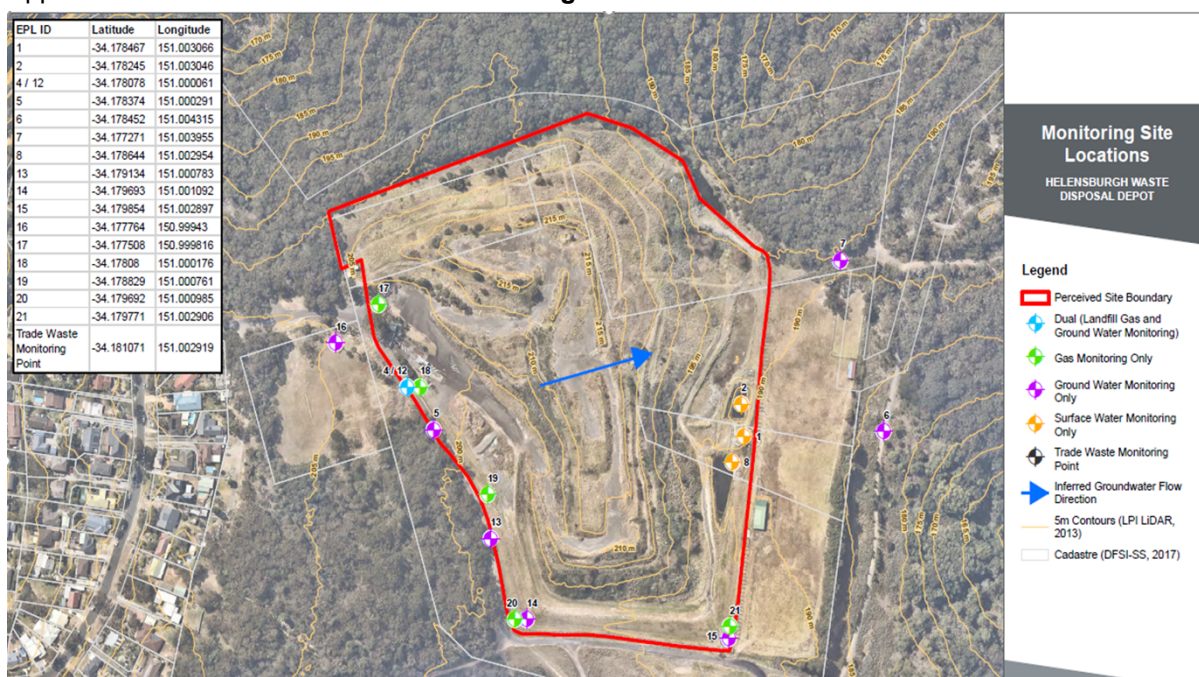
Figure 2: Monitoring Site Locations

An elevation profile was created utilising an aerial image taken in December 2024 from Nearmap which shows that the lowest elevations of the site are located in the eastern portion with an approximate relative level (RL) of 190 m Australian Height Datum (AHD). The highest elevations are located at the centre of the site at the location of the former waste deposition area with an approximate RL of 210 m AHD.

Approximate surface contours are shown on **Figure 2**.

Subsurface gas monitoring was completed during the reporting period to assess for potential offsite migration. The fieldwork methodology for subsurface gas monitoring is summarised below in **Table 1-4**. The location of each subsurface gas monitoring location is shown on **Figure 2**.

The fieldwork methodology for stormwater monitoring is summarised below in **Table 1-5**. The location of stormwater monitoring locations is shown on **Figure 2**.

Leachate monitoring was completed periodically during the reporting period to provide data on the composition, height levels and volumes of leachate produced by the Site, and to record details about any irregular discharges or overflows of leachate from the Site. The fieldwork methodology for leachate monitoring is summarised below in **Table 1-6**. The location of leachate monitoring locations is shown on **Figure 2**.

Surface water monitoring was completed periodically during the reporting period to verify that offsite surface water bodies were not being impacted by leachate or by sediment-laden stormwater from the landfill. The fieldwork methodology for surface water monitoring is summarised below in **Table 1-7**. The location of each stormwater monitoring location is shown on **Figure 2**.

Groundwater monitoring was completed periodically during the reporting period to track groundwater quality with time and evaluate interactions with leachate and potential contaminants. The fieldwork methodology for groundwater monitoring is summarised below in **Table 1-8**. The location of each groundwater monitoring location is shown on **Figure 2**.

Monitoring of trade wastewater was completed periodically during the reporting period to confirm that water quality parameters of wastewater discharge were within the acceptable criteria. Discharge of trade waste to sewer was undertaken by Council in accordance with the *Consent to Discharge Industrial Trade Wastewater* (Sydney Water 2023) (the *Consent*). The fieldwork methodology for trade wastewater monitoring is summarised below in **Table 1-9**. The trade waste monitoring location is shown on **Figure 2**.

Interpretation of groundwater levels across the Site from the reporting period indicate that the inferred groundwater flow direction is from the west to the north east, which is consistent with the local topography and is shown on **Figure 2**. Groundwater is situated at the greatest depths in the higher elevations of the Site toward the western boundary and is shallowest toward the eastern boundary in close proximity to the nearest surface water body, the Hacking River. With continuing heavy rainfall, the monitoring points at higher elevations along the western and southern boundaries continue to flow resulting in an overall decrease in analyte concentrations in the water column across the Site.

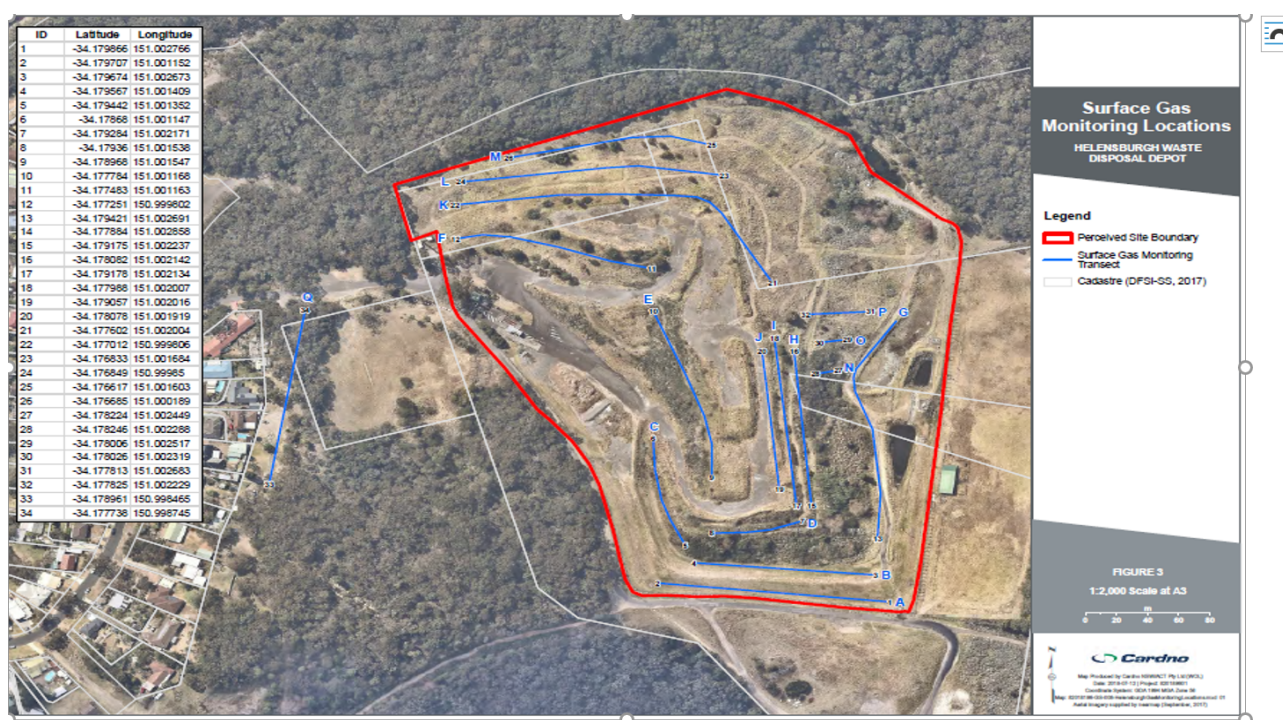
Figure 3: Surface Gas Monitoring Locations

Surface gas monitoring was completed during the reporting period to assess for potential surface emissions of landfill gases (LFG) emanating from the landfilled areas at the Site. The purpose of surface gas monitoring is to demonstrate that the cover material effectively controls the emission of landfill gas. The fieldwork methodology for surface gas monitoring is summarised below in **Table 1-3**. The location of each surface gas monitoring location is shown on **Figure 3**.

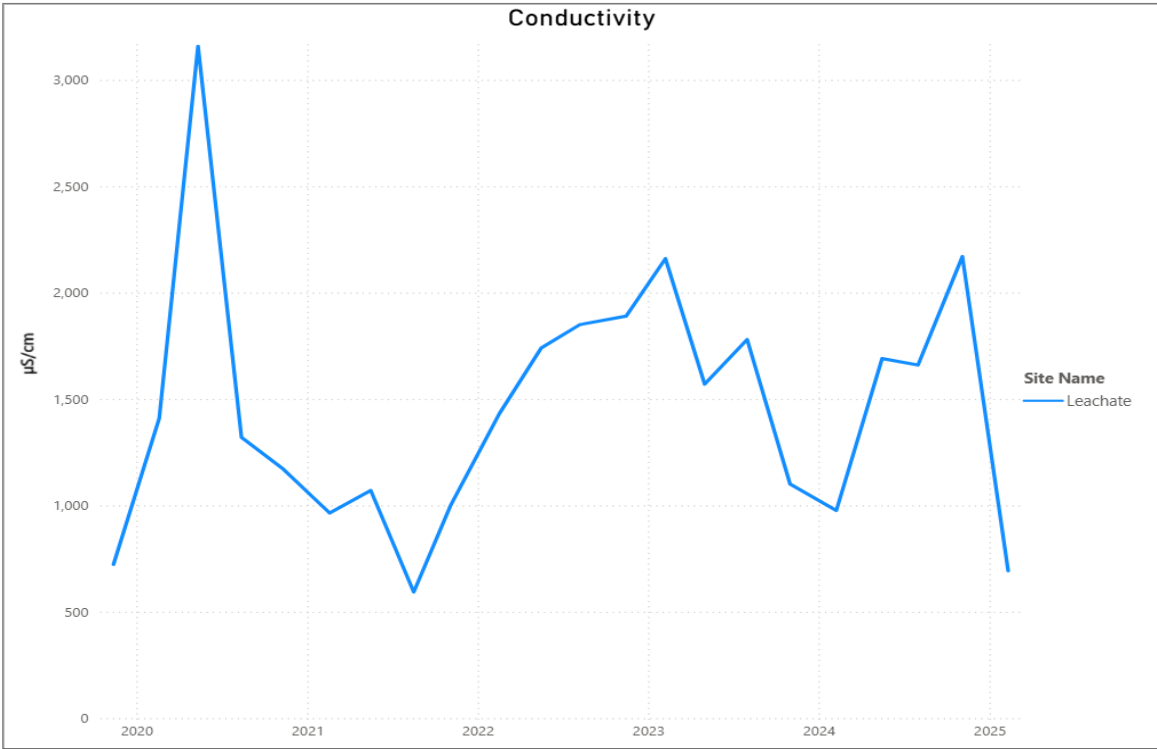
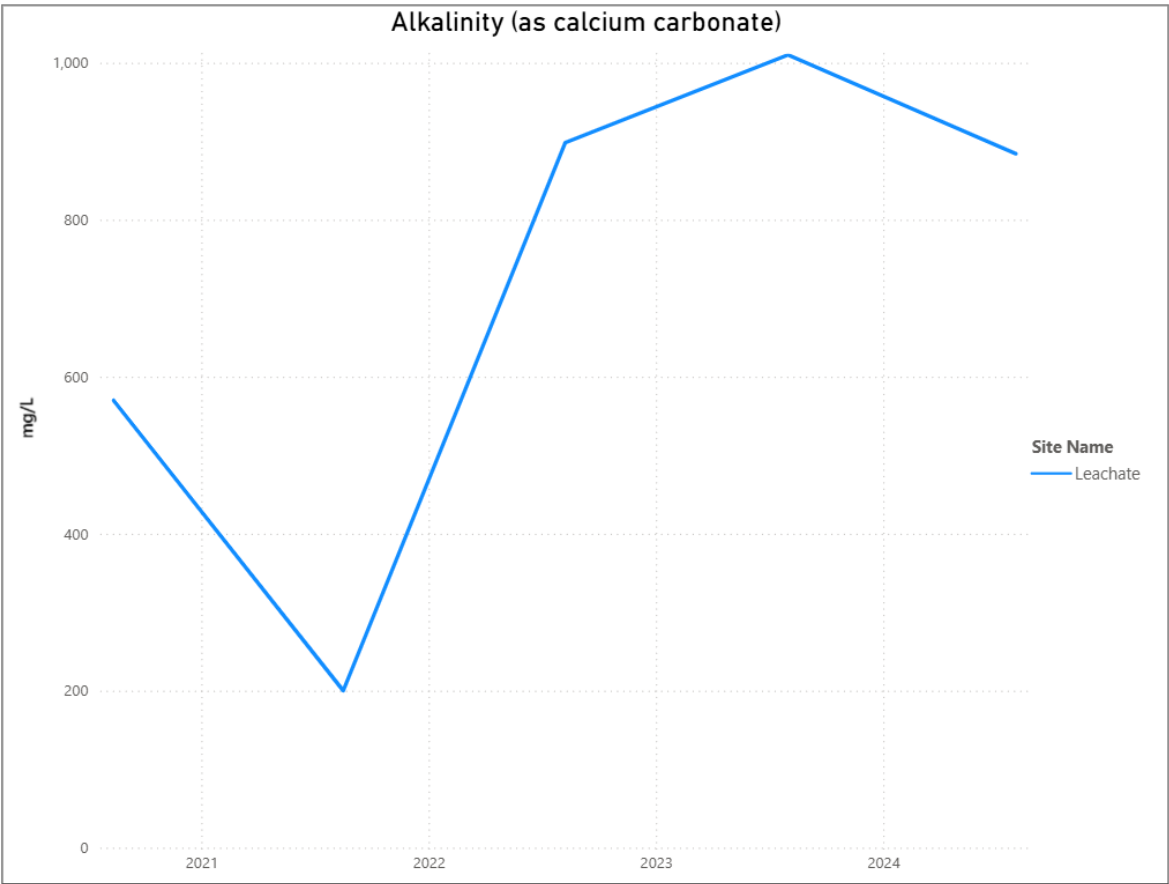
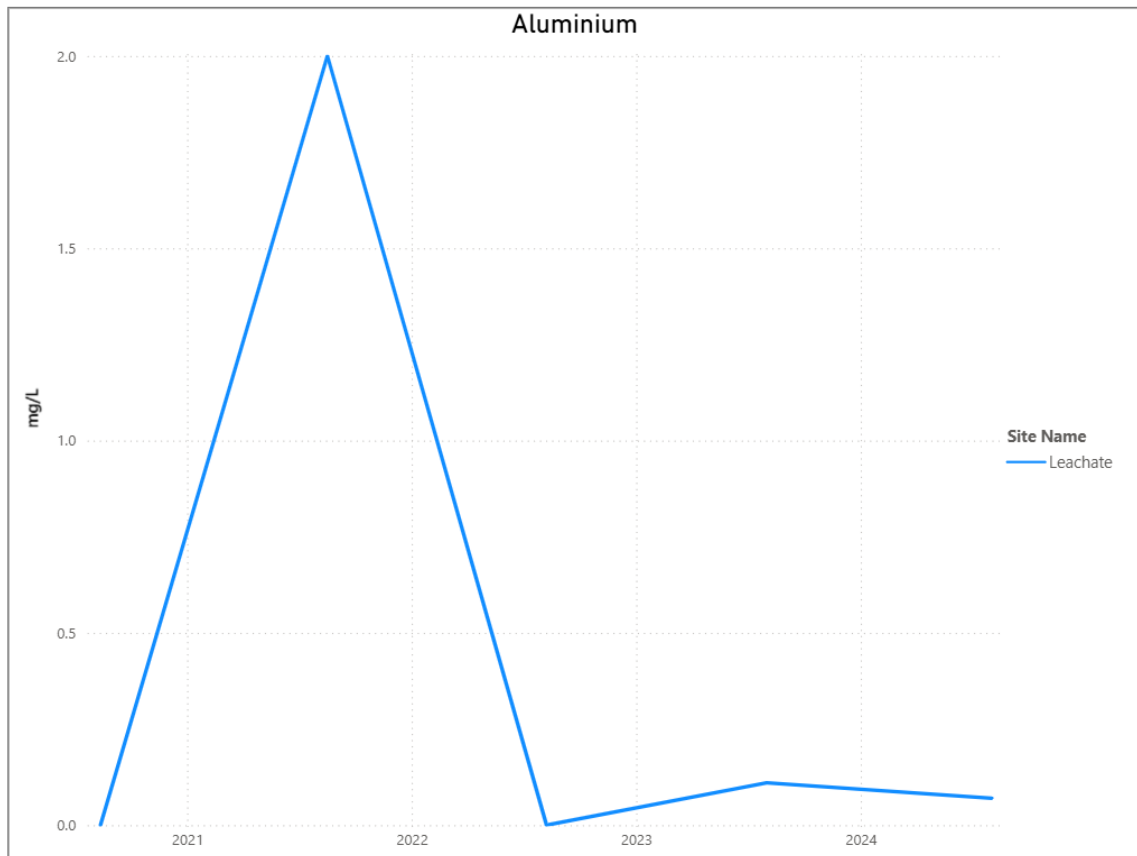
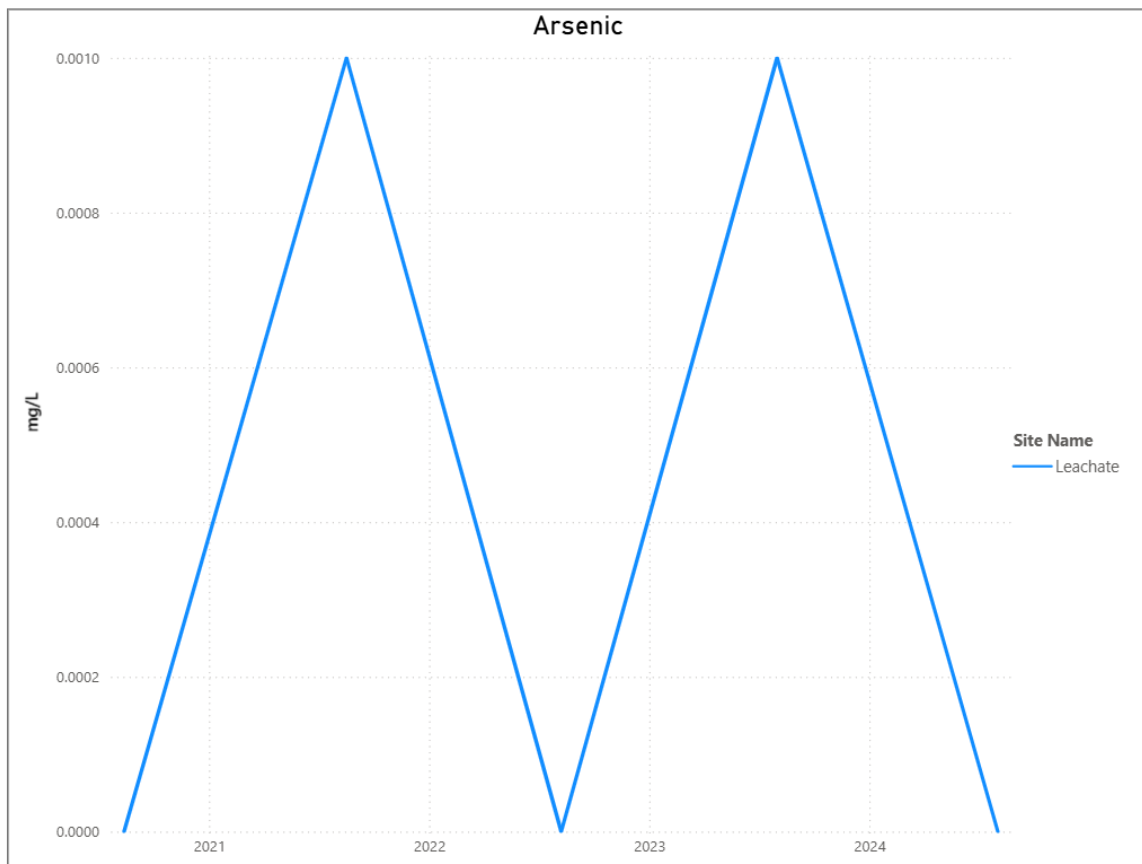
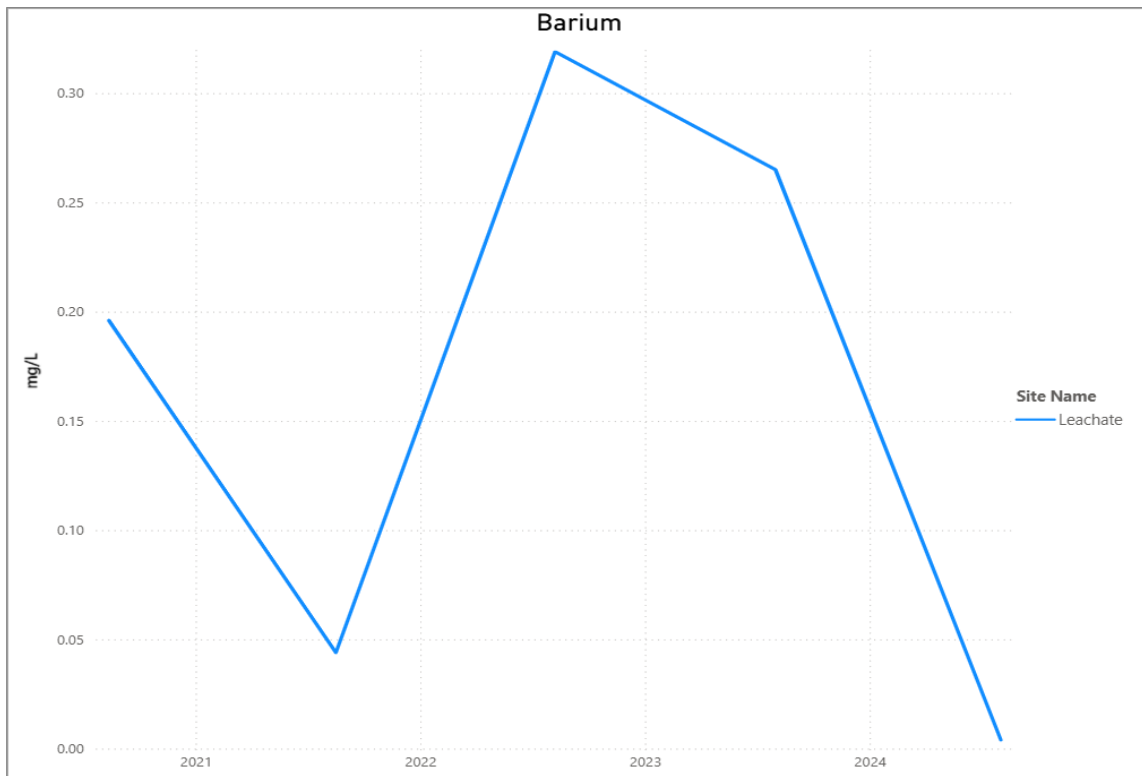
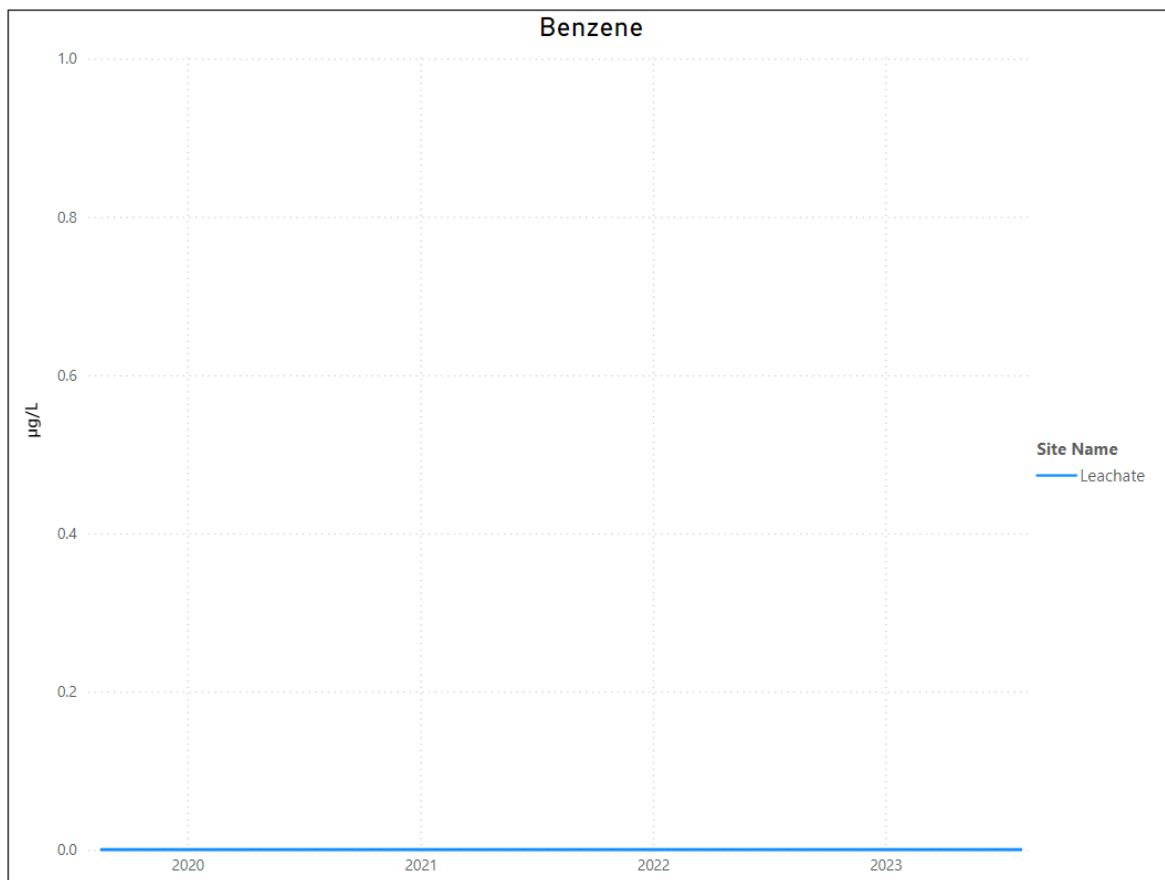
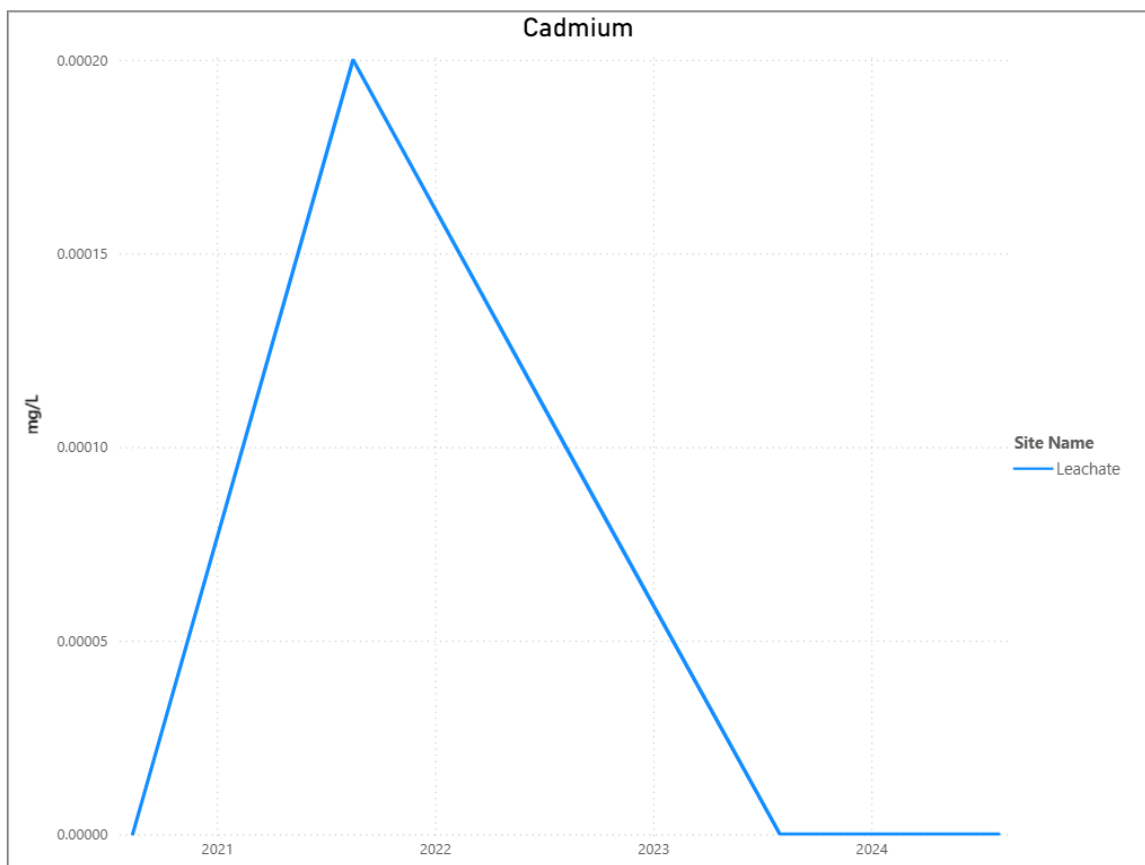
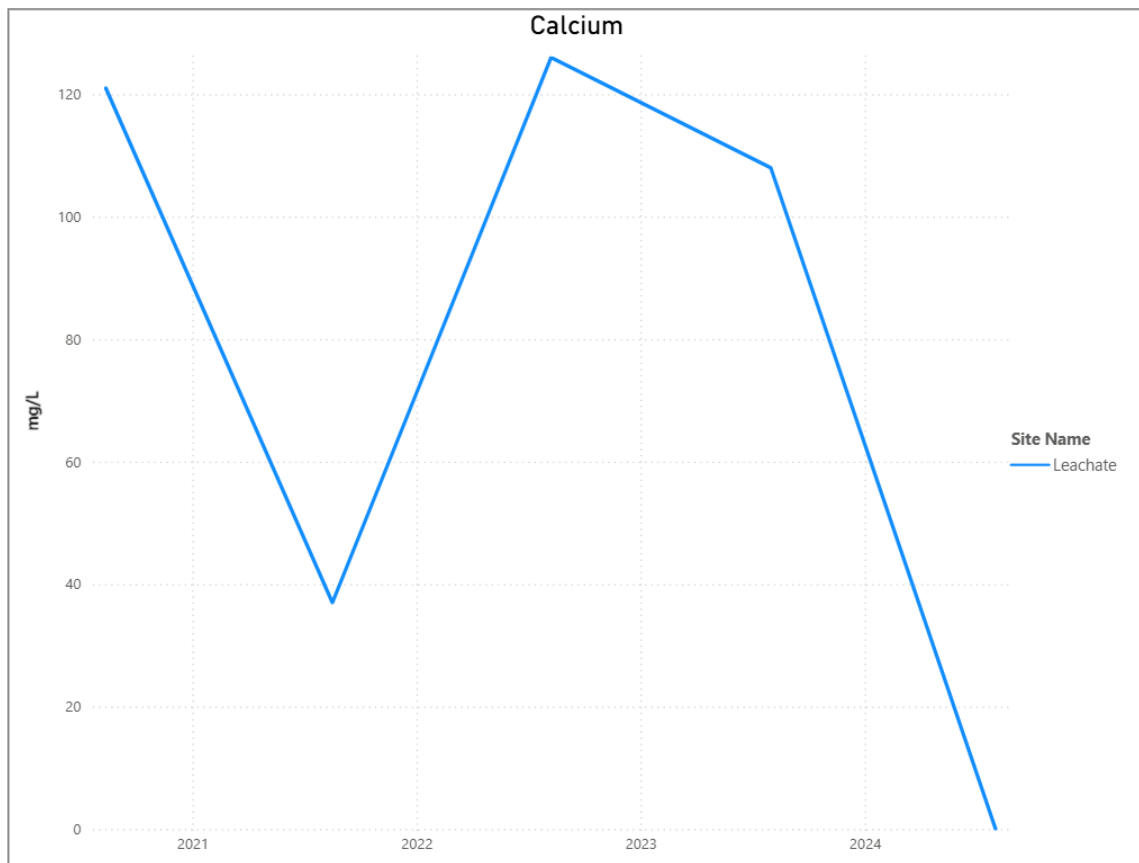
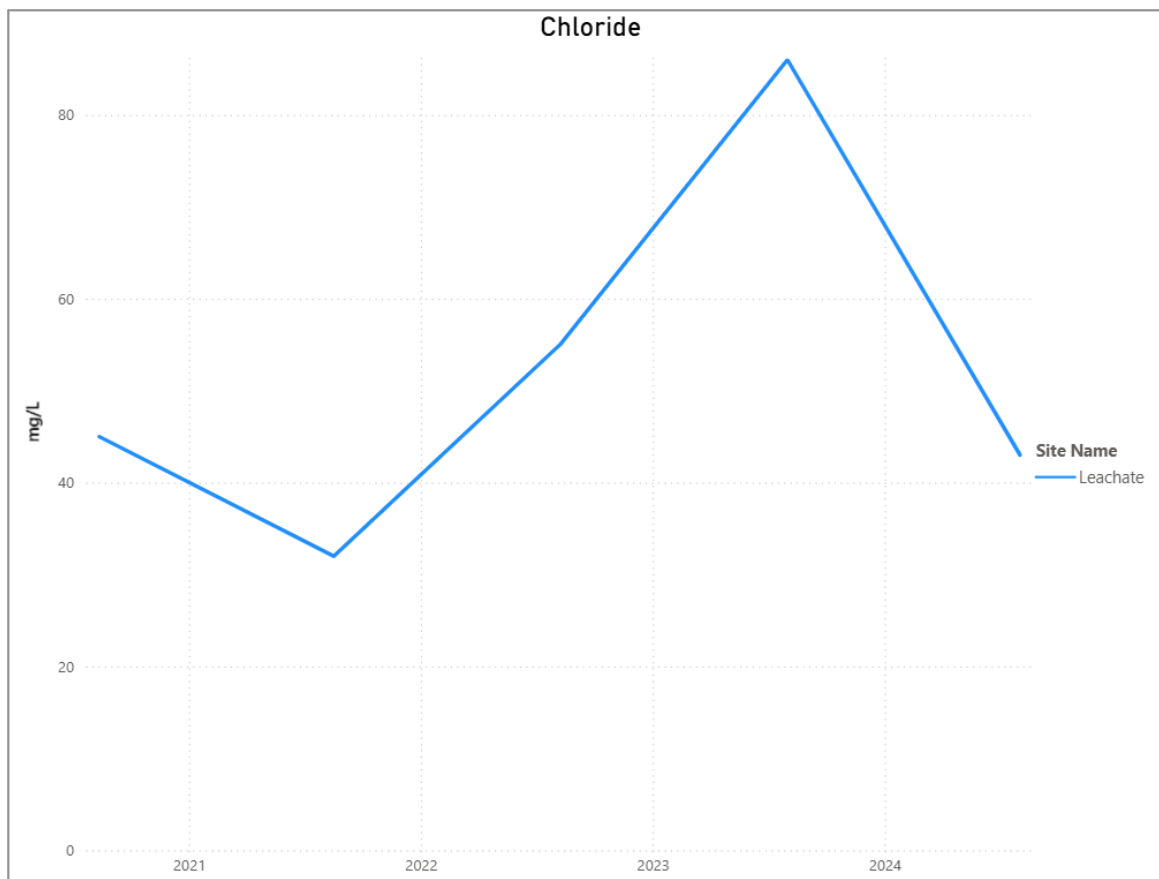
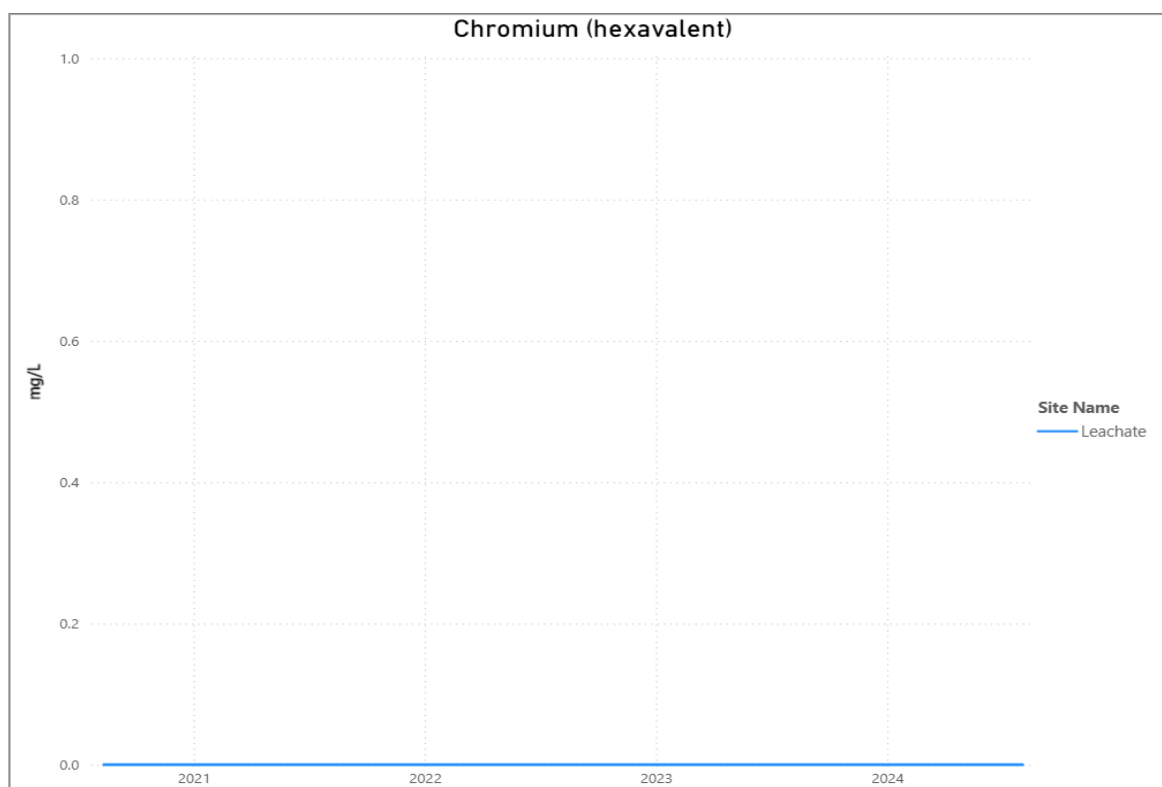
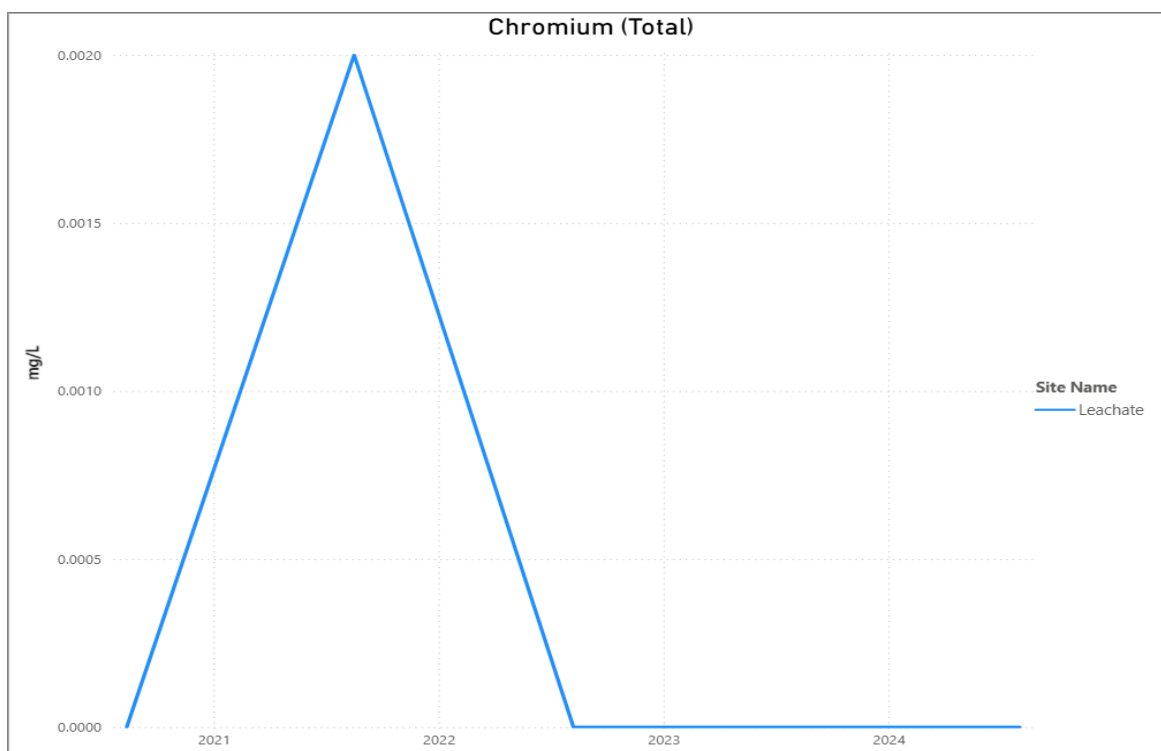
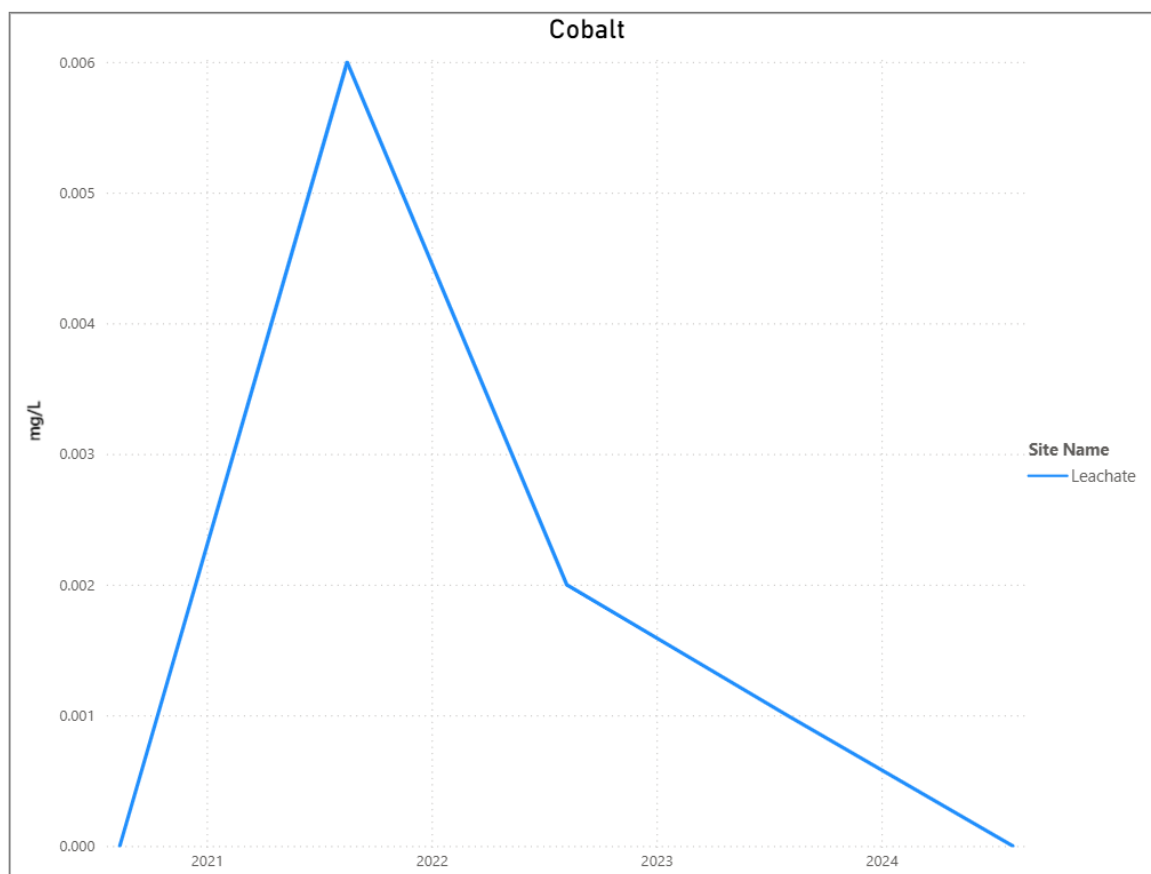
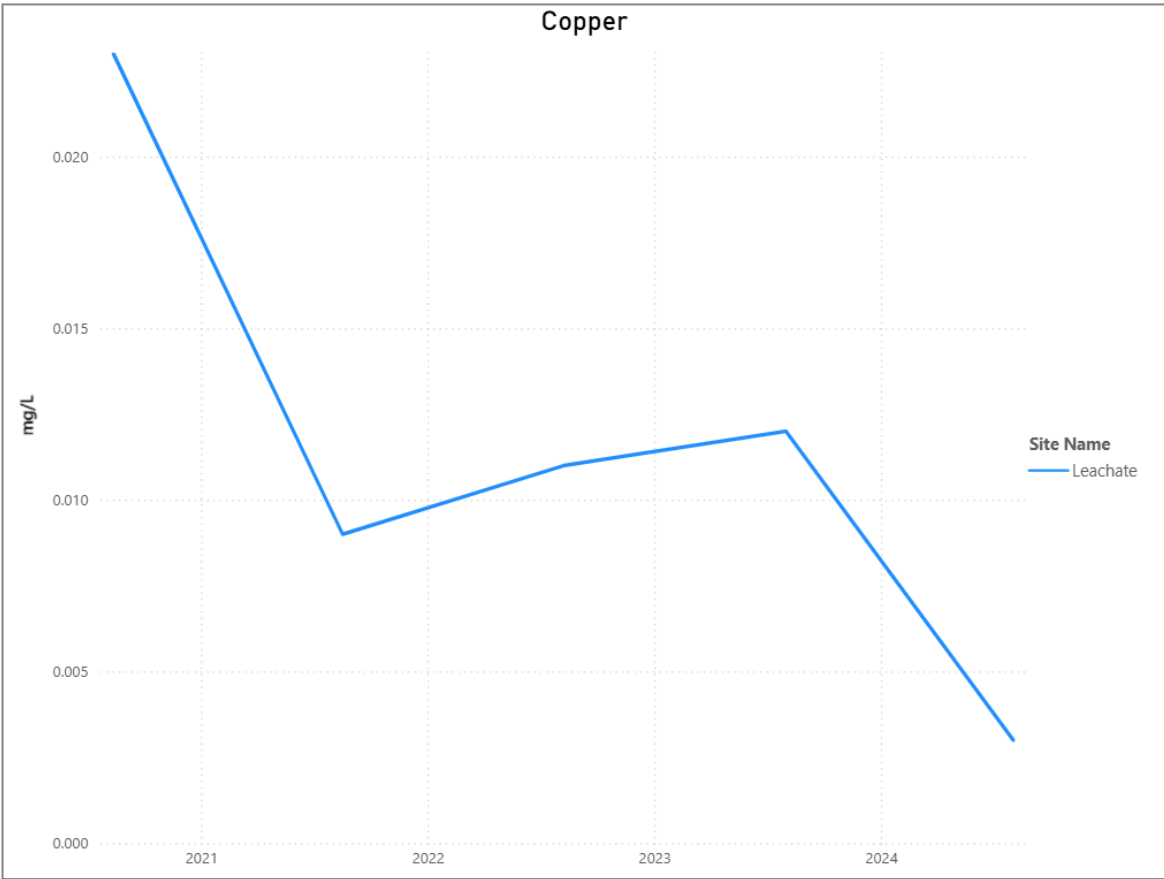
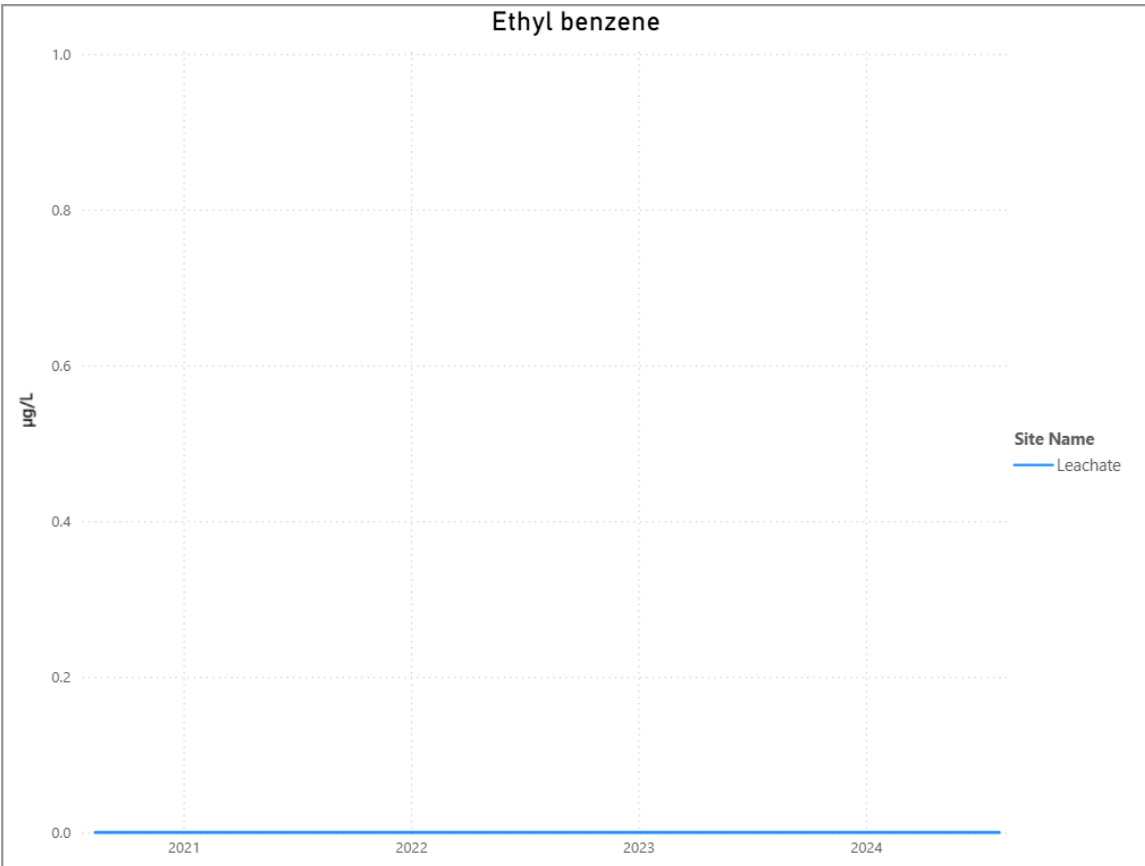
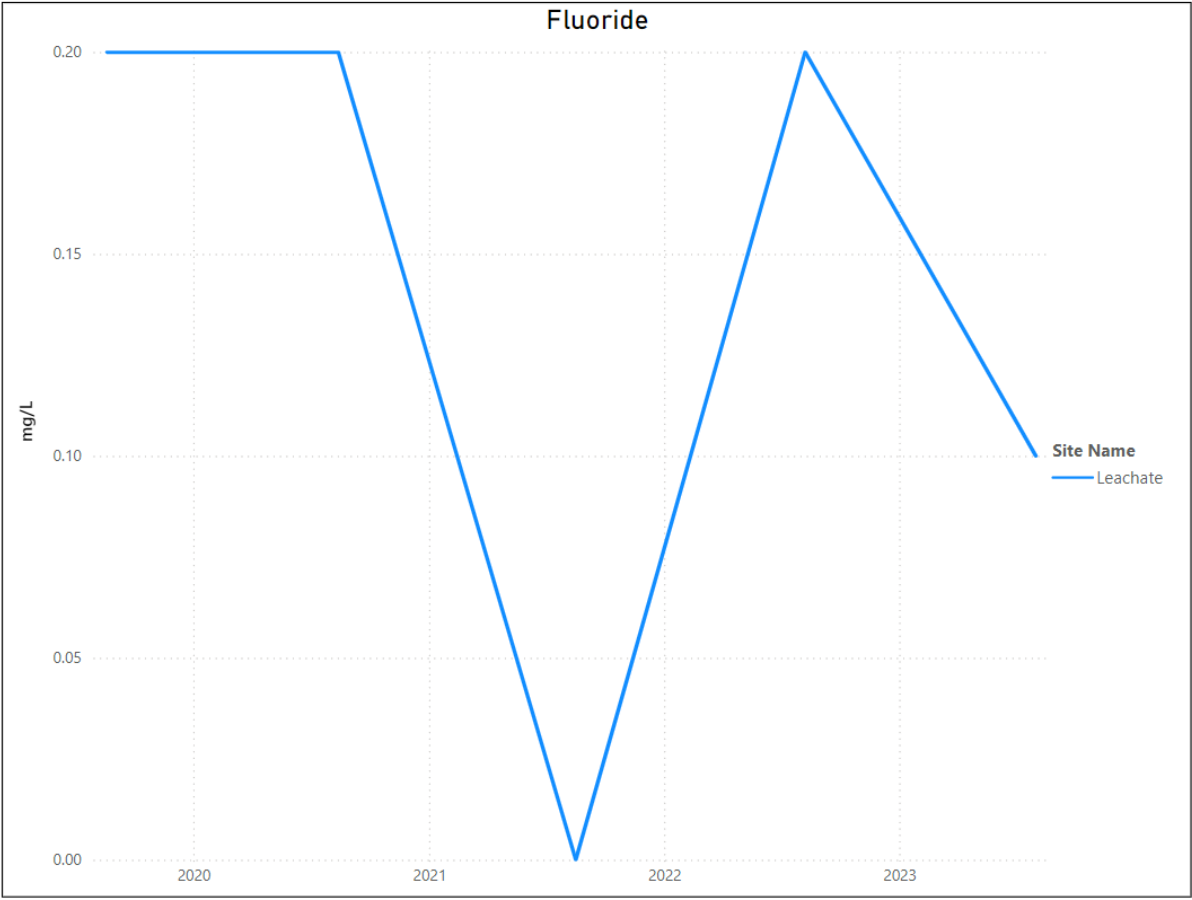
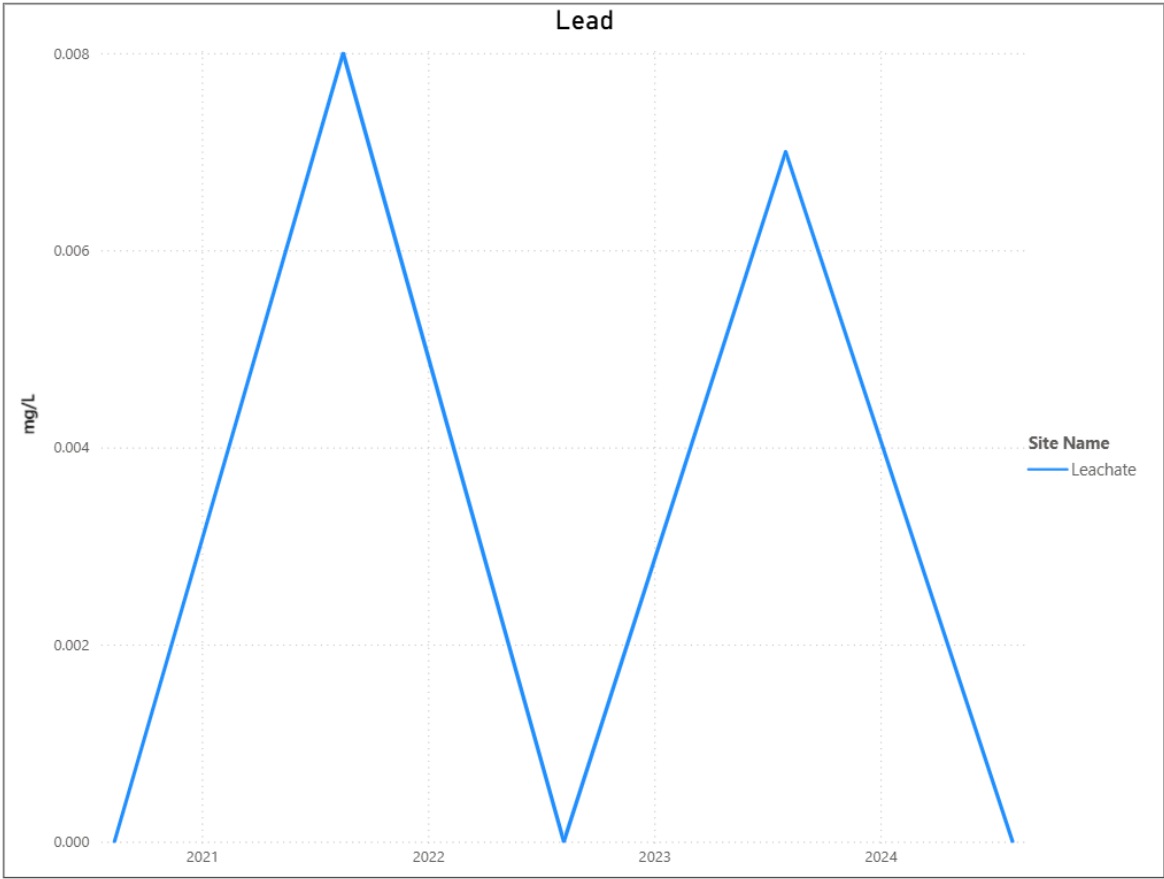
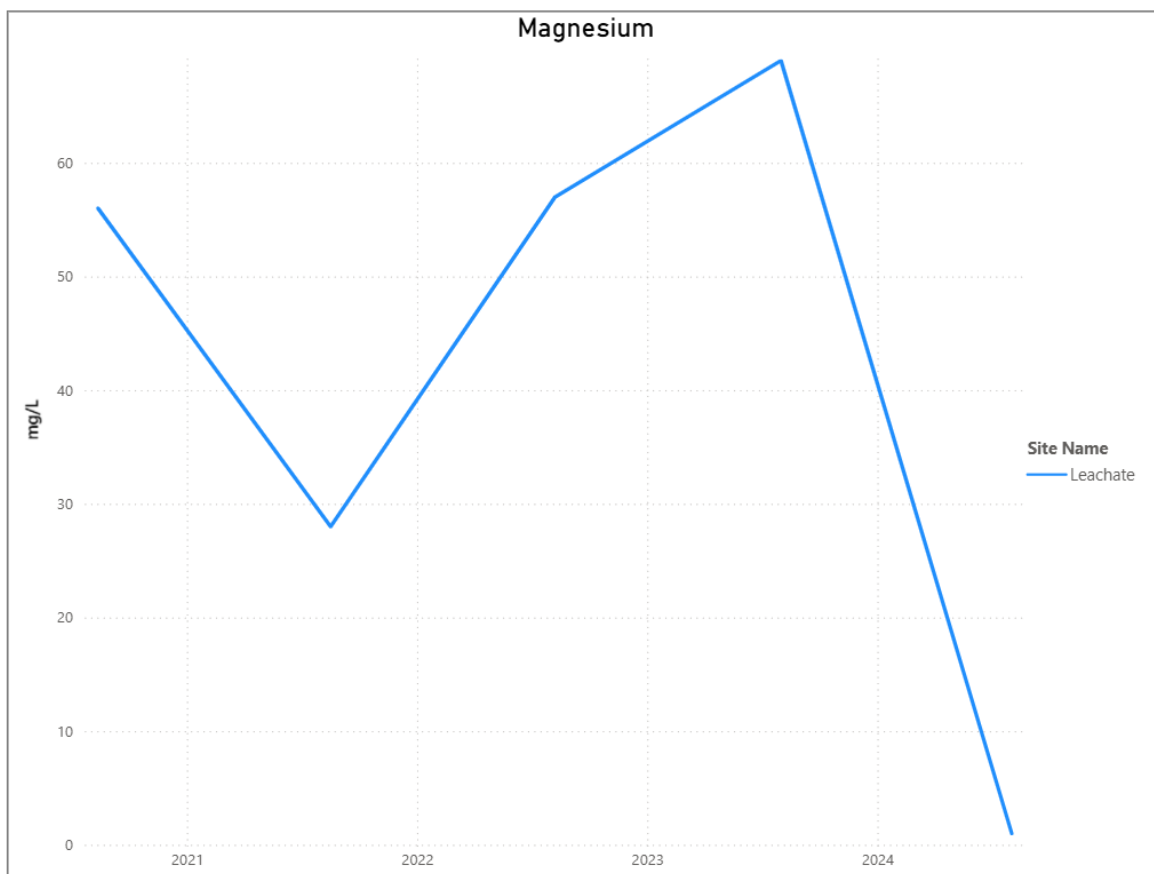
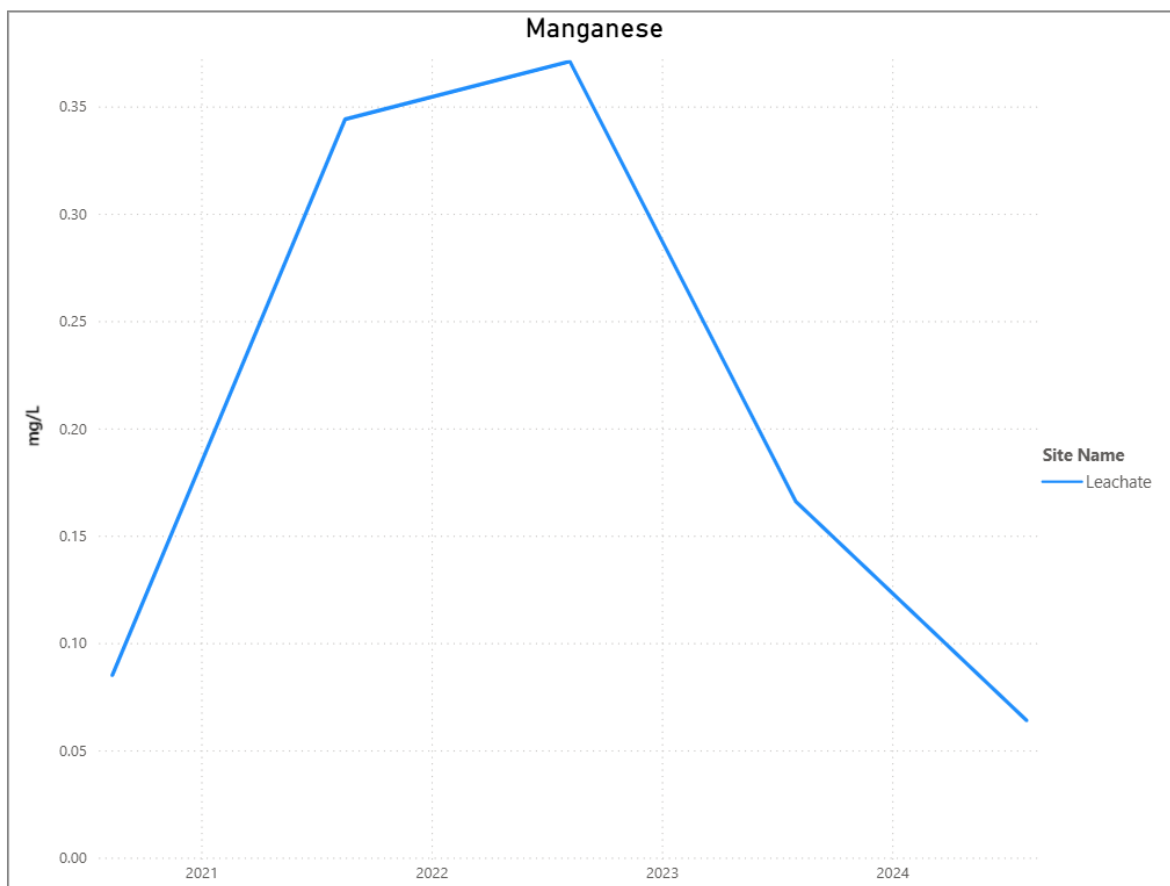
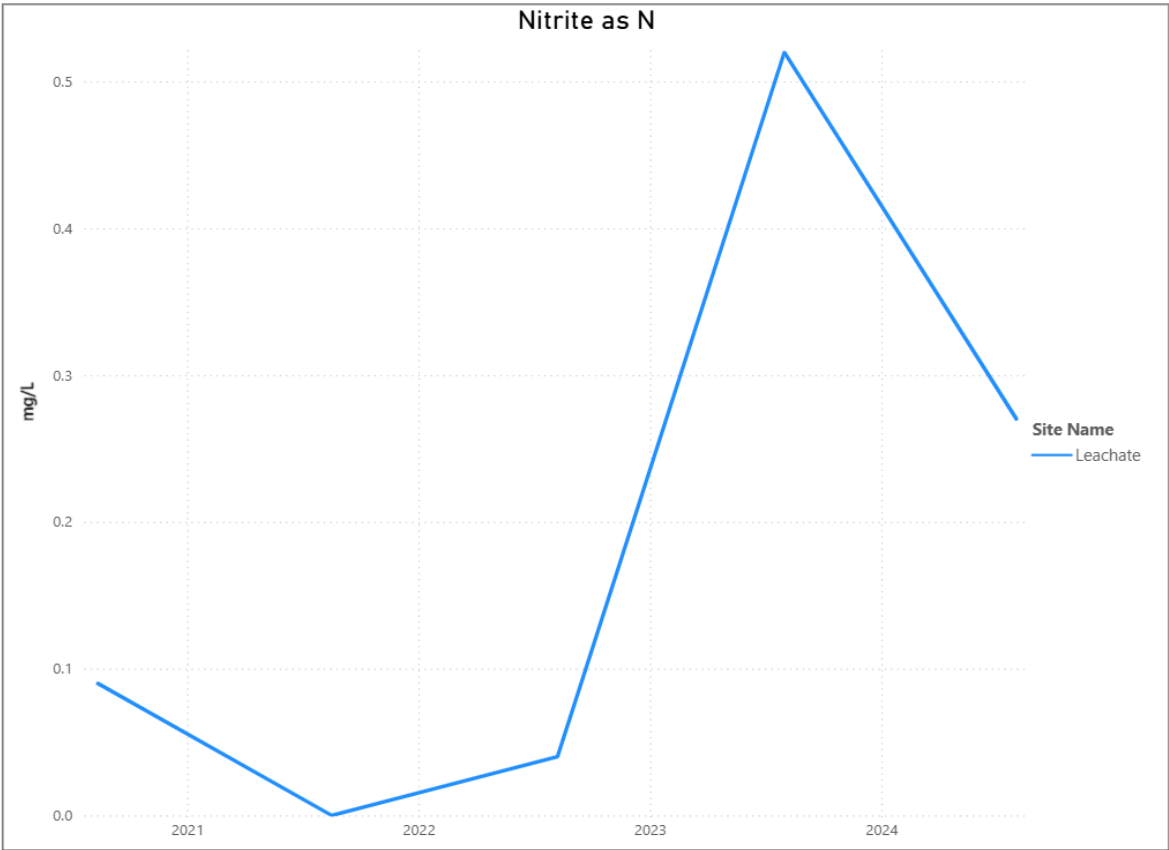
Helensburgh Quarterly Leachate Results including 2024/25 reporting period
