FINAL REPORT:

Lake Illawarra Bank Management Strategy

November 2022

Lake Illawarra Coastal Management Program

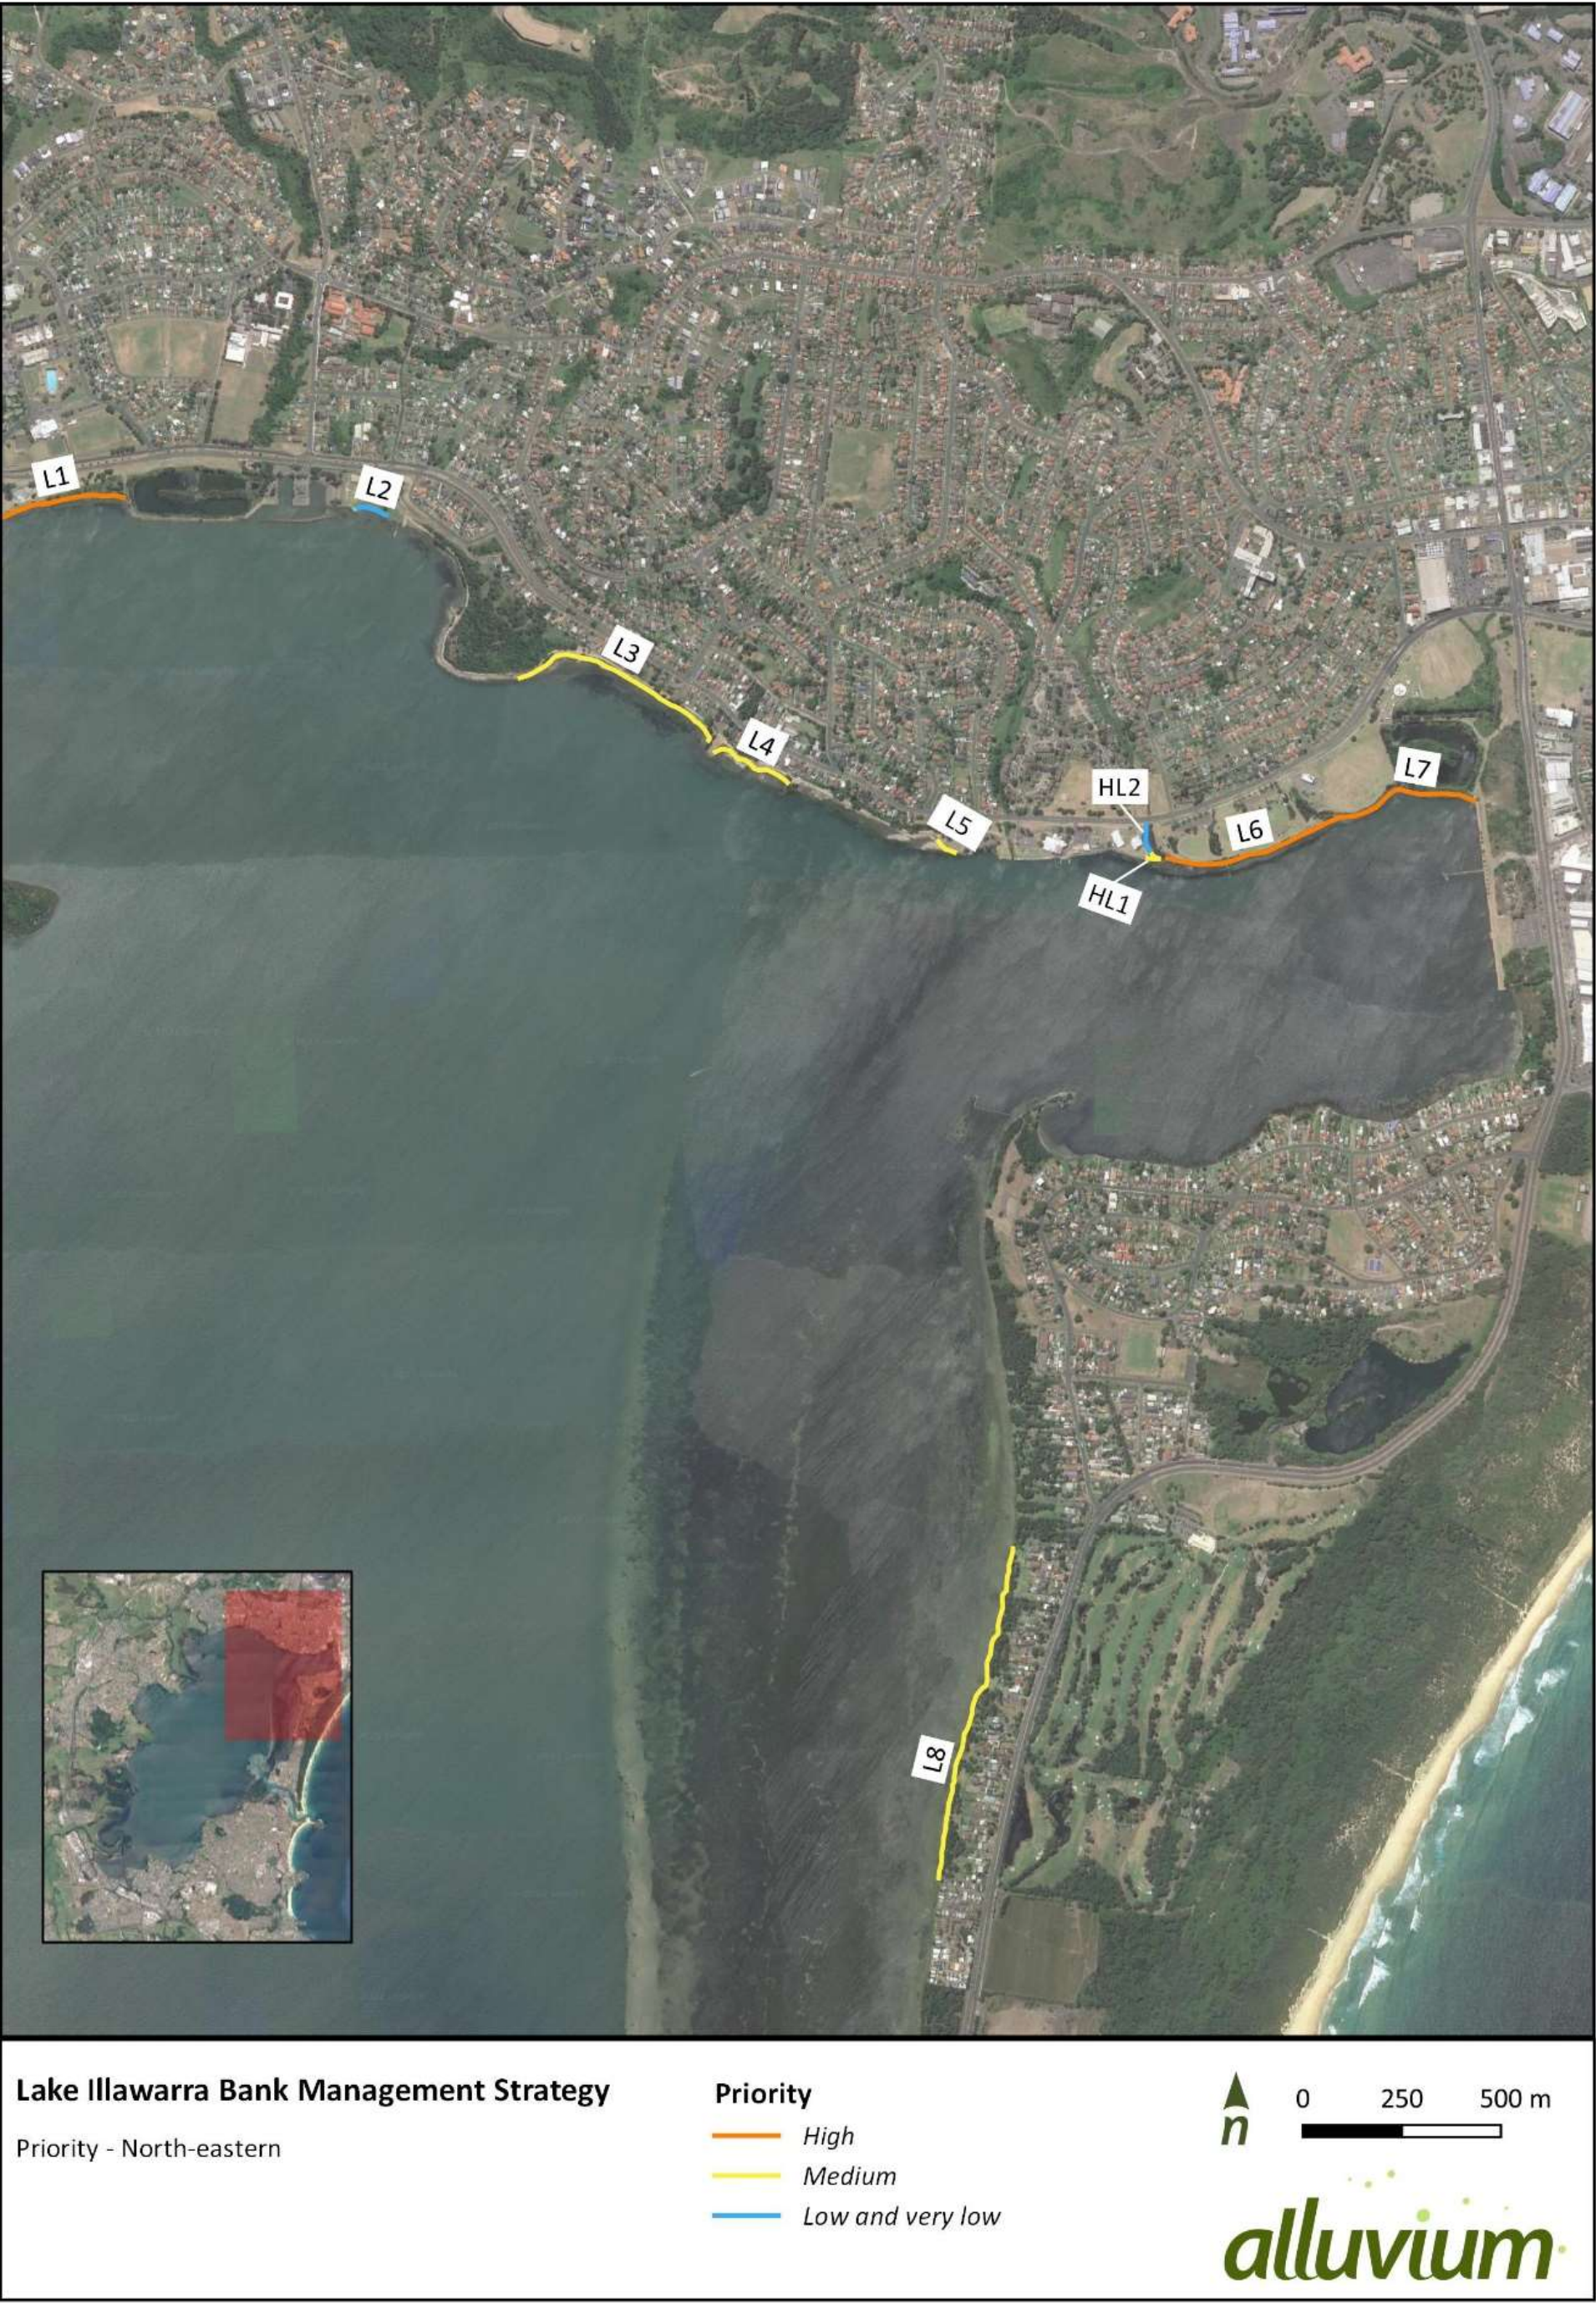
Figure 12. A map showing the priority ranking of sites in the North-eastern quadrant

‡ L20 was lowered to medium priority status due to the minor severity of erosion observed.

* L11 was lowered to low priority status as it is bedrock controlled and so future erosion risk is very little.

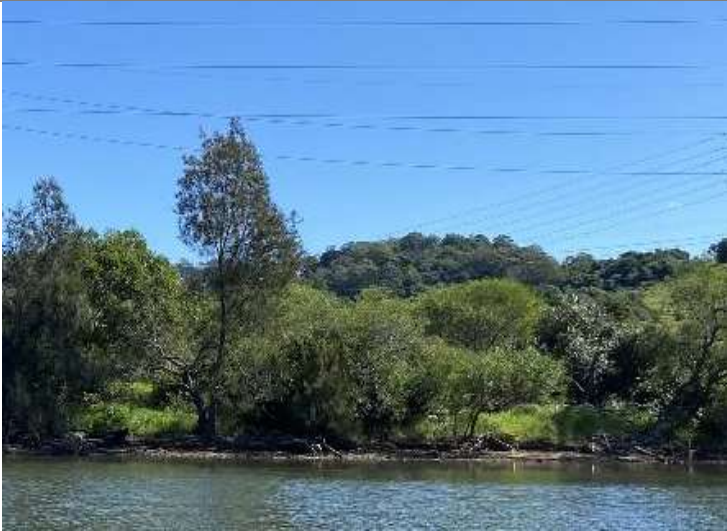
| 4. Lake shoreline with cultural heritage values | <ul style="list-style-type: none"> • Lakefront • Shallow water • Low angle shoreline • Cultural heritage value • Good vegetation coverage • Wind wave dominated erosion • High recent erosion rate | <p>(photo taken on 3 May 2022)</p> | L19 | <ul style="list-style-type: none"> • Toe or bank protection works (rock fillets or logs) • Rock fillet/oyster reef • Consult with Indigenous community on how they would like to protect the site |

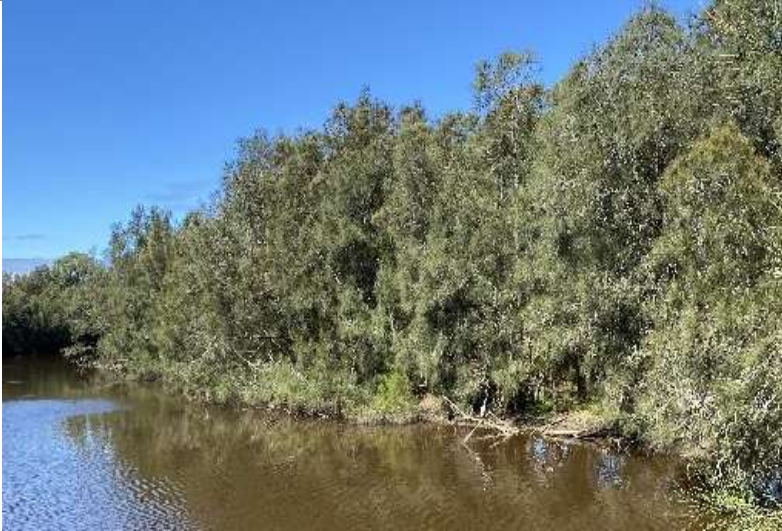
| 6. Tributary channel with good riparian vegetation corridor | <ul style="list-style-type: none"> • Within tributary channel • Steep vegetated banks • Healthy, continuous, and wide vegetation corridor • Undercutting evident in active erosion areas • Exposed to fluvial and tidal currents • Bank saturation ameliorated by vegetation | <p>(photo taken on 5 April 2022)</p> | HK1, HK2, HK3 | <ul style="list-style-type: none"> • Monitor • Develop erosion progression trigger • Large woody debris to reduce fluvial energy and enhance fish habitat in active erosion areas |

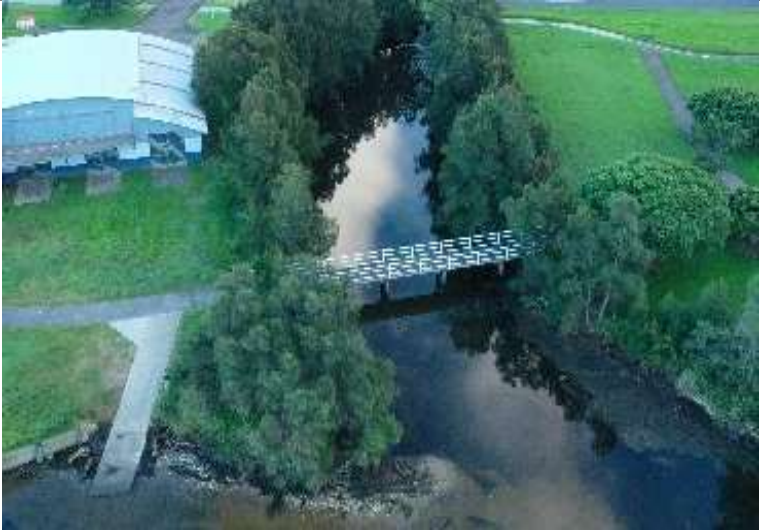
| 8. Tributary mouth | <ul style="list-style-type: none"> • Where tributaries flow into lake • Highly dynamic erosion and sedimentation areas • Low angle shoreline • Exposed to fluvial, tidal and wind wave-driven currents • Good native vegetation coverage with high biodiversity value | <p>(photo taken on 5 April 2022)</p> | HL1, L17 | <ul style="list-style-type: none"> • Monitor • Logs or rock fillet toe to reduce wave energy • Rock fillet/oyster reef |

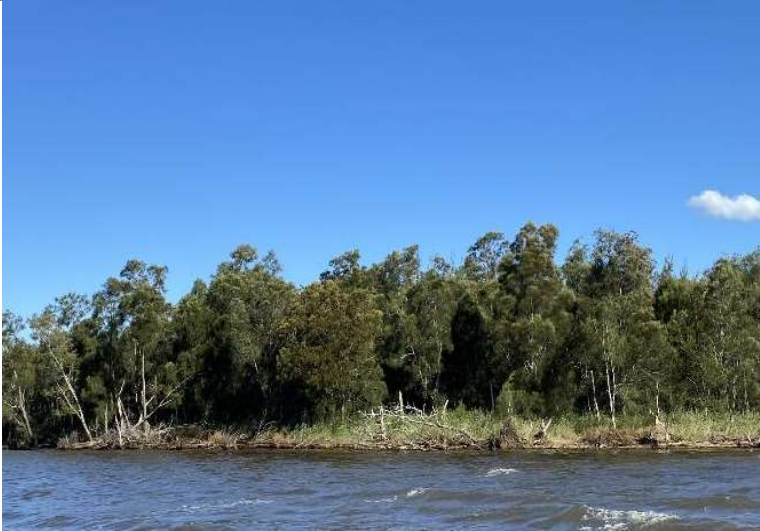
| 9. Tributary mouth with increased acid sulfate soil risk | <ul style="list-style-type: none"> • Where tributaries flow into lake • Highly dynamic erosion and sedimentation areas • Low angle shoreline • Exposed to fluvial, tidal and wind wave-driven currents • Good native vegetation coverage with high biodiversity value • Potential Class 2 acid sulfate soils with further bank retreat | <p>(photo taken on 3 May 2022)</p> | L16 | <ul style="list-style-type: none"> • Reposition fallen timber • Logs or rock fillet toe to protect vegetation • Rock fillet/oyster reef |
